# Pontiac Engine Front Seal Upgrade

By Bill Hanlon

February 8, 2006, updated December 8, 2006

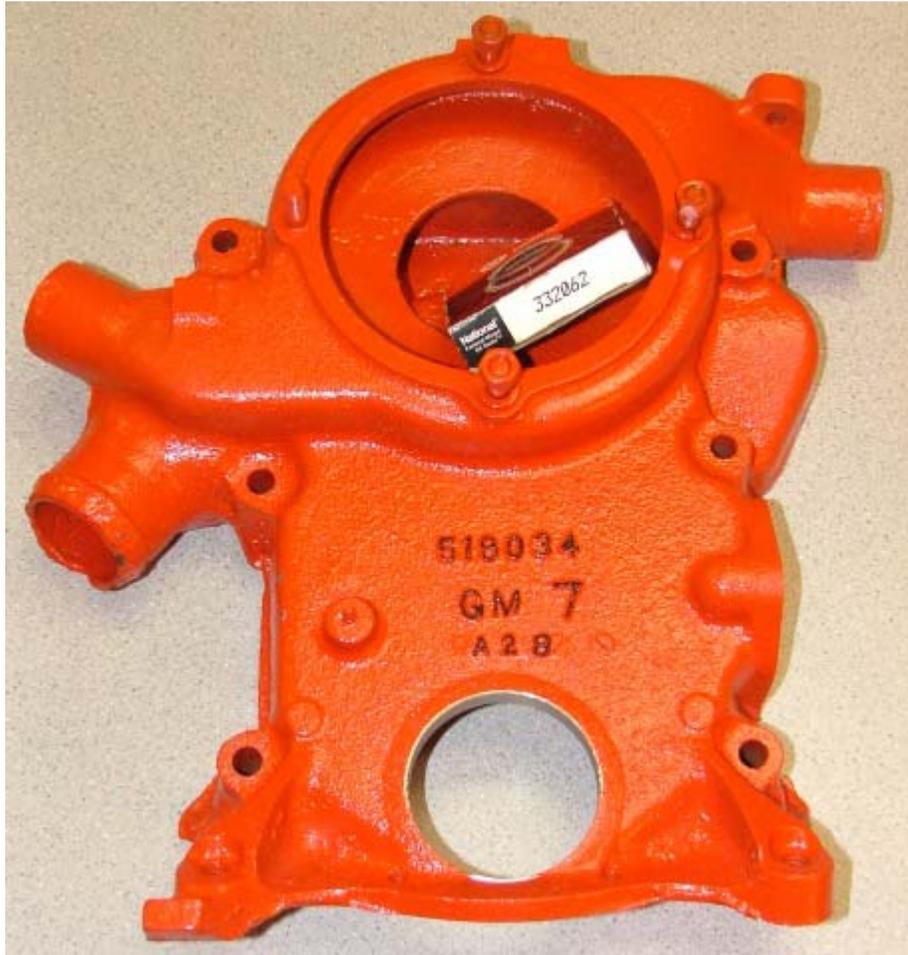
I took the specs, a seal and my '58 timing cover to a machinist friend. He bored all the way through the cover at 2.518"

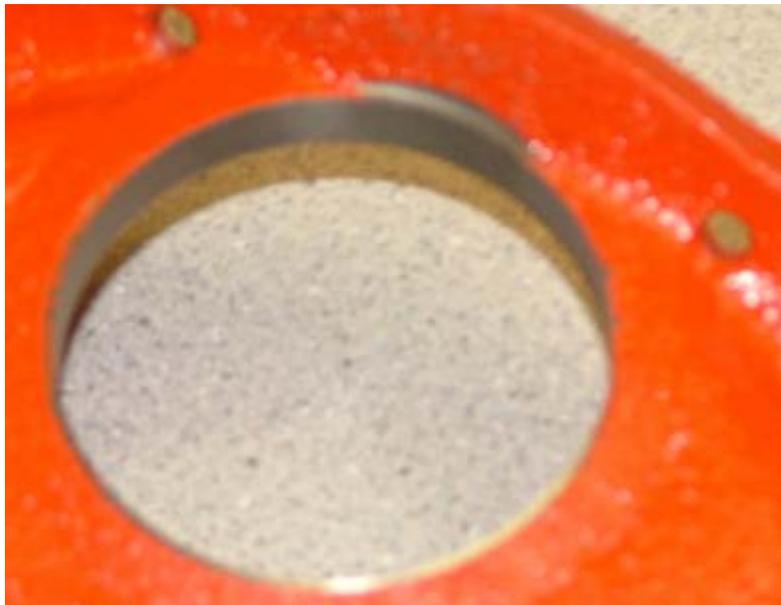
and also cut the opening from the outside another 0.100" larger (2.618") just down to the point that he was touching metal all the way around the opening.

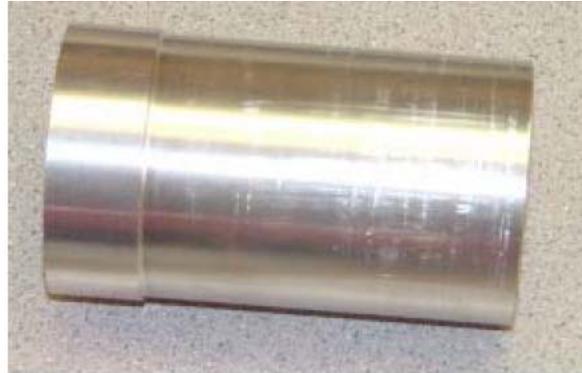
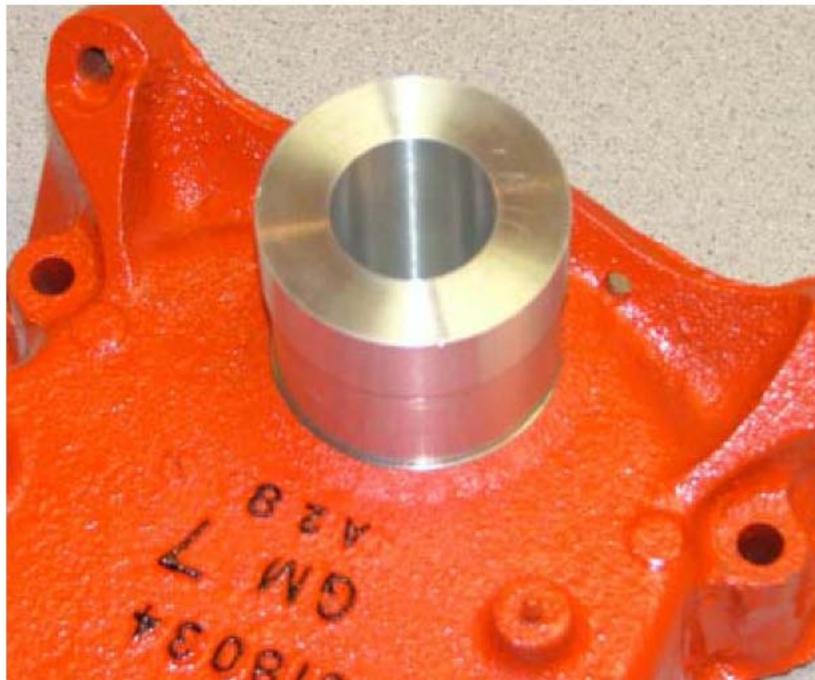
by having the machinist make me an alignment tool.

I had him cut the "alignment tool" ID to 1.377", 0.002" larger than the crankshaft snout so it would slip onto the shaft. I also had him cut a keyway through the ID, larger than the key actually used in the crankshaft. (Didn't do this until AFTER the pictures were taken.) The OD on the small end of the tool is cut to 2.516", 0.002" smaller than the bore through the timing cover, making it a slip fit into the cover. The OD on the large end of the tool is 2.600".

After installing the new timing cover to block gasket onto the modified timing cover, I slid the small end (2.516") of the tool into the cover and then slipped the tool over the end of the crankshaft to align the timing cover. Tightened the cover down and removed the tool. The cover hole is now centered (give or take 0.004") over the crankshaft snout.

To install the seal I placed the seal over the crank snout with the internal lip pointing towards the engine and then turned the tool around, big end (2.600") towards the timing cover. This bigger diameter won't fit into the newly bored out opening, but instead will "bottom out" on the face of the cover that I had the machinist cut at 2.618". This prevents the possibility of driving the seal too deep (or even all the way through) the hole. A few taps with a mallet and the seal was home.

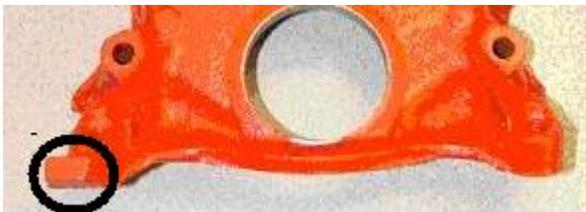
Another mod I would make while doing this job is to cut off the tab in the circle below. Why you ask? Because if you ever decide to mount a belt driven accessory (like an A/C compressor) on the passenger's side of the engine outside of the head and below the valve cover you will find that the belt will be pushed forward about 1/8" by this tab if the belt is coming off the rearmost crankshaft pulley.
