# PONTIAC

## Service Craftsman News

No. 9 S-266

# 1955 NEW MODEL INFORMATION

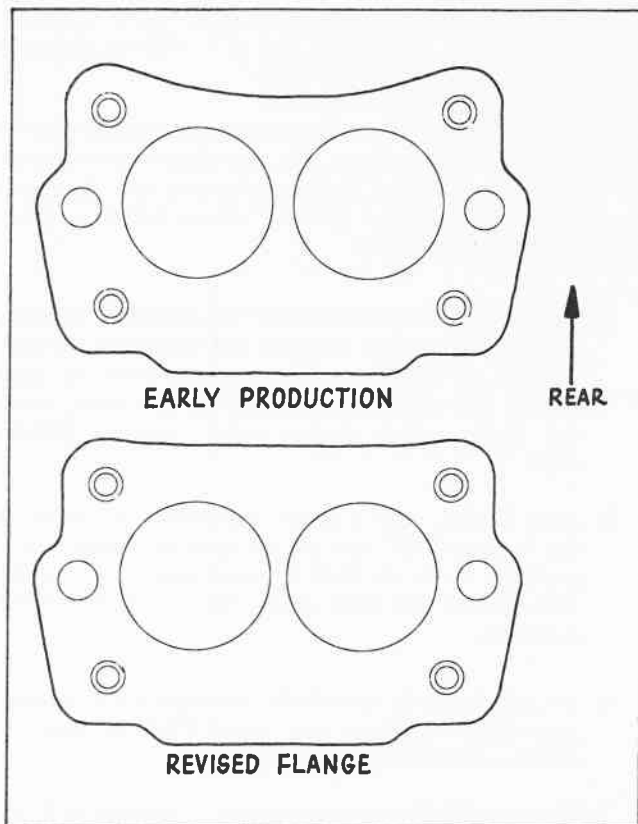
Fig. 2 Early and Revised Type Intake Manifolds

Approximately 1,000 engines have been built with an intake manifold which will accommodate the Carter Carburetor only. After these first 1,000 engines, the manifold casting is changed so as to accommodate either the Rochester or Carter carburetors. The early manifold can be identified by a curved section at the rear of the carburetor mounting flange (Fig. 2) while the revised manifolds are nearly straight across the rear of the carburetor mounting flange.

If a Rochester Carburetor is inadvertently installed on one of the early intake manifolds, there is a possibility of a high vacuum leak at the windshield wiper vacuum passage in the carburetor flange due to insufficient sealing area.

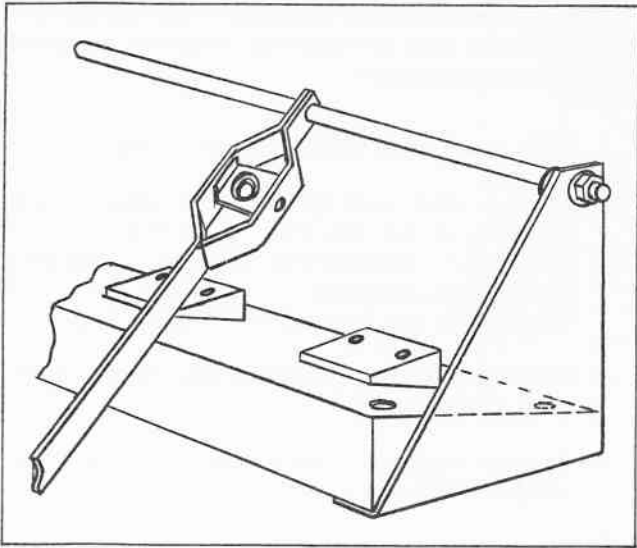
Fig. 5 Correct Assembly of Tool J-5712

Tool J-5712 is shipped disassembled and must be assembled in the dealership. Fig.5 shows the proper assembly of the base and end pieces. Note that the thinnest edge of the base goes to the vertical edge of the end pieces. Improper assembly will result in incorrect operation of the tool.

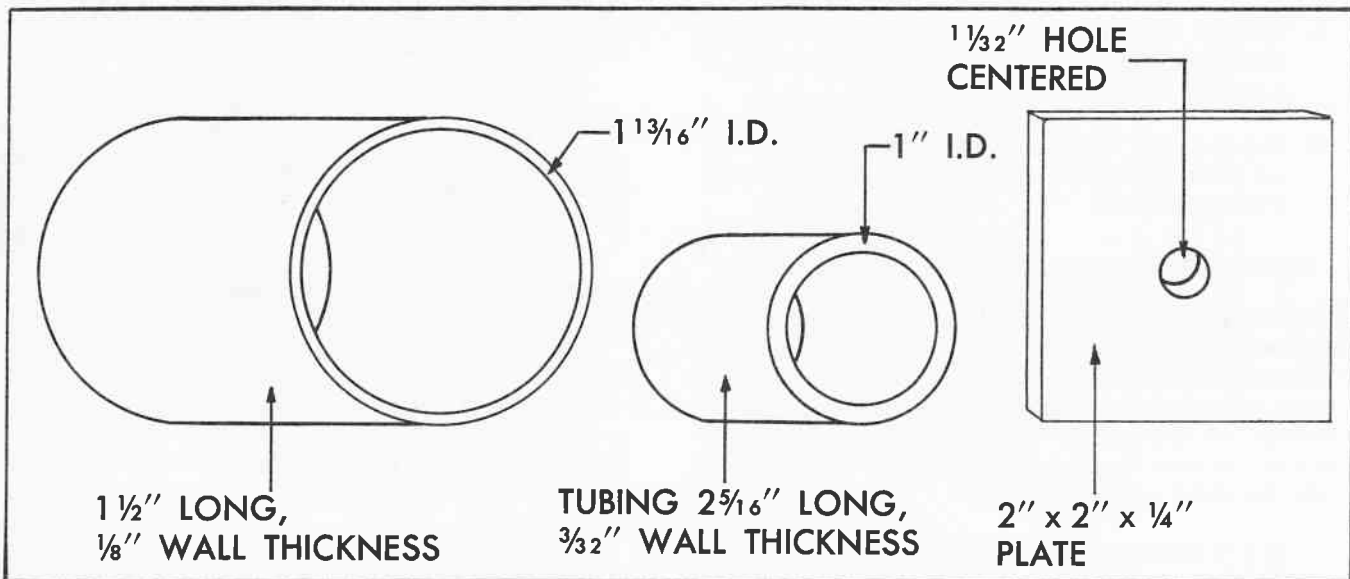
Fig. 6 Installation Tools For Compressor Shaft Seal Repair

If there is an indication of a compressor shaft seal leak, evidenced by the presence of oil around the shaft seal, check around shaft area with a leak detector. When the seal was originally assembled all parts were dipped in oil and visible oil may be surplus forced out in operation.

If the leak detector indicates a refrigerant leak, all seal parts must be replaced. Following is the seal replacement procedure.

1. Make installation tools as shown in Fig. 6.
2. Procure shaft seal kit #3134106 which contains one each of the following: Shaft Seal "O" Ring, Seal Seat, Seal Bellows "O" Ring, Snap Ring, Seal Bellows Assembly. These parts are illustrated in Fig. 7.
3. Attach manifold gauge set to compressor and pump down compressor.
4. Remove magnetic clutch assembly, spacer and brush and bracket assembly.
5. Clean front of compressor with a stiff brush using carbon tetrachloride as a solvent and blow clean and dry with compressed air.
6. Remove seal plate snap ring with #2 Truarc pliers or with screwdriver and needle nose pliers.
7. Remove seal seat and seal bellows assembly. (Pry off each with a screwdriver.)
8. Remove seal bellows "O" ring 3134092 (in seal face plate and bearing retainer) by using a sharp awl or a small screwdriver.
