# PONTIAC

## Service Craftsman News

No. 3 S-270

# ELECTRIC WINDOW REGULATOR SERVICE INFORMATION

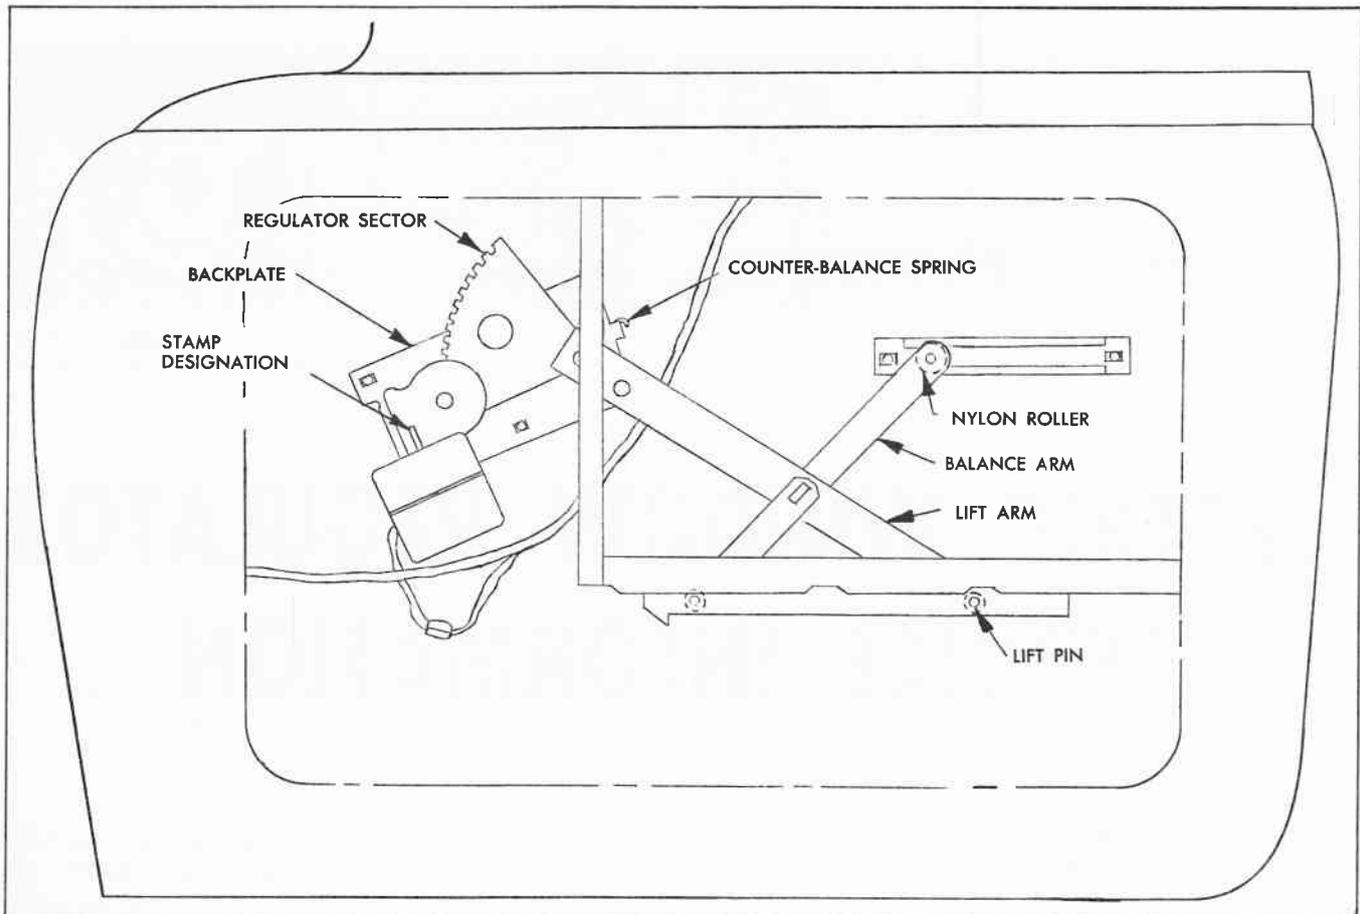
Fig. 1 Electric Window Regulator Assembly

1. Evidence of Pinion Gear Overtravel on Sector Gear - If the check of the regulator assembly installation revealed that the motor pinion gear

had jammed at the end of the regulator sector gear, extra teeth may be filed at the end of the sector gear. It is extremely important to make the extra teeth conform to the rest of the teeth, otherwise the condition can recur. Carefully check the added teeth for proper fit with the pinion gear teeth.

2. **Extreme Side-play of the Sector Gear** - If backplate or side of sector gear next to the backplate show that surfaces are contacting on any portion of the travel of the sector gear, the assembly should be replaced. (Paint will be scraped off at areas of contact.) This condition is due to a loose stud at the counter-balance spring and sector gear to backplate.
3. **Lift Arm Pins Too Loose** - If any of the lift pins

(the studs which retain the nylon roller to the regulator assembly) are loose, they should be tightened to prevent the pins from falling off and disengaging window from regulator during operation. The pins are of a rivet type construction and can be tightened by a normal riveting procedure. If they cannot be tightened satisfactorily, replace the regulator.

4. **Nylon Rollers Binding in Channels** - If the rollers do not slide easily in their channels, greater clearance may be obtained by filing edge of channel or aligning channel to roller with pliers.
5. **Bent or Distorted Regulator Backplate** - Replace regulator assembly.
6. **Lubrication:**
  - a. If operation is noisy due to lack of lubrication between the coils of the counter-balance spring, lubricate between the coils with a graphite grease.
  - b. Lubricate all studs with a medium grade oil.

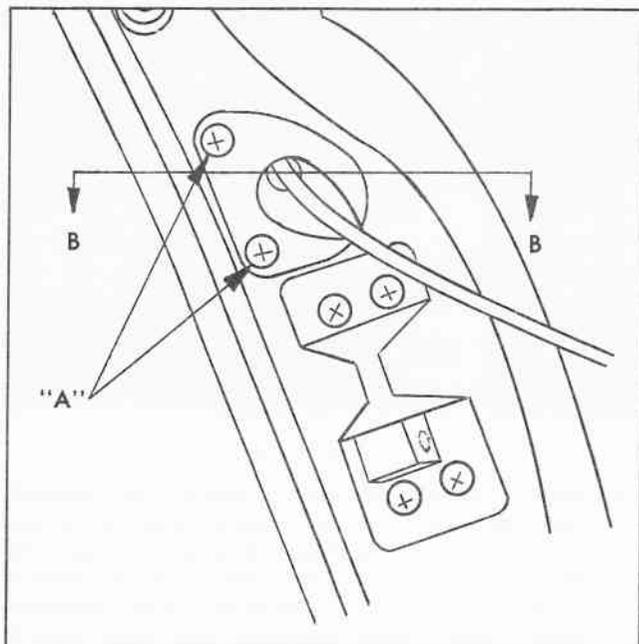
Fig. 5 Tail Gate Cable Support Guide

If the tail gate support cable binds at the rubber grommet installed on the back body opening facing reinforcement, the following procedure may be used to replace the rubber grommet with a new wax-impregnated felt grommet. The new grommet is re-

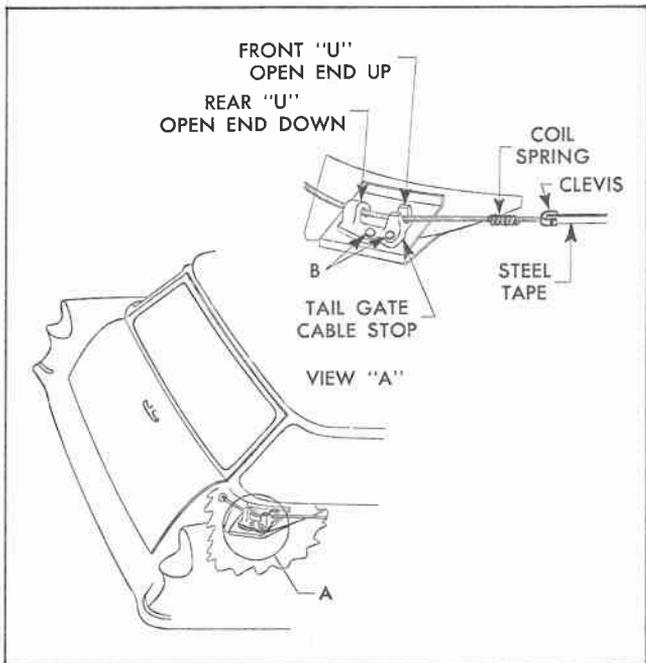
Fig. 7 Installation of Tail Gate Cable Stop

If either of the following conditions are encountered, the tail gate cable stops may have been installed on the wrong side of the body and should be checked for proper installation.

1. On the right side of the body, reach up between the rear quarter inner and outer panels and check the cable stop to make certain it is installed with the open end of front "U" facing upward, as shown in Fig. 7.
2. On the left side of the body reach in through the gas tank filler neck door and check the cable stop to make certain it is installed with the open end of the front "U" facing upward.

3. If either or both cable stops are improperly installed, remove the stop or stops and reinstall as described below.

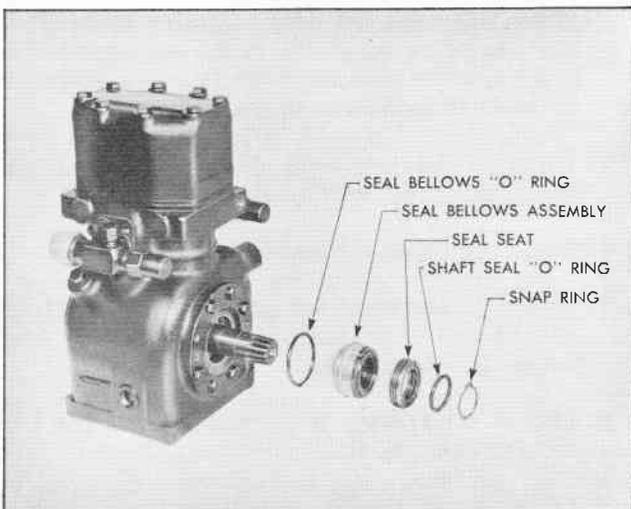
Fig. 8 Exploded View of Compressor Shaft Seal Assembly

If there is an indication of a compressor shaft seal leak, evidenced by an excessive amount of oil around the shaft seal, check around shaft area with a leak detector. When the seal was originally assembled all parts were dipped in oil and visible oil may be surplus forced out in operation.

If the leak detector indicates a refrigerant leak, all seal parts must be replaced. Following is the seal replacement procedure.

1. Procure shaft seal kit #3134106 which contains one each of the following: Shaft Seal "O" Ring, Seal Seat, Seal Bellows "O" Ring, Snap Ring, Seal Bellows Assembly. These parts are illustrated in Fig. 8.
2. Attach manifold gauge set to compressor and pump down compressor (see page 30 1954 Air Conditioning Shop Manual).
3. Remove magnetic clutch assembly, spacer and brush and bracket assembly.
4. Clean front of compressor with a stiff bristle brush using carbon tetrachloride as a solvent and blow clean and dry with compressed air.
5. Remove seal plate snap ring with #2 Truarcl pliers or with screwdriver and needle nose pliers.

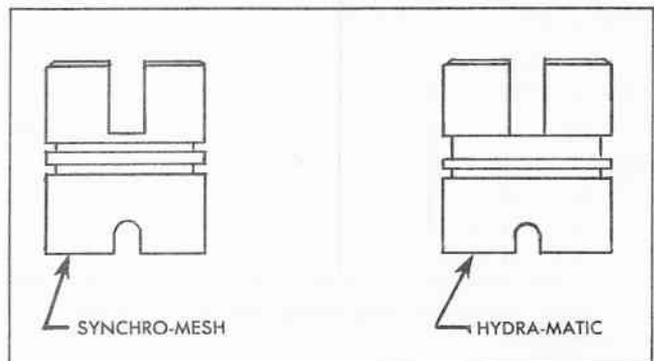
Fig. 11 Hydra-Matic and Synchro-Mesh Choke Pistons

A slightly different choke piston is used on the Synchro-Mesh carburetor. The Synchro-Mesh piston has two narrow grooves of equal width while the Hydra-Matic choke piston has one wide and one narrow groove. (See Figure 11). These pistons should not be interchanged.

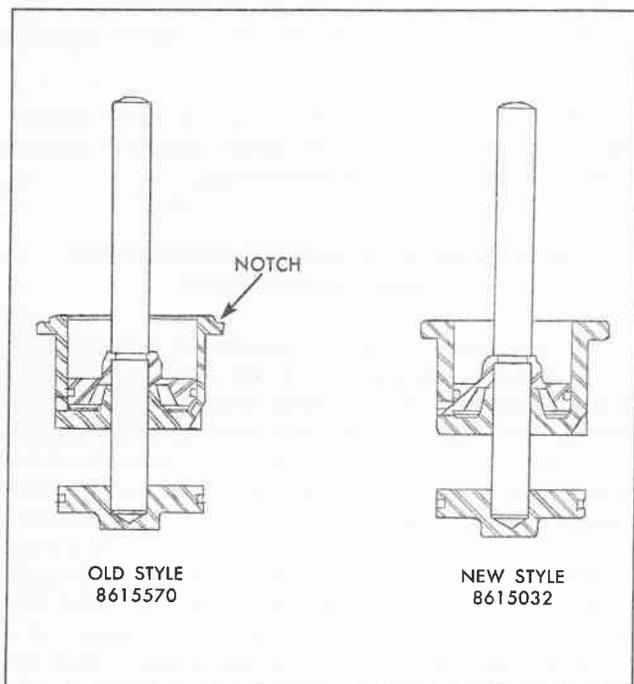
A new front servo band apply piston assembly is now in production beginning with transmission number P55-109663. The new assembly has a smaller diameter compensator piston which improves the forced 4-3 downshift. It will also improve other shifts slightly.

The part number of the new assembly is 8615032 and it can be identified by the compensator sleeve, as shown in Fig. 15. Only the new assembly should be used in servicing the 1955 front servo.

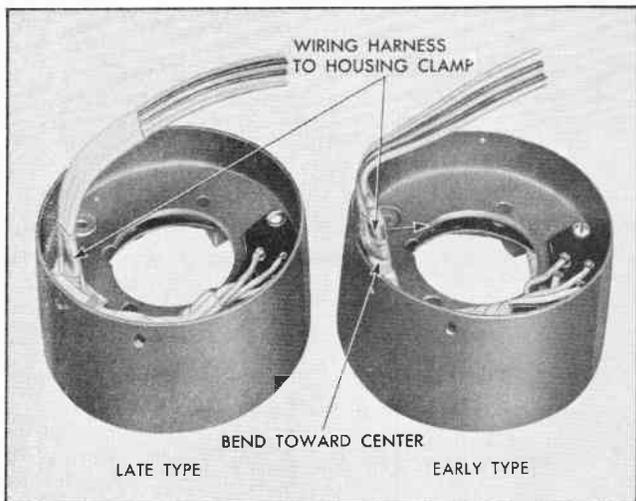
Fig. 17 Early and Late Type Direction Signal Wiring Harness to Housing Clamp

On some early production cars, the direction signal wiring harness contacts the gearshift lever support at the upper end of the steering column. On these cars the continual movement of the support, during shifting, chafes the wires and eventually cuts through the insulation causing a short circuit. This causes the direction signal fuse to blow making the direction signal and the hand brake warning lamp inoperative.

When this condition is encountered, remove the direction signal control assembly and replace the wiring harness and switch base assembly. Route the new wiring harness in the guide clamp and push it down through the clamp until it lies flush against the underside of the housing. Then bend the clamp around the harness to hold it securely in place. Before re-installing the control assembly, bend the clamp and harness toward the center of the housing to make sure it will not contact the gearshift lever support.

This condition has been corrected in production by the release of a new type clamp which more positively positions the wiring harness (See Fig. 17).
