PONTIAC

Service Craftsman News

No. 7 S-274

July, 1955

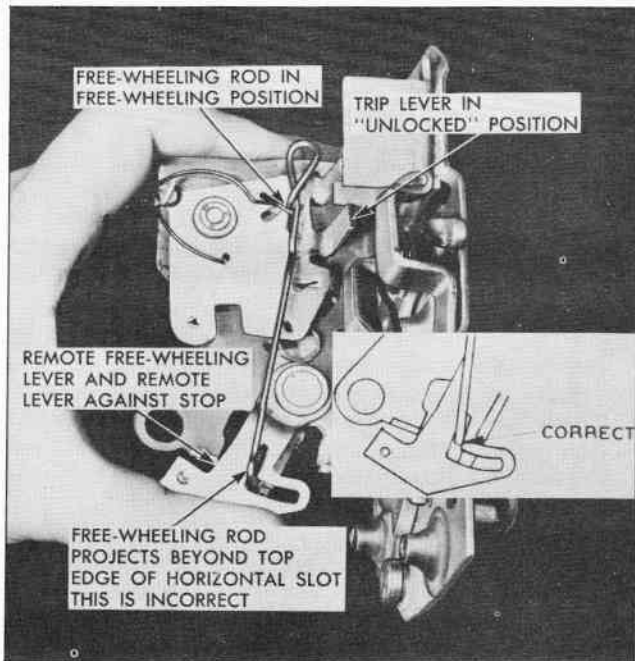
Fig. 5 Rear Door Lock in Unlocked Position

If a rear door with the lock set in free-wheeling cannot be opened with the inside remote control handle when the inside locking knob is in the up (unlocked) position, the condition may be caused by an improperly installed remote control assembly or a free-wheeling rod that is too long.

1. Check for correct fore and aft positioning of remote control assembly on door inner panel. If necessary, reposition remote control assembly for proper lock operation by loosening screws and moving remote control to obtain the proper adjustment. NOTE: This may be all that is required to correct condition.
2. If lock is still inoperative, remove lock from door.
3. With trip lever in the up (unlocked) position and free-wheeling rod in free-wheeling position, actuate both remote free-wheeling lever and remote lever against stop on lock frame, as shown in Fig. 5.
4. While holding levers against the stop, observe position of lower end of free-wheeling rod in relation to horizontal slot in remote free-wheeling lever (See Fig. 5). If any portion of rod projects beyond top surface of slot, lock is defective and should be repaired as follows:

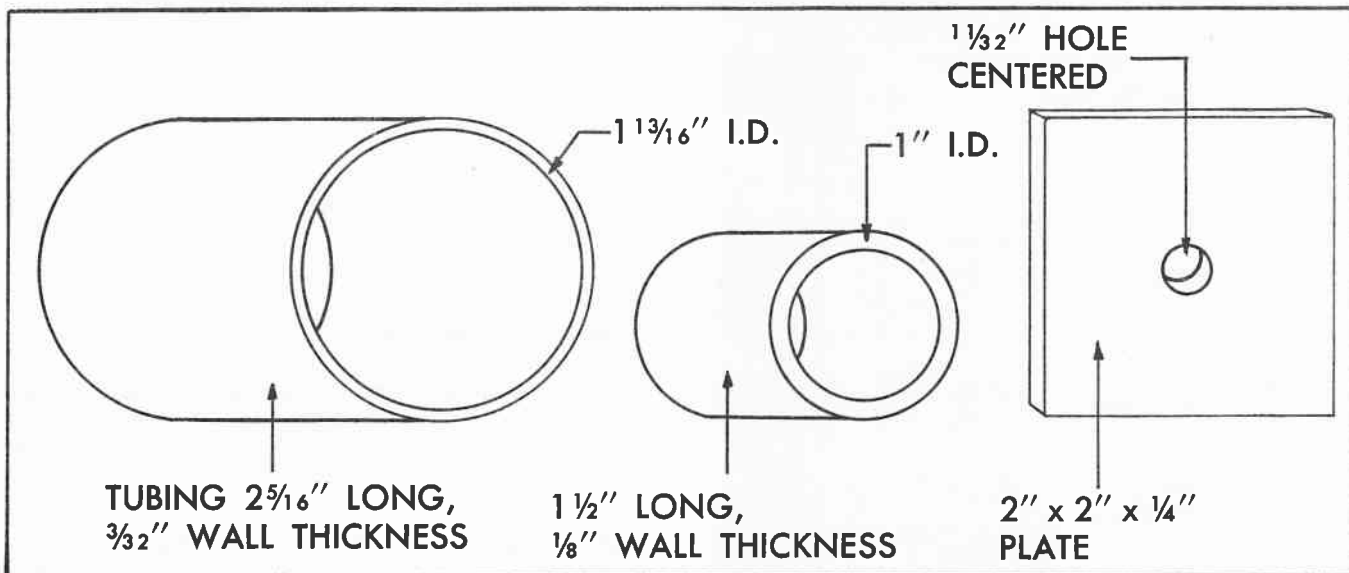
Fig. 9 Installation Tools For 1954 Compressor Seal Replacement

A new compressor seal has been released to service all 1954 compressor assemblies which have leaking seals. The new kit is #3135683, and replaces compressor seal kit #3134106.

If you have not already made the tools for installing the compressor shaft seal explained in the October-November 1954 issue of the Service Craftsman News, and also in the March 1955 issue of this same publication, then make the three tools as shown in Fig. 9. Then install seal as follows:
