# PONTIAC

## Service Craftsman News

No. 10 S-277

November, 1955

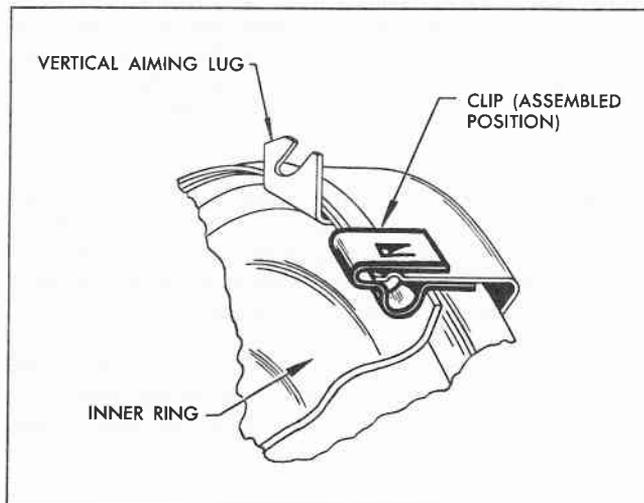
Fig. 1 Spring Clip Installed

When installing Guide T-3 headlamps on 1955 models equipped with Guide headlamps having retaining rings with attached aiming lugs, install a spring clip on each unit as shown in Fig. 1 to ensure rigidity of the assembly. Leave clip in place after aiming. Clips are available through G.M.P.D. Warehouses under part number 5947710 (package of 10).

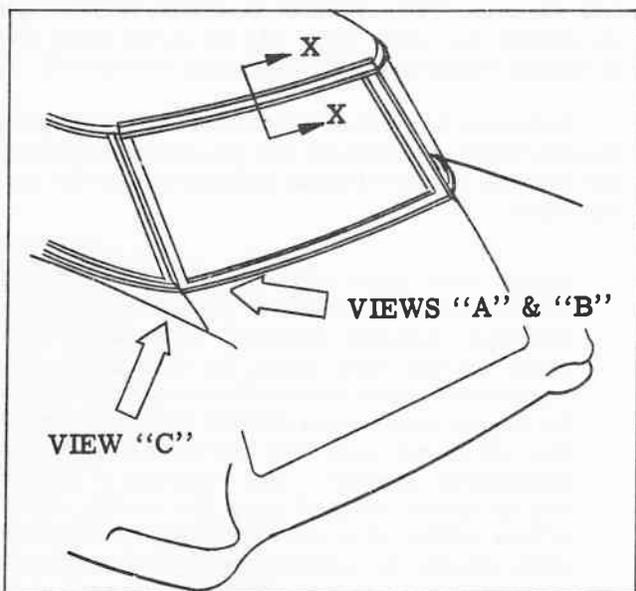
Fig. 4 Safari Lift Gate

Since the May "News" was issued, several changes in the lift gate sealing have been made in production. The following information has been prepared to inform the field of the new parts and of their use in the elimination of possible waterleaks on bodies which do not have a lift gate weatherstrip (body side) retained by a metal retainer.

1. Remove lift gate from body opening (detach lid from hinge straps).
2. Remove all lift gate weatherstrips (lift gate side and body side) and clean off cementing surfaces.
3. If the rear quarter window lower rear reveal molding has a tab as shown in View "A", Fig. 6, cut tab from molding. Reinstall screw in original hole in lower end of rear quarter window rear reveal molding. If no screw is present, drill hole, seal and install screw (part #442610) to
