Service Craftsman News

No. 11 S-278

December, 1955

4-BARREL CARBURETOR CHANGES

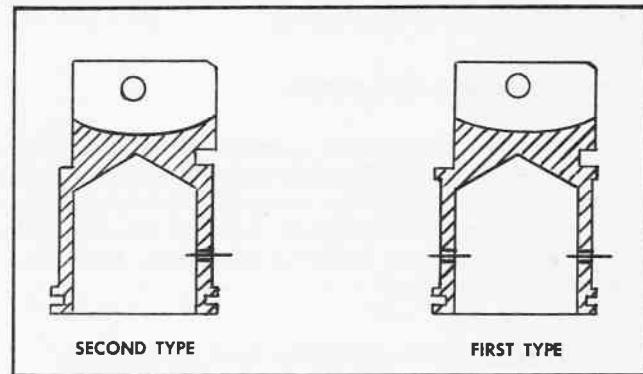
Fig. 1 Comparison of First and Second Type Rochester 4-Jet Choke Pistons

The Rochester 4-Jet change consists of a new choke piston. A comparison of this new piston and the earlier type shows that the new piston has only two lands and one hole as compared to three lands and two holes found on the first type. Fig. 1 gives a comparison of the two pistons.

The new piston is released for service under part number 7009710. When installing the new piston set the choke to one notch rich as was covered in the "November News."

The choke piston can easily be installed with the carburetor on the car by disconnecting the choke linkage, removing choke valve, choke cover and baffle plate. Use care that choke valve screws do not drop down into carburetor. The suggested time allowance for the operation is .4 hrs.

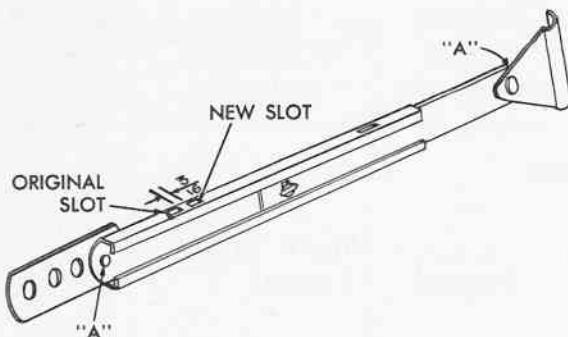
Fig. 7 Right Lift Gate Support - 1955
Safari Shown

If rattles in the lift gate supports and/or hinges are encountered when a station wagon is driven with the lift gate in the open (horizontal) position, the supports may be reworked on all models, and/or the lift gate hinges replaced with revised hinges on all models except Safari, to eliminate excessive movement of the lift gate as follows:

2. Remove right lift gate support on all models.
3. At a distance 3/16" above the original slot in the support used for locking the lift gate in the open (horizontal) position, make an additional slot of the same size. See Fig. 7. The use of this new slot in the right lift gate support when locking the lift gate in the horizontal position will eliminate any looseness between the inner and outer channels of the supports. Slot can be made as follows:

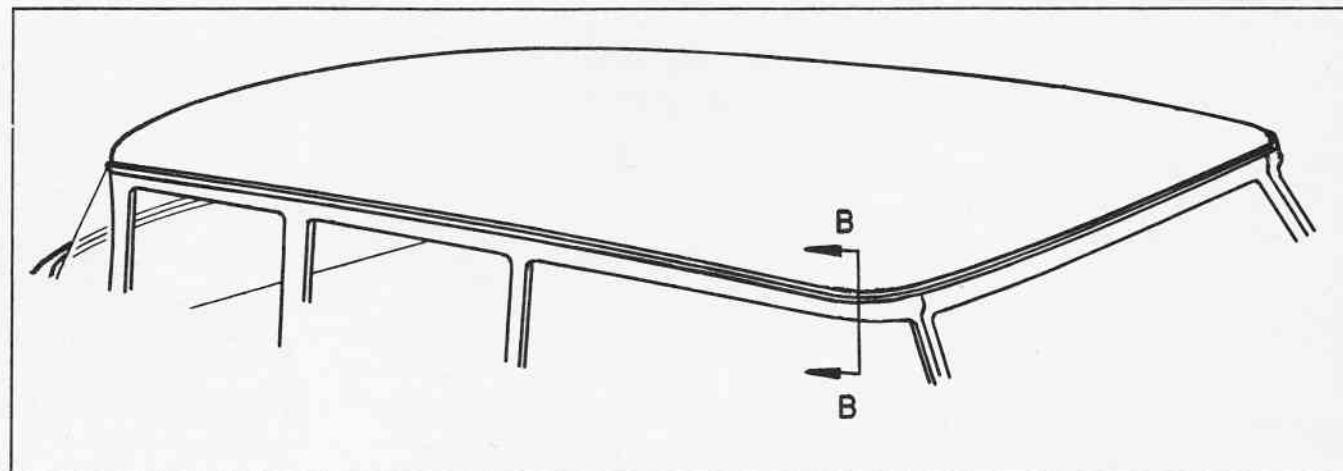
Fig. 9 Station Wagon Drip Moulding Area

Several reports have been received regarding paint failure at the joint between the roof drip moulding and the upper rear quarter panel on station wagon models. Following is a suggested repair procedure for this condition:

1. Remove paint and rust thoroughly to bright metal finish.
2. Apply thin coat of neoprene weatherstrip cement at point "A" (Fig. 9).
3. Dry to hard surface (approximately 3 hours).
4. Repaint and refinish.
5. Check joint at point "C" (Fig. 10) and reseal if necessary.

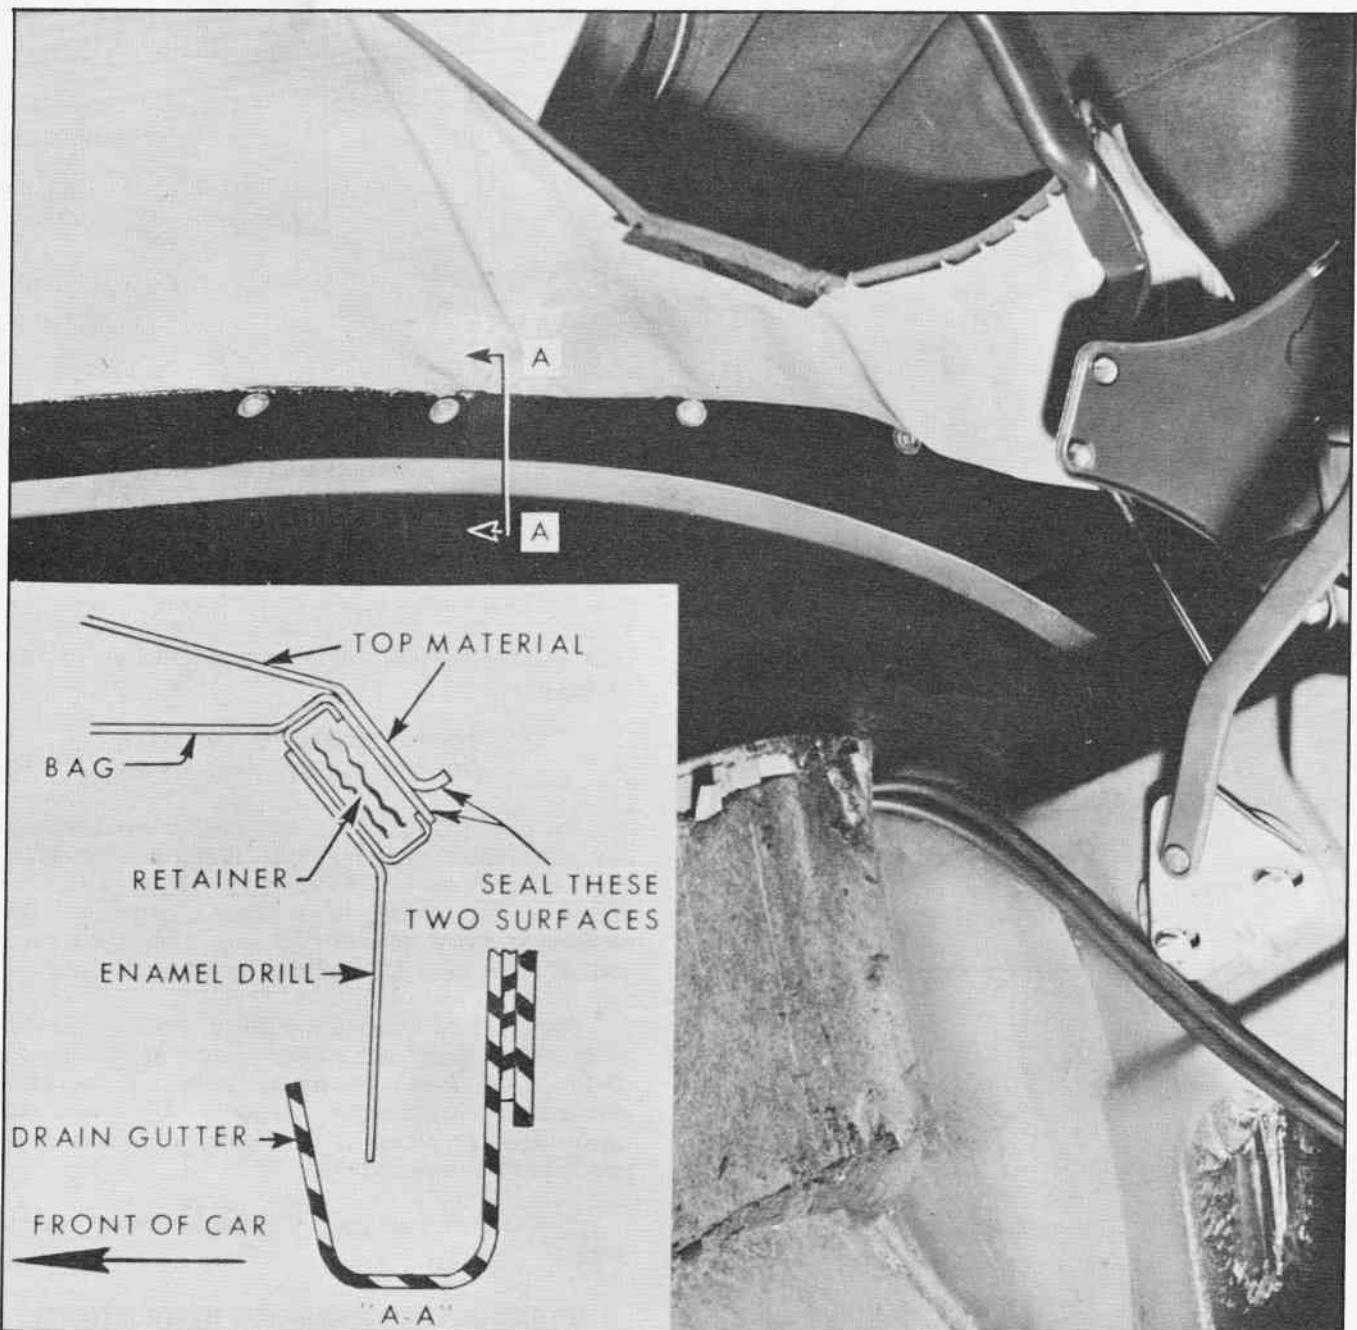
Fig. 11 Convertible Top Water Wicking Repair

If water wicking is encountered at the folding-top compartment bag or at the inner surface of the folding top material along the back and/or rear quarter belt lines, the edges of the bag and top material should be sealed along the rear trim stick.

5. a. If water overshoots gutter below bottom edge of folding top, cement cotton side of a piece of enamel drill to inside (metal) surface of retainers with an approved weatherstrip cement. The top edge of enamel drill should not extend above top edge of retainers and should be of sufficient width to extend into gutter for entire length of gutter. (See step "c" and see Fig. 11.)

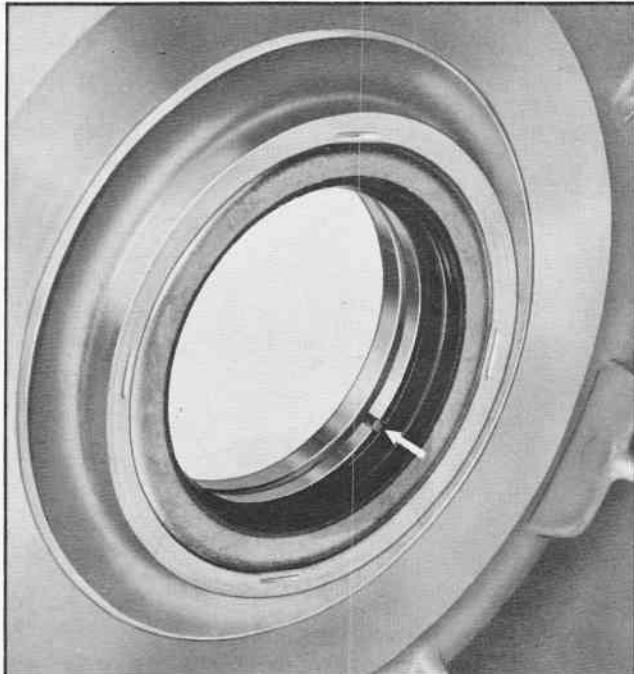
Fig. 12 Over Staked Flywheel Housing Bushing

Some cases have been found where the Flywheel Housing Bushing on the Strato-Flight Transmission has been overstaked causing grooves as shown in Fig. 12. The grooves run between the four normal staking marks and the circular lubrication channel.

These grooves may be the cause of torus drain back or front seal leak. If disassembly for one of the above conditions or any other condition is necessary, the Flywheel Housing Bushing should be inspected for these grooves. In all cases where the grooves are present the Flywheel Housing Assembly should be replaced.

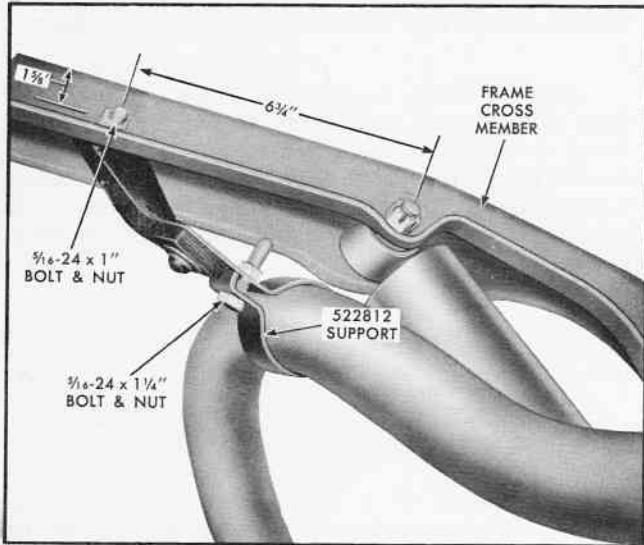
Fig. 13 Left Hand Front Tail Pipe Support Installed

Due to the Product Information Reports received on tail pipe rattle on dual exhaust equipped cars a front tail pipe support assembly is now in production and is available for service under part number 522812 as a master warehouse item.

The suggested time allowance for this operation is .5 hours.

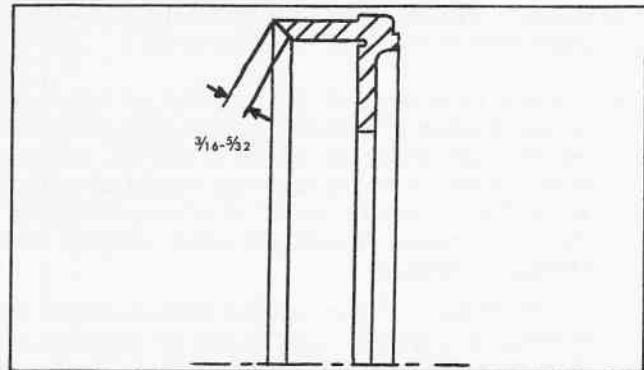
Fig. 14 Neutral Clutch Drum Chamfer

The drum must have a 5/32" - 3/16" width chamfer measured across chamfered surface on the inside leading edge (Fig. 14). If chamfer is less than 5/32", the drum should be replaced.

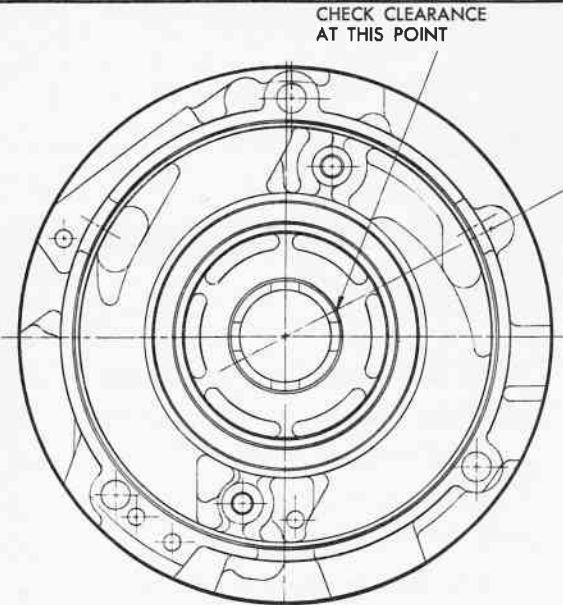
Fig. 16 Point of Clearance Check - Front Pump Bushing and Torus Shaft

The clearance between front unit driven torus shaft and front pump bushing must not exceed .003" using a 1/2" feeler gauge at point shown in Fig. 16. The measurement must be taken at the point shown since this is the point of greatest thrust. If a .004"

gauge can be inserted between the front unit driven torus shaft and the front pump bushing, the front pump and front unit driven torus member should be replaced.

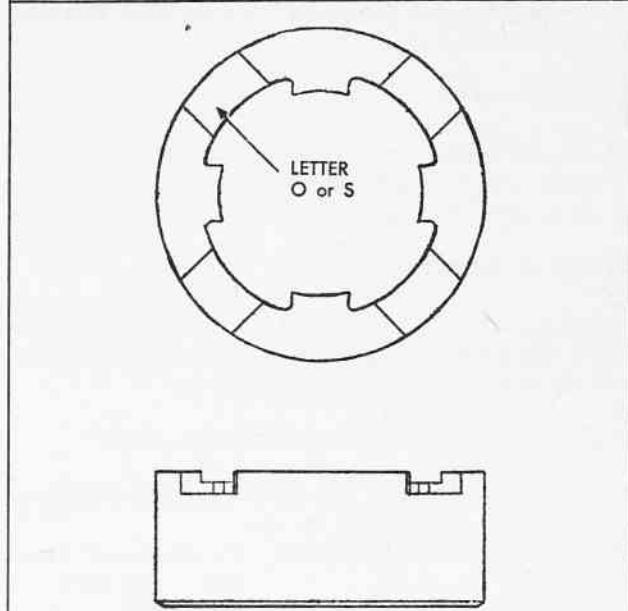
Fig. 18 Front Sprag Inner Race Identification

If the inner race is not of the late type, which can be identified by an "O" or "S" in the recess of the tang end, it should be replaced (see Fig. 18).

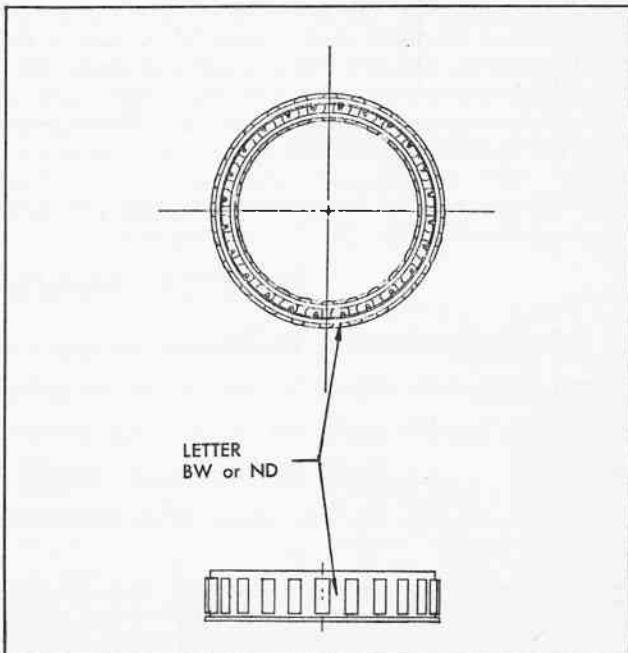
Fig. 19 Front Sprag Identification

Front Sprag - Extent damaged and identification letter. See Fig. 19.
