PONTIAC

Service Craftsman News

NO. 1 S-279

JANUARY, 1956

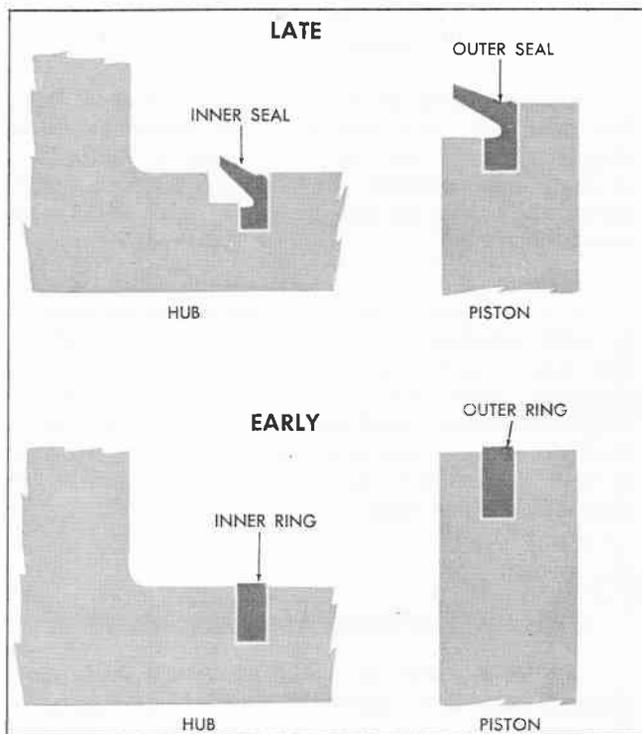
Fig. 1 Early and Late Type Hub and Piston

The inner and outer overrun clutch piston seals, neutral clutch piston seals, and reverse clutch piston seals are being changed from metal rings to composition rubber lip type. To accommodate the new seals it was necessary to redesign the seal grooves for both the inner and outer seals. These changes affect service as follows:

1. Overrun Clutch-- The new seals for the overrun clutch piston are now in production. In conjunction with the use of new seals, a new front pump assembly and overrun clutch piston assembly went into production. The difference in design of the seal grooves in these parts can be seen in Fig. 1.

2. Reverse Clutch-- The new seals for the reverse clutch piston are now in production along with a new rear pump (to accommodate the inner seal) and a new clutch piston (to accommodate the outer seal). The seal grooves in the early and late hubs are shown in Fig. 1. The ring grooves in the early and late reverse clutch pistons are very similar and both look like the late type in Fig. 1. The only sure identification of the early and late reverse clutch pistons is to test the fit of the metal oil ring in the groove. The metal ring will not fit in the groove designed for the rubber seal since this groove is slightly narrower.

3. Neutral Clutch-- The new seals for the neutral clutch will go into production in the near future. Along with the change in seals a new case center support and neutral clutch piston will be required in production. The difference in design of the seal grooves can be seen in Fig. 1. Also required is a new neutral clutch drum (Fig.2).

In each clutch all parts must be the same type. For example: If a late type front pump having the step type groove for the rubber seal is installed in an early transmission, the late type overrun clutch piston and rubber lip type inner and outer seals must also be installed.

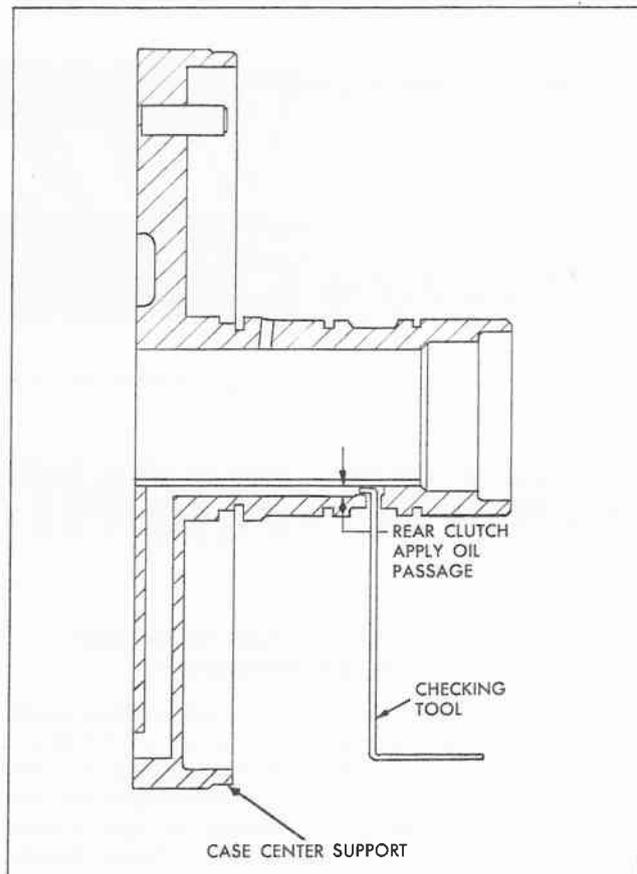
Fig. 3 Checking Rear Clutch Apply Oil Passage

The rear clutch apply oil passage in the case center support has been enlarged to obtain an improved 2-3 shift. This passage should always be checked before the case center support assembly is put into a transmission, to make certain the improved part is used.

The special tool (.068" gauge) which was furnished attached to News Flash 55-39 should be inserted into the rear clutch apply oil passage as shown in Fig. 3. If the tool will enter the passage, the support can be used. If the tool will not go into the passage, the support should be replaced.

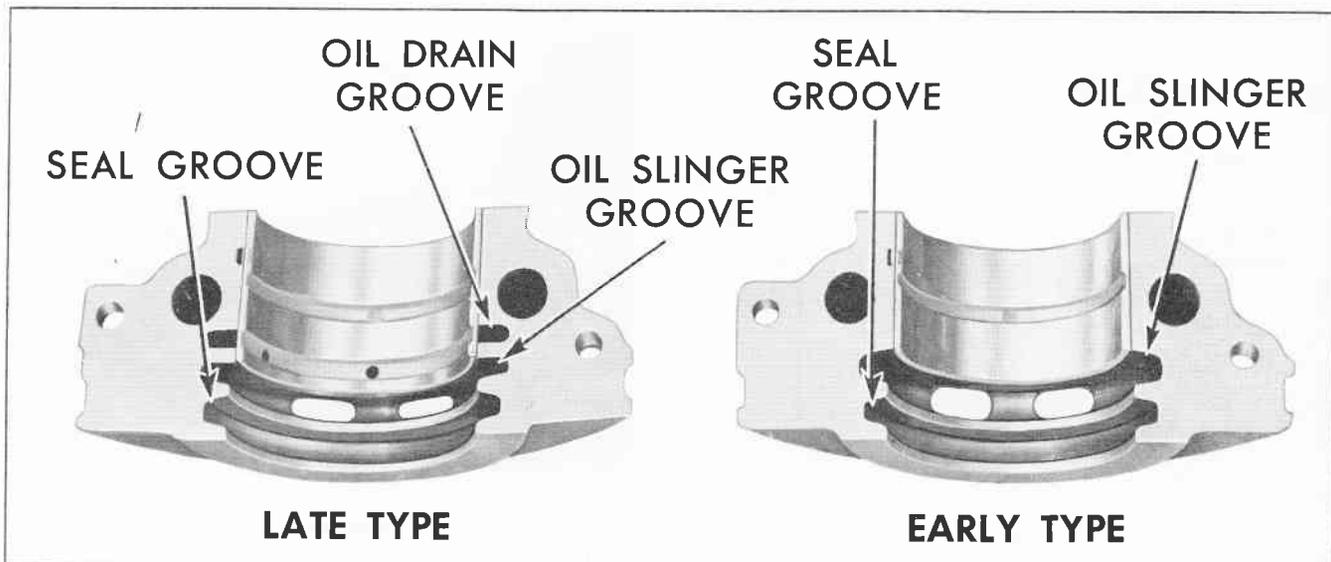
Fig. 4 Comparison of Early and Late Type Rear Main Bearing

Fig. 4 illustrates the new rear main bearing design now being used to reduce the possibility of crankshaft rear main oil leaks. As shown in the illustration a groove and three oil drain holes are now incorporated in the bearing shell. These holes index with a machined oil drain groove in the main bearing cap and engine block. The new design allows oil drainage from the crankshaft journal and thereby eliminates oil getting to the packing seal under normal operating conditions. The packing seal is required for acceleration of the car or steep up hill driving.

Engines built on or after January 3, 1956 have the new type rear bearing shells, however, a number of engines were built after December 16, 1955 with the grooves machined in the block and cap but with the first type bearing shells installed. This was done because new shells were not available. If leaks are encountered on engines having the new groove and first type bearing shells, the second type shells may be installed.

When installing the new type shells it will be noted that the upper and lower shells are not interchangeable due to a difference in tang location.

The new bearing shells are released under package number 522825 (one upper and one lower) and are available as a zone warehouse item.

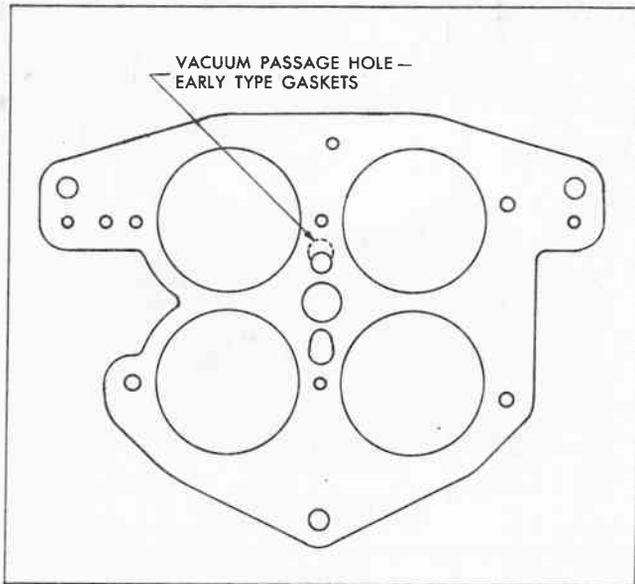
Fig. 5 Rochester 4-Jet throttle Body To Bowl Gasket

Engine stalling during warm up on cars equipped with the Rochester 4-Jet Carburetor may be due to a leak in the choke piston vacuum passage. A leak in the passage reduces the effect of engine vacuum in opening the choke thereby allowing engine to "load-up." Investigation of cases of this nature indicates that the usual cause of the condition is a leak at the carburetor throttle body to bowl gasket. The gasket originally used was shaped in such a manner that it could cause a leak between the vacuum passage and one of the secondary throats.

The new gasket is illustrated in Fig. 5. The dotted line on the illustration shows the outline of the vacuum passage hole on early type gaskets.

A new gasket is now being used in production to eliminate the possibility of a leak. The new gasket is available under part number 7009762 through the zone warehouse. All future carburetor gasket and repair kits will contain the new gasket.

To test for a choke vacuum leak, remove the choke housing to manifold pipe and check the vacuum at the choke housing. If vacuum is less than 10 inches, improper choke action will result. Replace the first type gasket with the 7009762 gasket and recheck choke vacuum to be certain condition is corrected. When gasket is being installed inspect upper

face of throttle body for smoothness and complete finish. The time allowance for this operation is 1.2 hours.

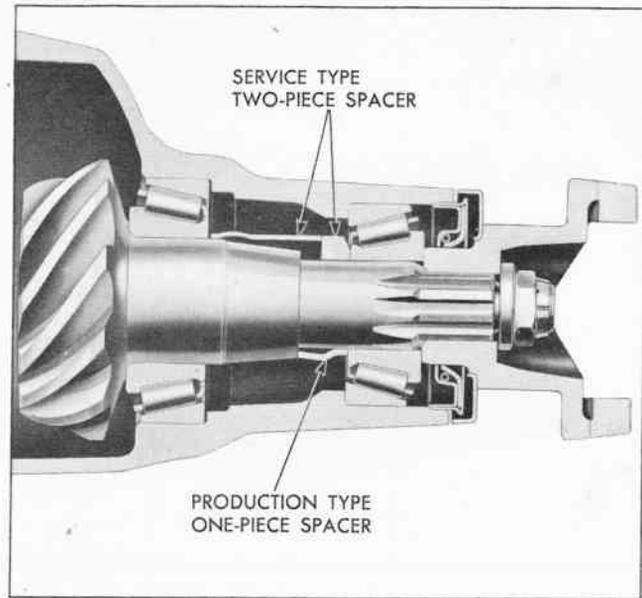
Fig. 6 Service and Production Pinion Bearing Spacers

Several Product Information Reports have been received indicating a misunderstanding of the difference between production and service pinion bearing spacers.

In early 1955 production a two piece differential pinion bearing spacer was used. In later 1955 and 1956 production a one piece spacer was used. However, the two piece spacer was retained for service for all 1955 and 1956 models (Fig. 6 illustrates the one piece production type spacer and the two piece service type).
