PONTIAC

Service Craftsman News

No. 3 S-281

March, 1956

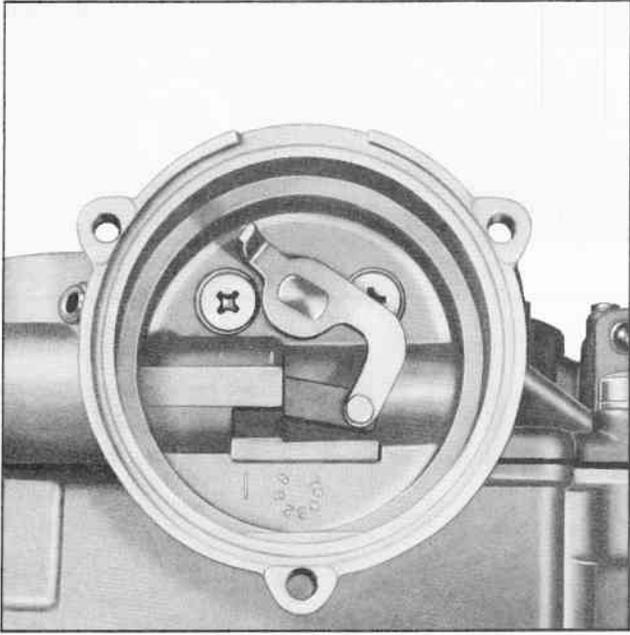
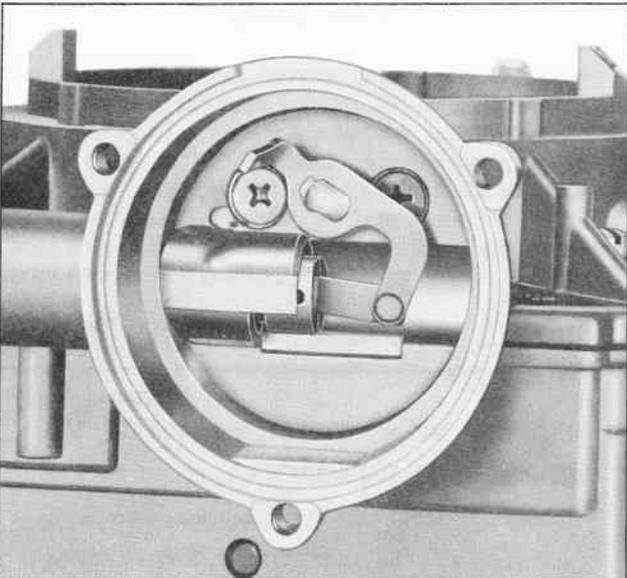
Fig. 1 Choke Piston Position Before Change

As a result of Product Information Reports covering loading during warm up of the Rochester 4GC carburetor, the contour of the choke piston link has been changed to give an increased opening of the choke valve on cold idle.

Fig. 1 illustrates the position of the choke piston with the choke valve closed before this change went into effect. Fig. 2 illustrates the choke piston after the change. Note that the piston now protrudes approximately 1/16" from the cylinder and that the piston

Fig. 2 Choke Piston Position After Adjustment

pin is one-half exposed. On all cases of loading the piston link should be bent using pliers as shown in Fig. 3 to achieve the new position.

The checking and setting of the choke piston as described above should be considered in the future as a regular carburetor adjustment and should be performed as such during carburetor overhauls and adjustments. Extreme care should be used to insure that no bind exists in choke system after adjustment.

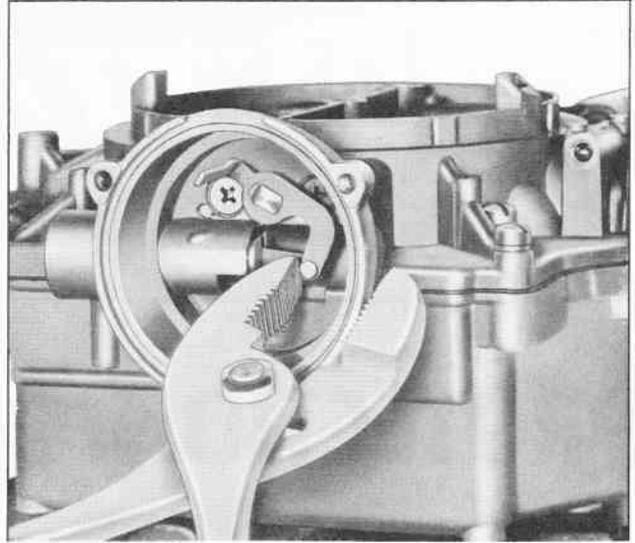
Fig. 3 Bending Choke Piston Link

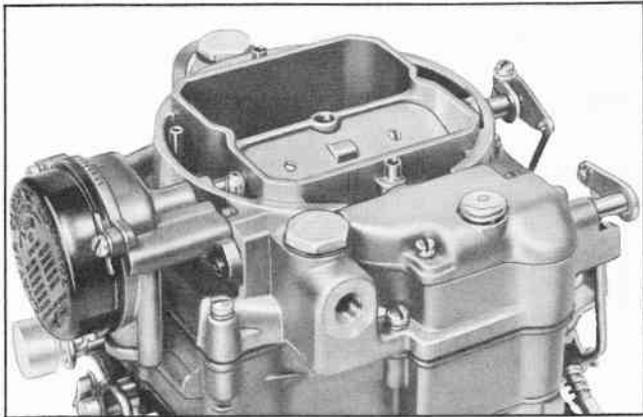
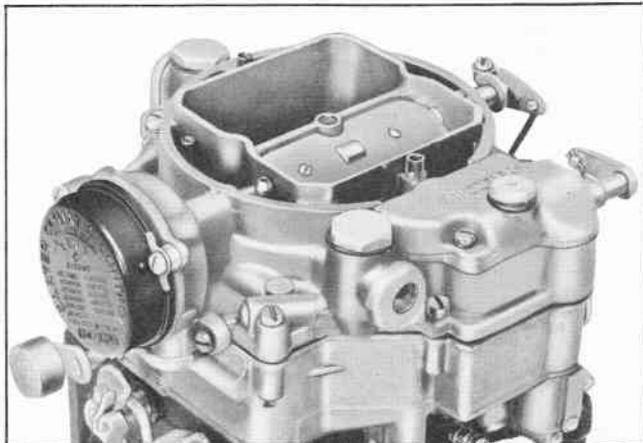
A new air horn casting and choke housing are now in production on the Carter WCFB 4-Barrel carburetor. Figs. 4 and 5 illustrate the differences in the new units. The new air horn and choke housing are not individually interchangeable with the earlier type.

Fig. 4 Carter 2364SA Carburetor

Fig. 5 Carter 2364S Carburetor

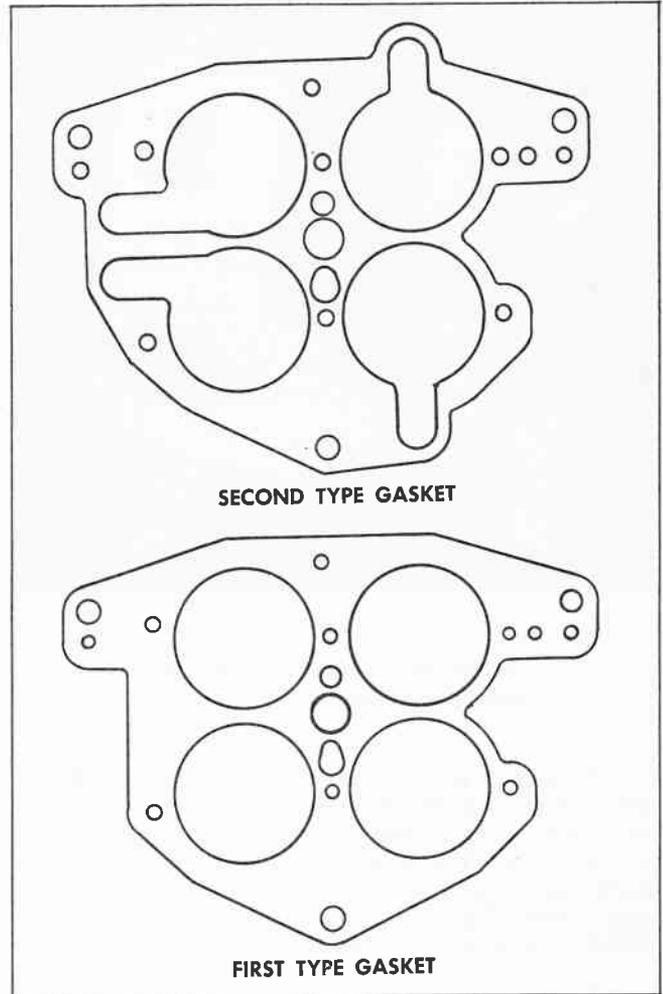
To improve hot starting characteristics of the extra horsepower engine a new throttle body to bowl gasket is now being used in production. The new gasket is released for service under part number 7009256 and should be installed on each carburetor in cases of hard hot starting. Fig. 6 illustrates the differences between the first and second type gaskets.

Fig. 6 First and Second Type Throttle Body To Bowl Gasket

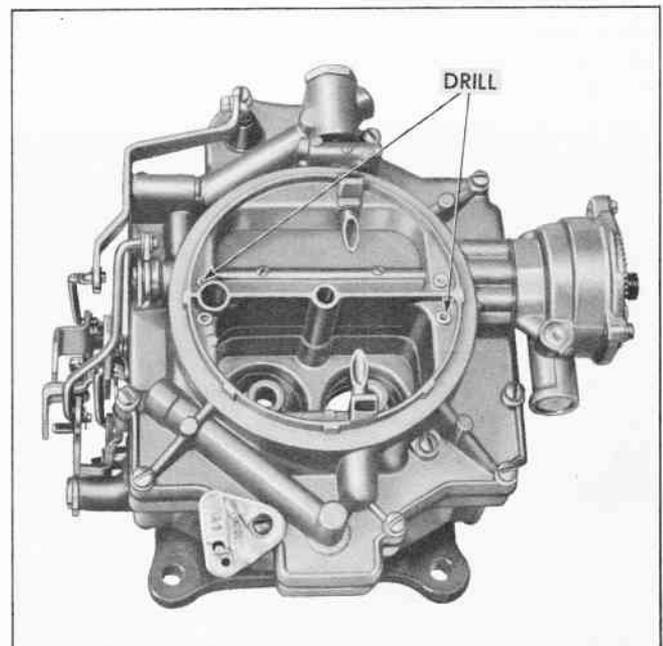
Several cases of engine stalling after a fast stop have been reported. Engineering tests have shown that this condition can be alleviated by removing the air horn assemblies from both carburetors and drilling out one internal vent in each side with a 1/8" drill. Fig. 7 illustrates the vents that should be drilled. NOTE: It is important that only the two vents pointed out in Fig. 7 be drilled otherwise excessive fuel spilling may result if car is used for racing. This condition has been corrected in production.

Fig. 7 Rochester Dual 4-Jet Carburetor

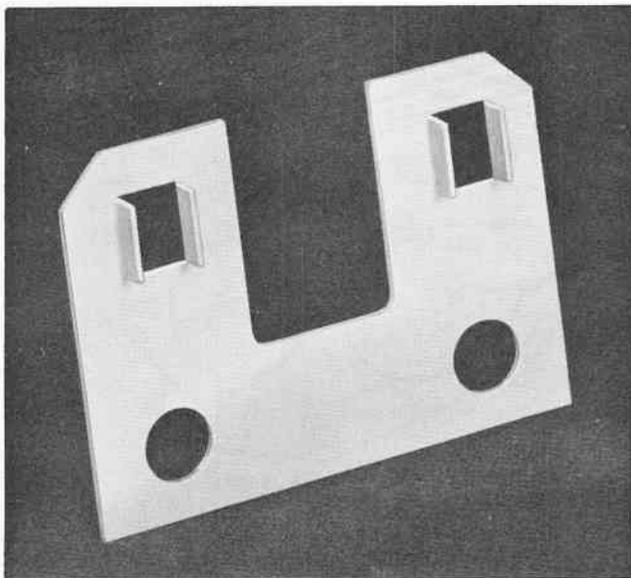
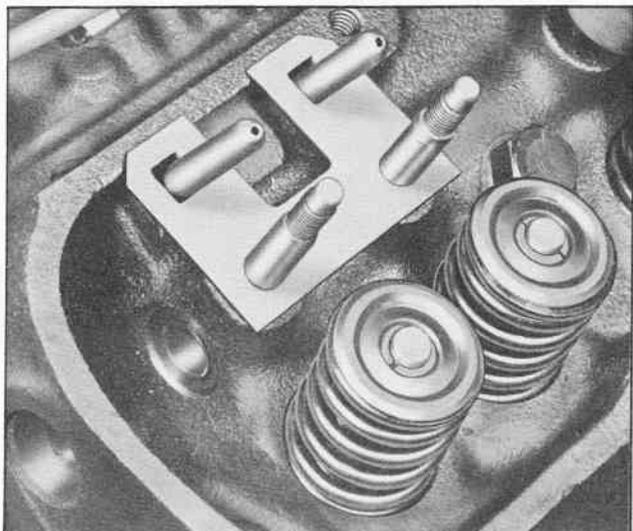
Fig. 8 Push Rod Guide

It is no longer necessary to replace a V-8 cylinder head because the guide holes for the push rods have been worn enough to cause noise or malfunction of the valve train. A new part is available to correct such cases. It is called push rod guide and is available from GMPD warehouses under part number 522937. Figure 8 illustrates the new part.

Fig. 9 Push Rod Guide Installed

Figure 9 shows the guide in place on the cylinder head. Note that the upper edge of the guide will be held in place by the rocker arm cover. Rocker arms should be removed and replaced in accordance with shop manual instructions. Flat rate operation 6-290 should be used for establishing charges on this operation.

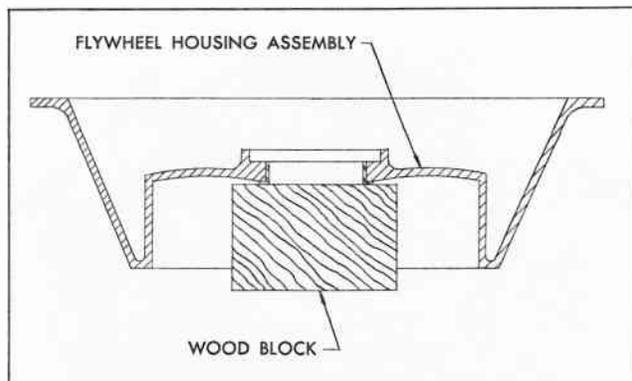
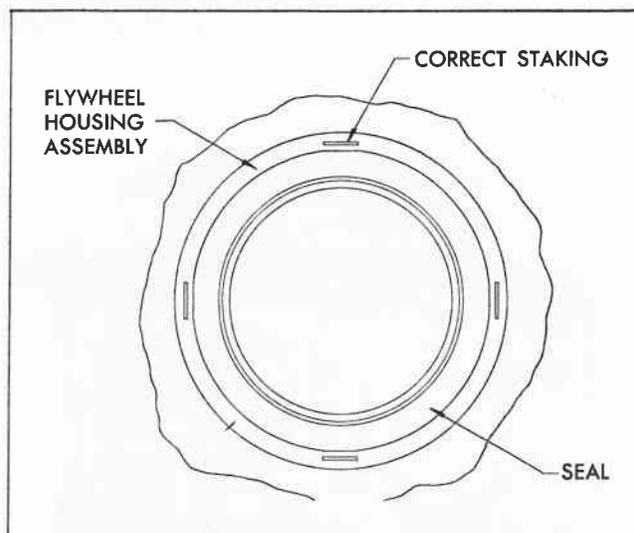
Fig. 10 Block Supporting Flywheel Housing

Fig. 11 Correct Staking To Retain Seal in Housing

1. Position the flywheel housing on a wooden block so as to support the housing at the oil seal hole, instead of at the outer rim. (See Fig. 10)
2. Install the front seal into the flywheel housing using K.M.O. Tool, J-6118.
3. With the front seal secure in the housing, stake the flywheel housing, using a standard screwdriver per Fig. 11.

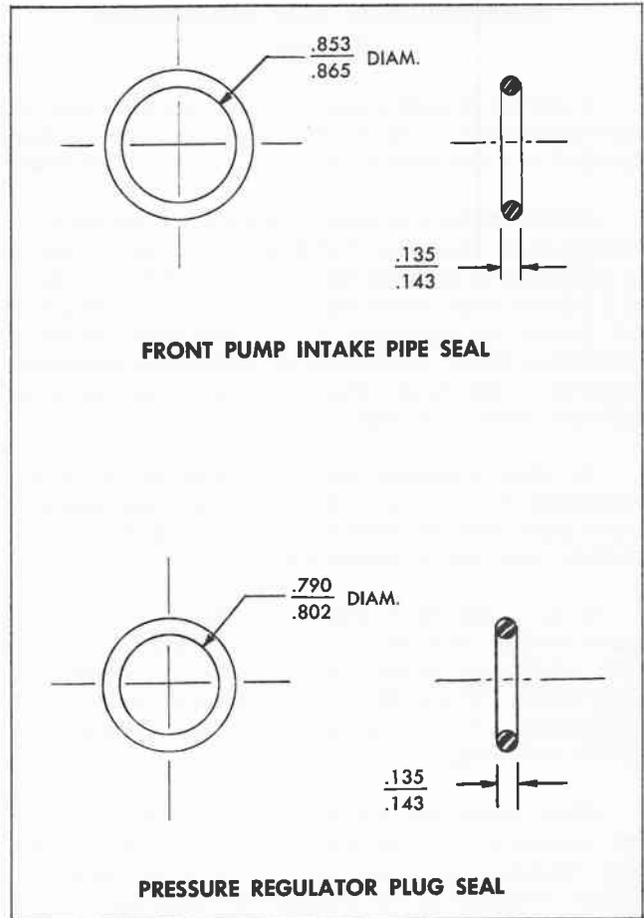
The "O" ring seal used on the front pump intake pipe is very similar to the "O" ring seal used on the pressure regulator plug. Fig. 12 shows the difference between the two seals. It will be noted that the thickness of the rubber used in both "O" rings is exactly the same; however, the diameter of the seal used on the front pump intake pipe is approximately .06" greater.

Fig. 12 Comparison of Front Pump and Pressure Regulator Seals

It is very important that these seals be used correctly. If the pressure regulator "O" ring seal is installed on the front pump intake pipe, a suction leak may occur causing oil starvation and foaming. Conversely, if the intake pipe seal is installed on the pressure regulator plug, an external fluid leak may result.

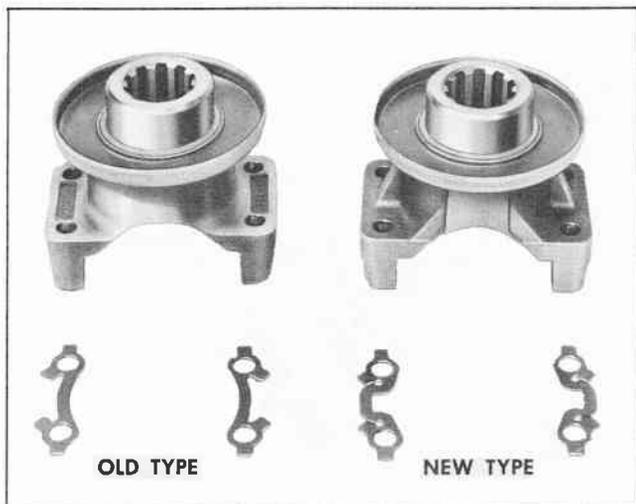
Fig. 13 Comparison of Old and New Type Companion Flange and Lock Plates

A new differential companion flange is now being used in production. The new flange is of ribbed construction and is stronger than the flange previously used. The ribbed construction of the new flange necessitates the use of a redesigned lock plate as illustrated in Fig. 13. This new lock plate is released for service under part number 5670765. The 5670765 lock plate can be used on the old type companion flange but the old type lock plate can only be used on the old type flange.

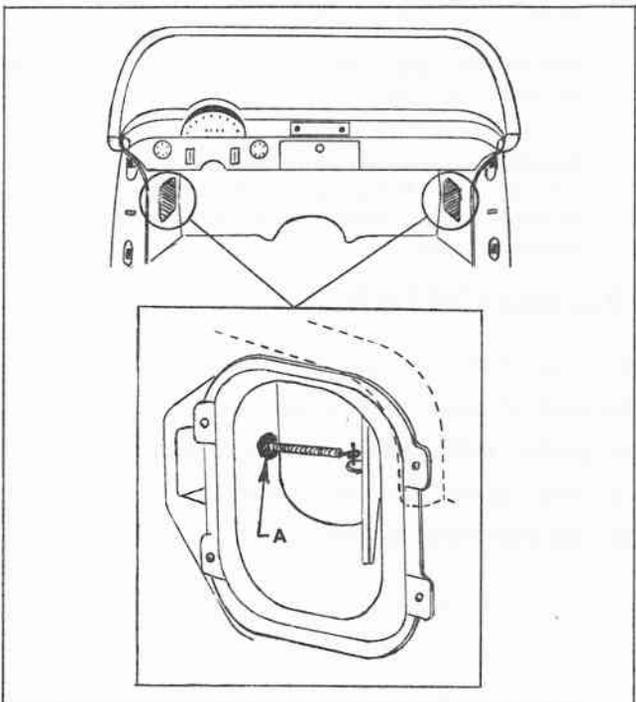
Fig. 14 Shroud Side Air Outlet Duct

If cold air enters the body through the vent door control cable hole in the shroud side air outlet duct, the condition may be corrected by applying body caulking compound around the cable and hole to prevent inward leakage of air.

To apply caulking compound open the vent door and remove air outlet grille and screen, then working through the air outlet duct apply an approved body caulking compound around control cable and hole. (See Fig. 14) Work caulking compound firmly around cable and well into hole to provide a proper seal.

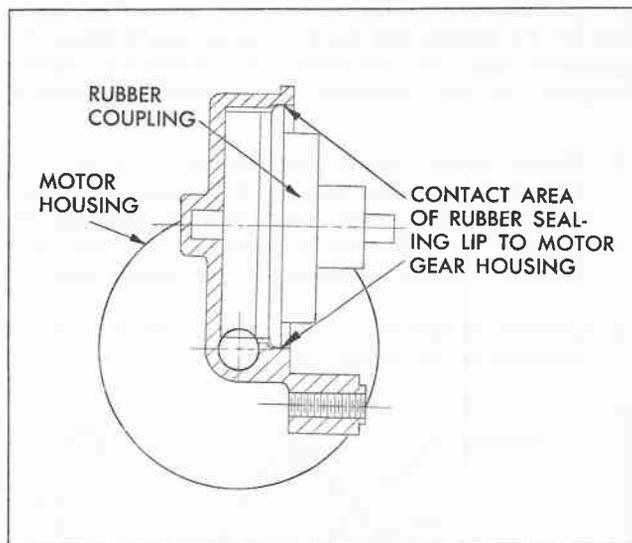
Fig. 15 Cross Section of Motor Gear Housing

If a "squeaking" noise is encountered when an electric window regulator is operated, the condition may be caused by insufficient lubrication of the motor rubber coupling sealing lip where it contacts the motor gear housing.

The "squeaking" noise may be eliminated by lubricating the sealing lip at the contact area as shown in Fig. 15. A silicone rubber lubricant or lubricant from the gear housing should be used. On some styles the sealing lip is accessible for lubrication through the door inner panel access hole. On other styles the window regulator must be removed to obtain access to the sealing lip. See Fisher Body Service News for removal and installation procedures.

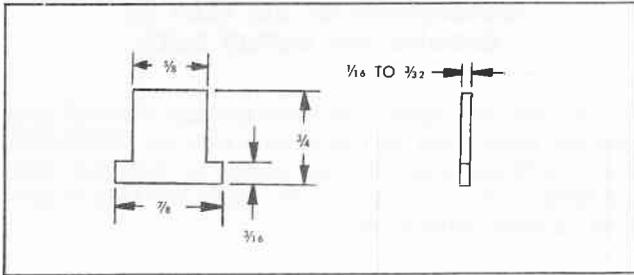
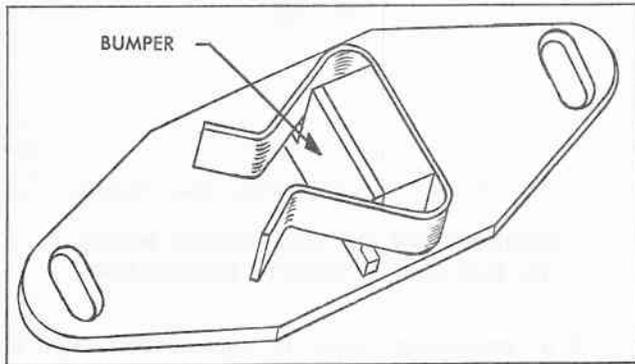
Fig. 16 Seat Back Retainer Bumper

If excessive movement of the folding seat back causes rattles when the seat is held in the "up" position by the folding seat back retainer assemblies, the condition may be corrected by cementing rubber bumpers to the retainer assemblies as follows:

Fig. 17 Rubber Bumper Installed

1. Obtain rubber stock (semi-hard), 1/16 to 3/32 inch thick and cut out two (2) bumpers as shown in Fig. 16. Use one bumper for right side and one bumper for left side of body. Do not use foam rubber. NOTE: Drawing is not actual size.
2. Cement bumpers to folding seat back retainer assemblies as shown in Fig. 17.

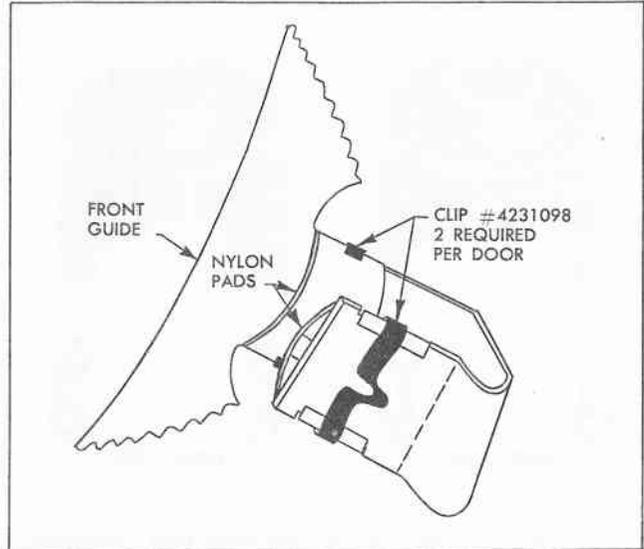
Fig. 18 Retaining Clips Installed

If a rattle develops in the rear doors on 4 Door Catalina Models, it may be caused by a rear door window front guide nylon pad becoming disengaged. To provide positive attachment of the nylon pads to the guide, a Rear Door Window Front Guide Nylon Pad Retaining Clip (Part No. 4231098) may be installed. The procedure for installing these clips is outlined below.

1. Remove rear door window front guide.
2. Attach retaining clips to nylon pads on front guide as shown in Fig. 18.
3. Reinstall previously removed parts. Adjust guide "in" or "out" for proper contact of the rear door window frame weatherstrip with the front door window frame.
