PONTIAC

Service Craftsman News

No. 5 S-283

May, 1956

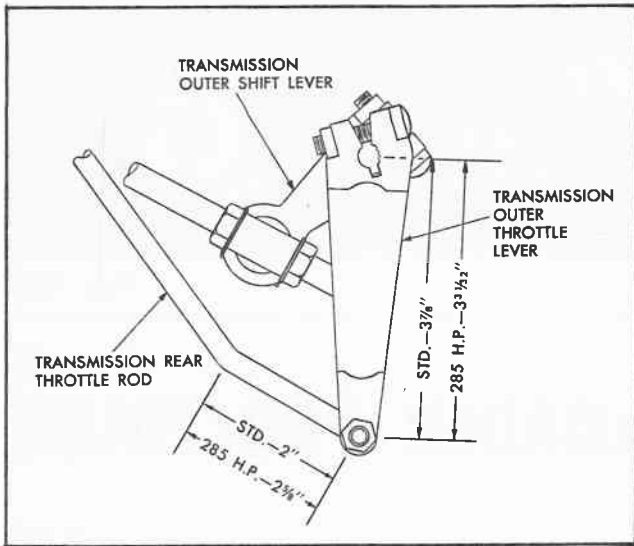
Fig. 1 Transmission Rear Throttle Rod and Outer Throttle Lever - Dual Range

The new parts provide more TV pressure at low speeds to reduce the tendency of bunching the 1-2 and 2-3 shifts. The increase in TV pressure also improves the 2-3 shift in both transmissions.

Dual Range Hydra-Matic Transmission -- The transmission rear throttle rod designed for use with the 285 horsepower engine has a 2-5/8" length from the center of the rear ball stud to the first bend while the rod used with the standard engine has a 2" length at this location (Fig. 1).

The transmission outer throttle lever for use with the 285 horsepower engine is 3-31/32" long from centerline of throttle shaft hole to centerline of hole for throttle rod ball stud. The lever for use with the standard engine is 3-7/8" long in the same area (Fig. 1).

Whenever a car with the 285 horsepower engine is encountered which has bunched shifts (1-2 and 2-3 too close together) or a poor 2-3 shift, check to see that the new parts have been installed. If not, replace the transmission rear throttle rod and the outer throttle lever with the new type.

Adjust linkage as outlined in the 1956 Hydra-Matic Manual. After setting the linkage to standard it may be necessary to "tailor" the adjustment in some cases to provide the best shift speed pattern and 2-3 shift action.

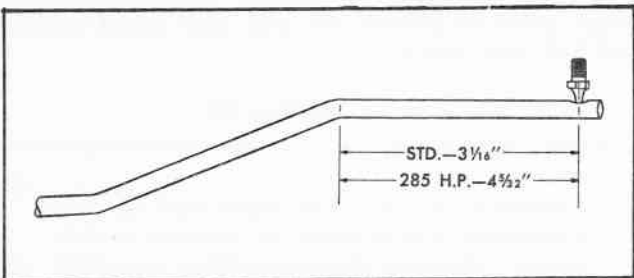
Fig. 2 Strato-Flight Transmission Rear Throttle Rod

Strato-Flight Hydra-Matic -- The transmission rear throttle rod designed for use with the 285 horsepower engine has a 4-5/32" length from the rear ball stud to the first bend (Fig. 2). The standard rod has a 3-1/16" length at this location.

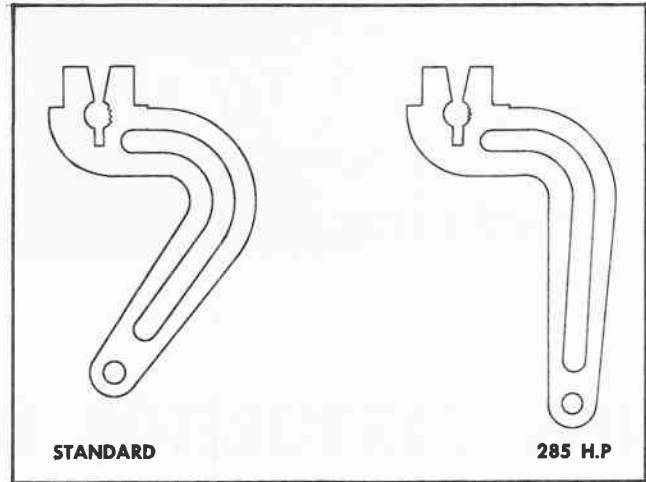
Fig. 3 Strato-Flight Outer Throttle Levers

The outer throttle levers have a very obvious difference in shape as shown in Fig. 3.

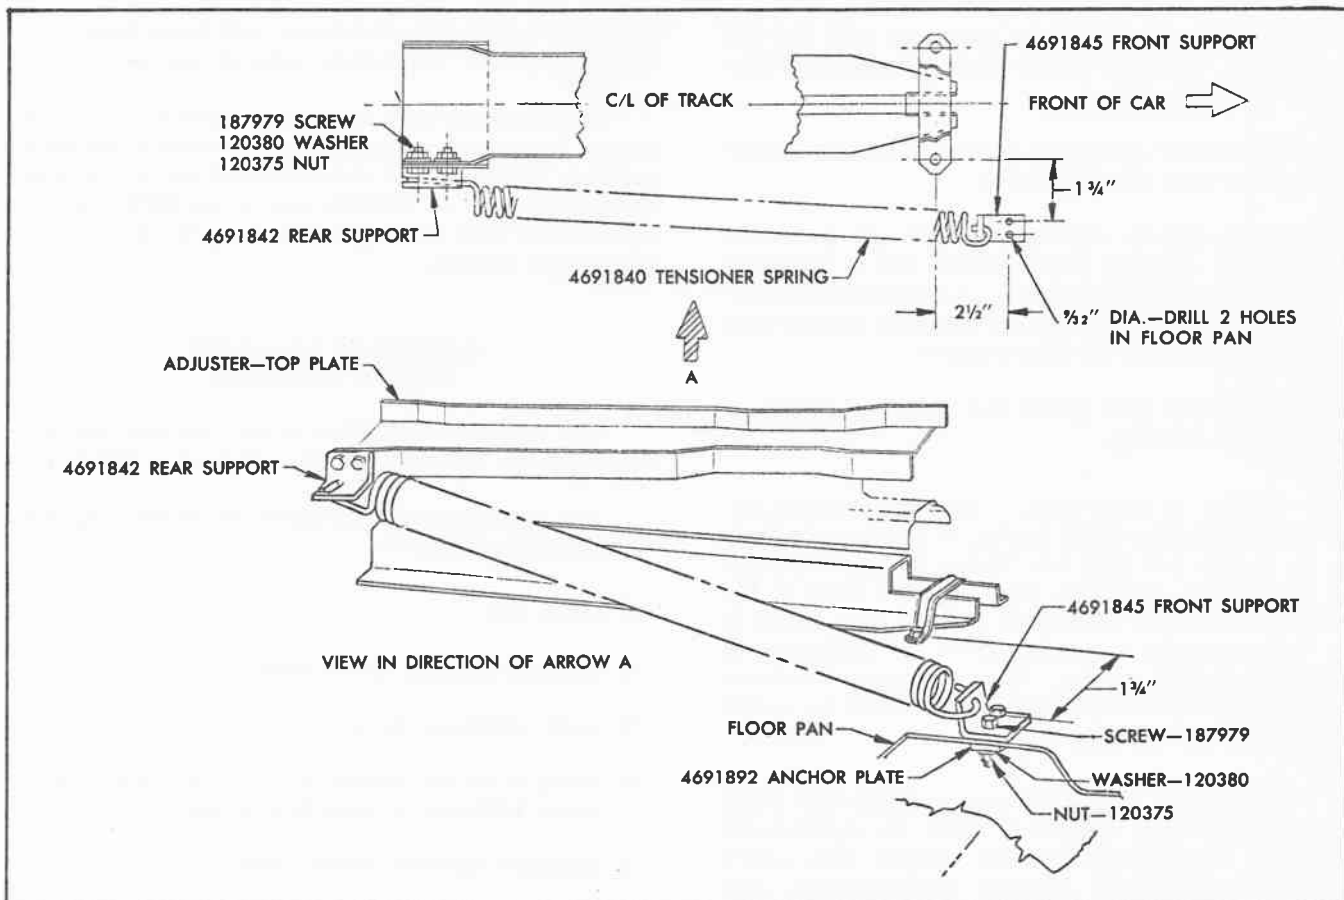
Fig. 4 Tensioner Spring Installation Drawing

If an excessive seat "chucking" condition is encountered on a power operated six-way seat, the installation of a tensioner spring will effectively reduce the noise and/or "chucking" caused by the movement of the seat adjuster parts at the pivot locations.

1. Operate front seat assembly to the extreme forward position and the rear edge of seat to the extreme upward position.
2. Remove left lower seat side panel; then bend the seat side panel attaching tab downward sufficiently to permit drilling two (2) holes in the top plate as shown in Fig. 4.

3. Locate rear support/flush with the top and rear edge of left seat adjuster top plate, as shown in the drawing; then, clamp support securely to top plate. Using the holes in the rear support as a guide, drill two (2) 9/32 inch diameter holes through seat adjuster top plate; then secure rear support to seat adjuster top plate with two (2) screws, washers and nuts. Bend seat side panel rear attaching tab to original location.

4. Operate seat rearward, rear edge downward and front edge to the extreme upward position; then turn back front floor covering to expose floor pan at tensioner spring front support attaching location. See Fig. 4.

5. Drill two (2) 9/32 inch diameter holes in floor pan at the locations indicated in the drawing; then

secure front support to floor pan with two (2) screws, washers, anchor plate and attaching nuts as shown in Fig. 4.

6. Check and if necessary tighten all seat adjuster to floor pan attaching bolts.
7. Operate seat to extreme forward and downward position. Engage short hooked end of tensioner spring on the front support as shown in the drawing; then with suitable tool carefully engage rear end of spring on the rear support.
8. Install seat side panel and position carpet to original location.
