# PONTIAC

## Service Craftsman News

No. 6 S-284

June, 1956

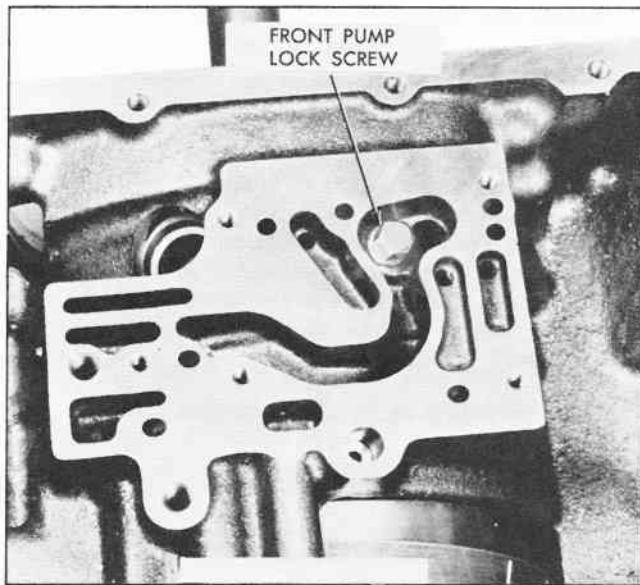
Fig. 3 Strato-Flight Front Pump Locating Screw

First production Strato-Flight Hydra-Matics had a lockwasher on the front pump lock screw. It was later felt that the lockwasher was undesirable since its sharp edges could shave off metal particles which would circulate with the oil.

A new washer head screw is now being used in production in place of the original screw and lock-washer (Fig. 3). The new screw is available under part number 8617629. Any time an early type lock screw having the separate lockwasher is removed in servicing a transmission, it should be replaced with the new washer head screw.

Some transmissions will be found in which the early type screw is used with a flat washer instead of a lockwasher. These screw and flat washer assemblies were used temporarily in production until the new screws became available and can be re-used when encountered.
