PONTIAC

Service Craftsman News

No. 7 S-285

July, 1956

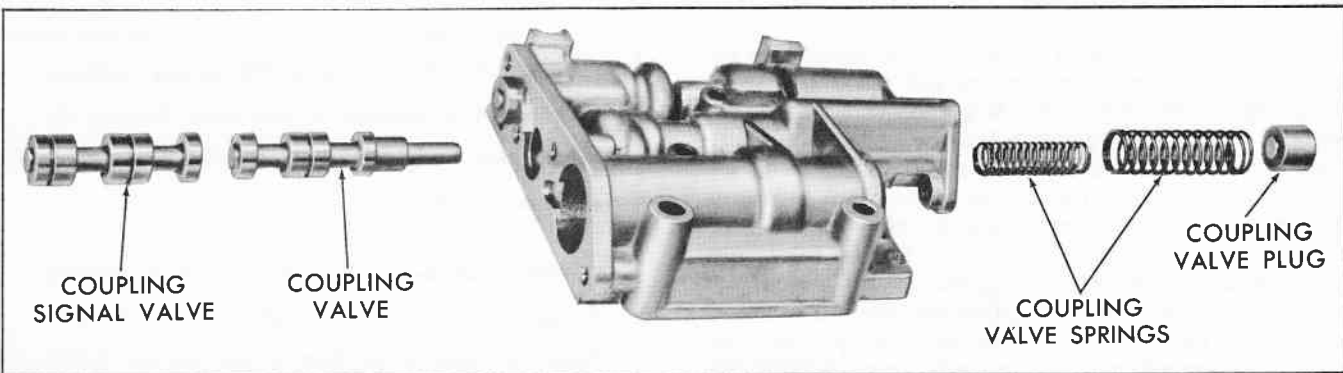
Fig. 4 Second Type Service Overrun Clutch Valve Body

When it has been determined which type shift valve body is on a control valve assembly, it can be assumed that the overrun clutch valve body is of the same type. If necessary to determine the type of overrun clutch valve body, the only method is by removing the rear plate which compresses the limit valve springs. It can then be determined whether the coupling valve plug is the 2nd type and whether there are one or two coupling valve springs (Fig. 4).

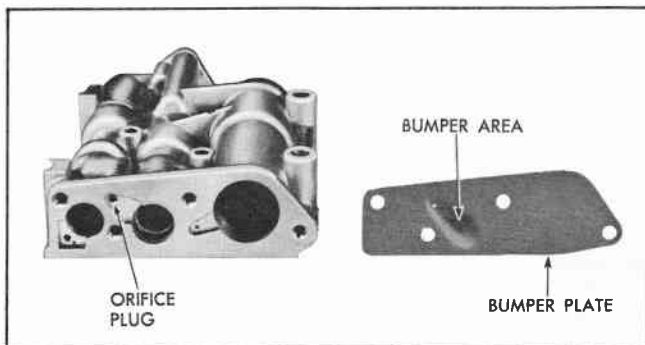
Fig. 5 Overrun Clutch Valve Body

A few cases have been encountered where the Strato-Flight transmission will emit a clicking noise when operating at very low speeds. The noise will usually occur just before the transmission shifts from 1st to 2nd, and is made by the coupling valve.

It is caused by variations in G-1 pressure due to the effect of the weight of the G-1 valve when it rotates from top to bottom. These pressure variations are amplified by the governor boost valve and directed to the end of the coupling valve. The coupling valve will be caused to oscillate, striking the overrun clutch valve body front plate and giving out a clicking noise.

This clicking noise can be eliminated by the installation of "Transmission Control Valve Body Repair Kit" Part No. 8616949. The repair kit consists of an orificed plug to reduce the pulsations in governor boost pressure at the coupling valve and a bumper plate to cushion the oscillations of the coupling valve.

The orificed plug should be installed in the governor boost passage in the overrun clutch valve body as shown in Fig. 5.

The bumper plate should be installed under the front plate of the overrun clutch valve body so that the coupling valve will strike it instead of the plate.

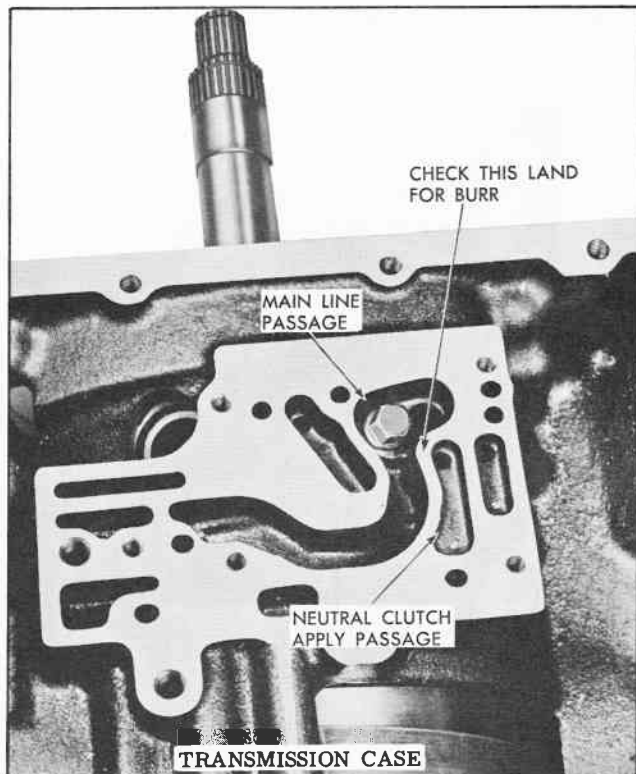
Fig. 6 Transmission Case

Several instances have been reported in which Strato-Flight transmissions lock up when shifted from drive or low range to reverse, but shift normally from neutral or park to reverse.

Investigation of this complaint has disclosed a nick or burr on the case land shown in Fig. 6. This nick allows main line pressure to bleed into the neutral clutch apply passage. The effect of this leak is to slow down the release of the neutral clutch causing a momentary lock-up when the transmission is shifted from drive to reverse.

When a complaint of this nature is encountered, remove the control valve assembly and check for damage at the location shown in Fig. 6. If a burr is found, remove it by stoning. Also check the spacer plate and replace it if it has been damaged by the burr.

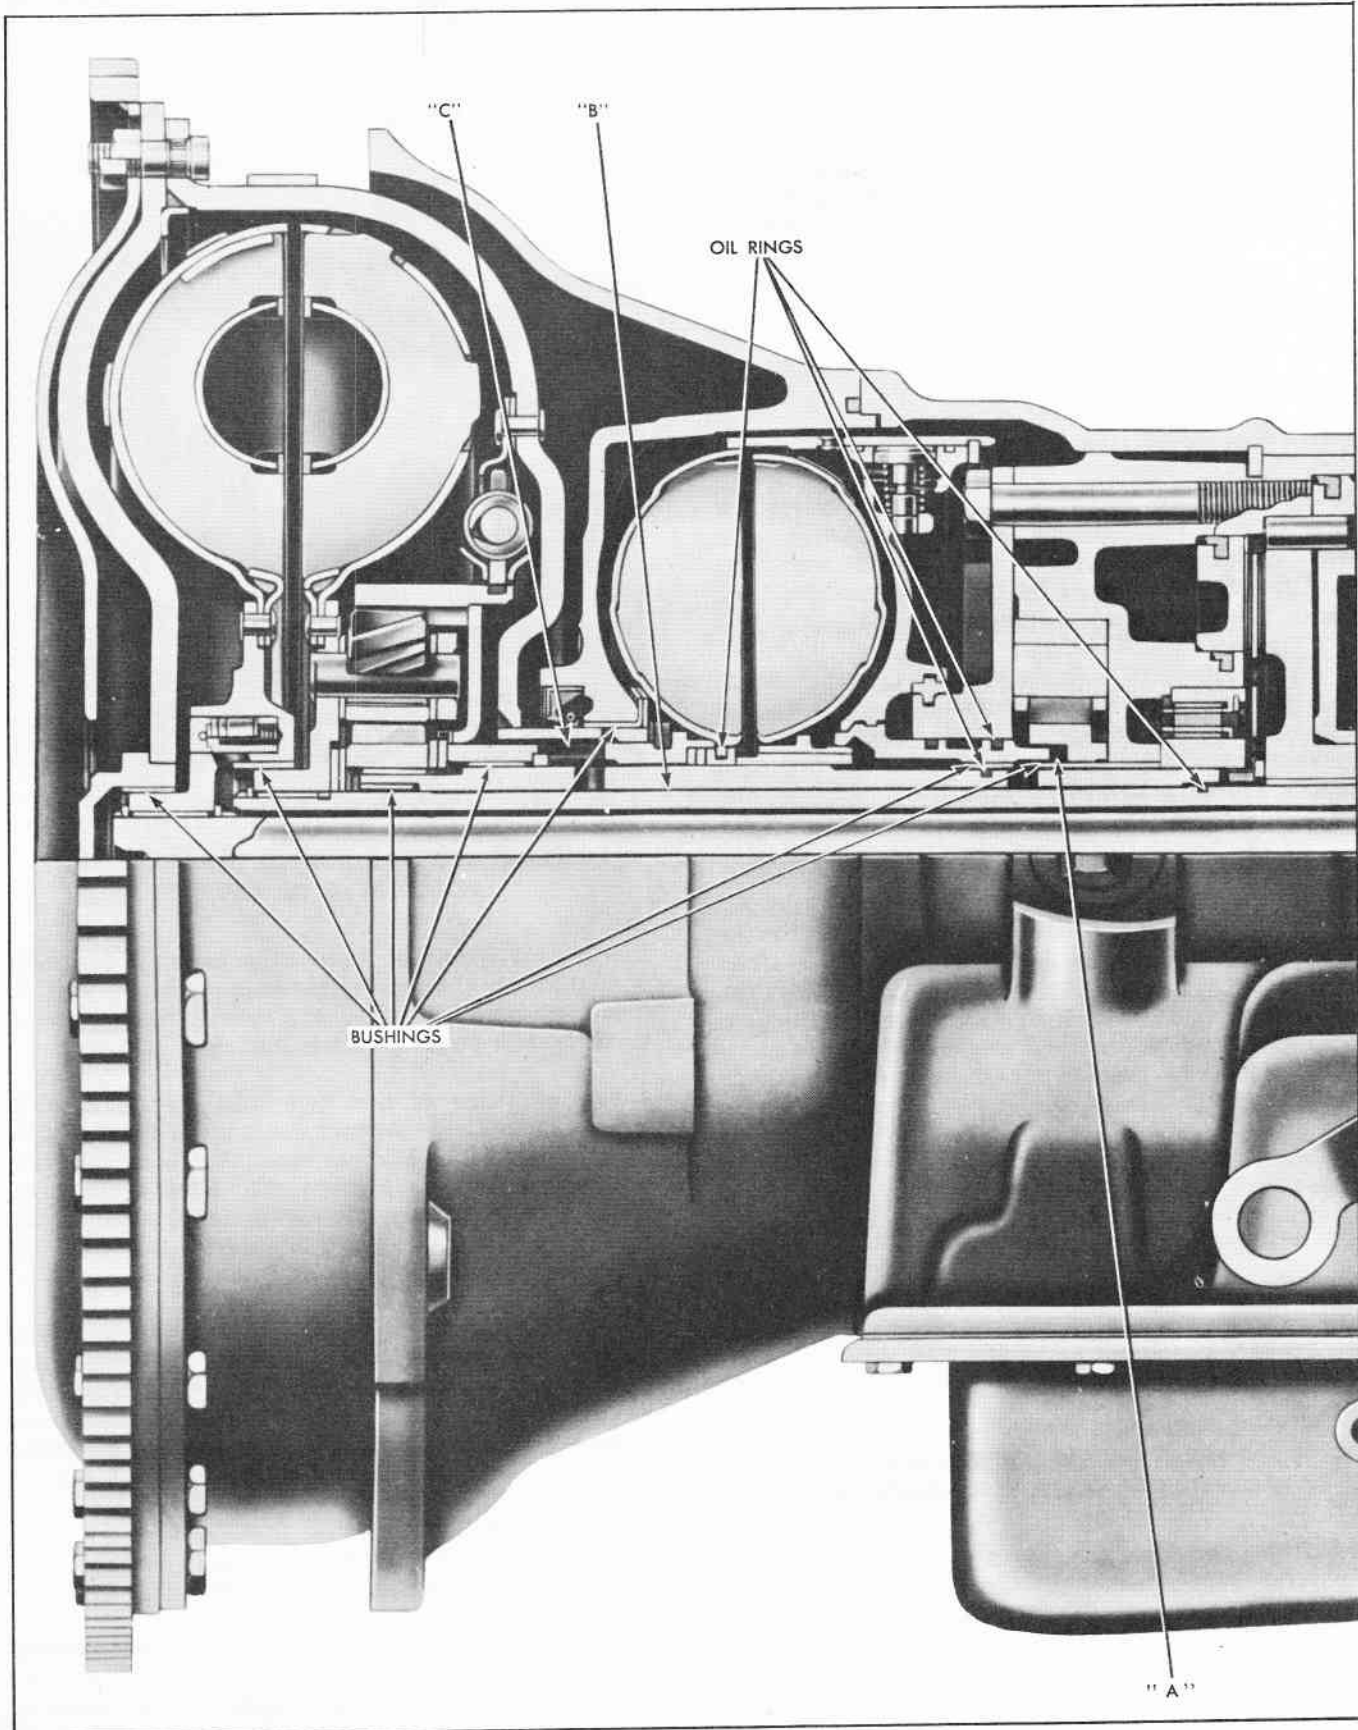
Fig. 7 Cutaway View of Strato-Flight Hydramatic

Occasionally a Strato-Flight Hydra-Matic transmission is encountered which will not drive the car for several seconds after the engine is started. This condition is usually noticed when the car has been parked for a considerable time, such as overnight.

The momentary failure to drive may be caused by the fact that a large portion of the fluid has drained back from the main fluid coupling. Since the points of leakage which have caused the fluid to drain back will also leak when the coupling is being filled, there will be a delay in refilling the coupling when the engine is started. As soon as the coupling is filled, it will function satisfactorily until it has again been parked for several hours.

Careful study of Fig. 7 will reveal the bushings and oil rings which control the flow of oil from the pump to the torus members. They are as follows:

While it is considered that oil is sealed by the above mentioned bushings and oil rings, actually there are "controlled leaks" at all these points. If the clearances become excessive, however, due to wear or damage, the leaks can become great enough to impair the filling of the torus. The result will be excessive drain back, slow filling, and a delay in drive after starting the engine.

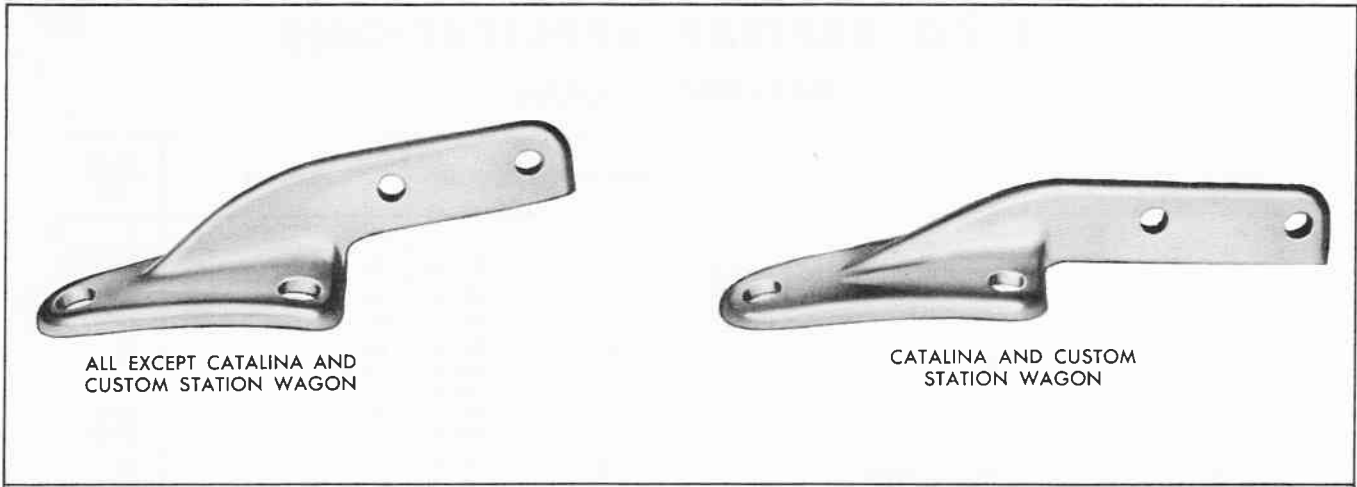
Fig. 8 Sun Visor Center Bracket Comparison

Reports of noisy outside sun visors have been received. Our investigation of these reports show that visor location is very critical with respect to wind noise and that noise will be eliminated if the visor is installed to the correct dimensions. Another cause of dissatisfaction can be eliminated if care is taken that the correct sun visor center bracket is used. Two brackets are available -- one for Catalina and Custom Station Wagon Models and one for all other models (Fig. 8). It is impossible to get a quiet satisfactory installation if the wrong bracket is used.

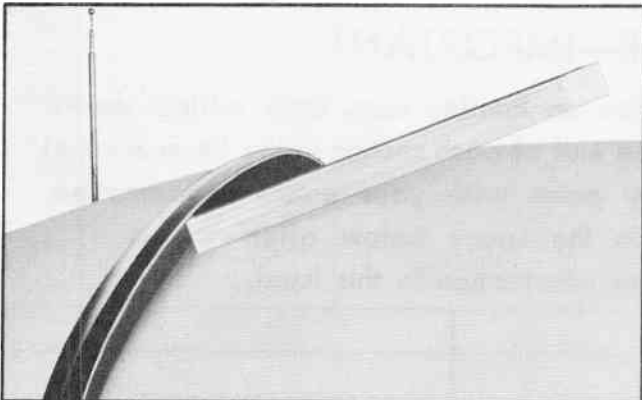
Fig. 11 Measuring Clearance Between Roof Panel and Visor

Fig. 11 shows the gauge being used to measure the clearance between the roof panel and the visor

at the rear center. In this instance the gauge should not enter between the roof and visor.

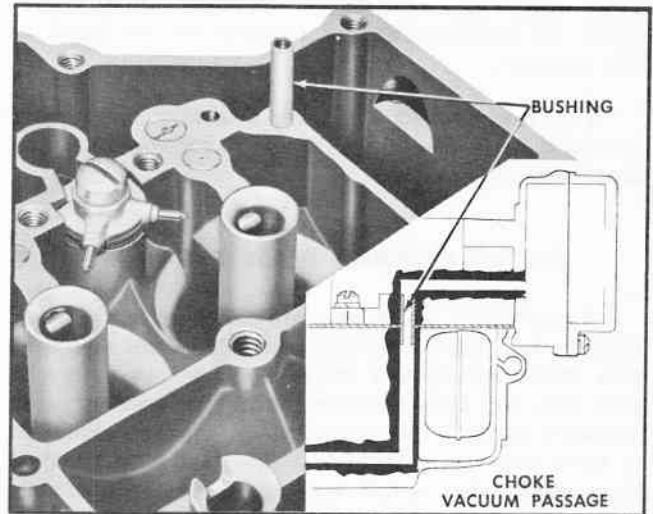
Fig. 12 Bushing Installed in Carter 4-Barrel Carburetor

Product Information Reports have been received stating that some Carter four-barrel carburetors have a tendency to "cut-out" on sharp left turns. Investigation of this condition showed the primary cause to be a leakage of fuel from the carburetor bowl to the choke vacuum passage shown in Fig. 12.

In some instances it is only necessary to tighten the bowl cover attaching screws to eliminate this condition. If this does not correct the complaint, it may be necessary to install a bushing (or standpipe), as shown in Fig. 12. Installation of this bushing assures a more positive seal and prevents fuel leaking into the vacuum passage on left turns. This bushing is released for service under part no. 3732788, and should be ordered through regular channels.

To install the bushing, remove the bowl cover and lightly tap bushing into place in the vacuum passage shown in Fig. 12. Inspect sealing surfaces of bowl cover and bowl for nicked or dented gasket surfaces and in all instances use a new bowl cover gasket. Reinstall bowl cover, tightening the inner attaching screws alternately and securely before tightening the outer screws.
