PONTIAC

Service Craftsman News

No. 4 S-293

April, 1957

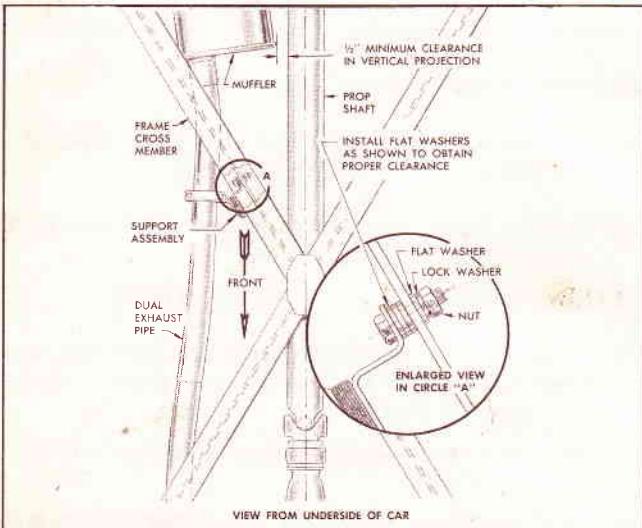
Fig. 1 Clearance Between Muffler and Propeller Shaft

CLEARANCE BETWEEN MUFFLER, 'PROP' SHAFT SHOULD BE CHECKED ON DUAL EXHAUST CARS

All 1957 cars equipped with dual exhausts should be examined when in your dealership for service of any nature to determine clearance between the left muffler and propeller shaft. This clearance must be a minimum of 1/2 inch in a vertical projection measured at the front of the muffler (See Fig. 1).

Less than 1/2 inch clearance may permit the muffler to contact the shaft when the car is being operated at fast initial acceleration or under severe conditions such as heavy loads, rough road rebound, sharp turning, etc. Such a condition may result in damage to the propeller shaft or cause a noise that is difficult to trace.

Cars found without this 1/2 inch clearance should be corrected immediately by loosening and re-positioning the exhaust pipe and muffler supports to give the necessary clearance.

Shims may be used under the front muffler support if clearance cannot be maintained by realignment of pipes. When proper clearance has been obtained, check for interference between the frame and exhaust system.

This condition has been corrected in production by installing mufflers with a flat depression at the extreme front edge to give additional clearance. The suggested time allowance for this operation will be a straight time of .5 hr.
