PONTIAC

Service Craftsman News

No. 5 S-294

May, 1957

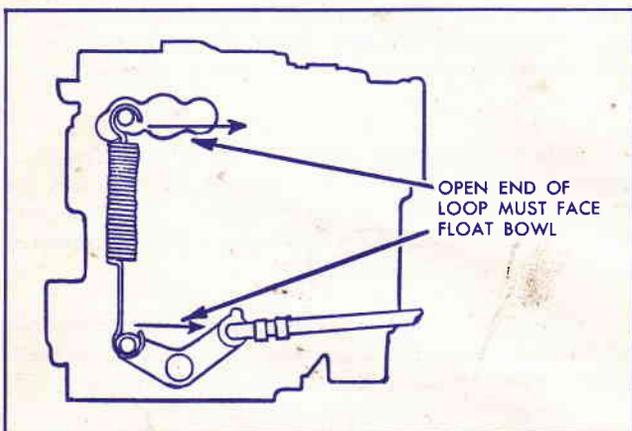
Fig. 1 Installation of Throttle Return Spring

The front and rear carburetors of the triple two barrel option have throttle return springs to insure complete closing of the throttle valves. It is very important for these springs to be installed as shown in Fig. 1. The open end of the spring loop should face toward the float bowl. A bind or breakage of the springs may occur if they are not installed correctly.

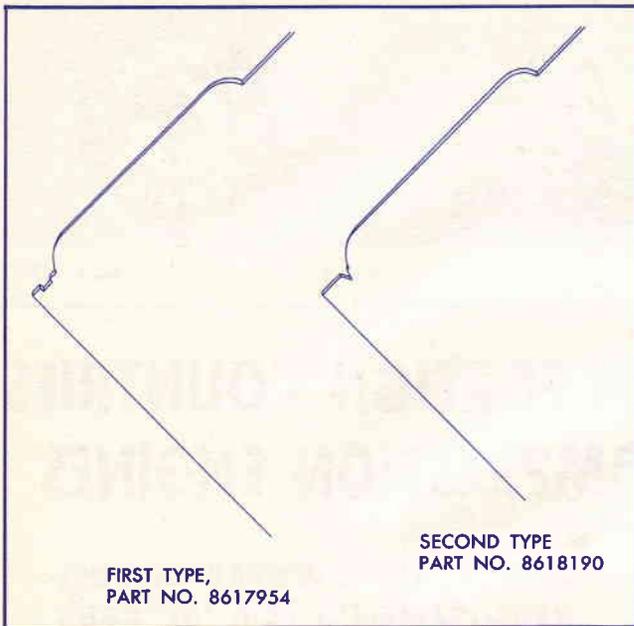
Fig. 2 First and Second Type Channel Plate Spacers

A new shift valve body is now being used on Strato-Flight transmissions. In conjunction with the new shift valve body a new channel plate to valve body spacer (see Fig. 2) is also required. In the new assembly 3-4 oil is routed to the governor boost valve to reduce the possibility of sticking or sluggish operation.

- First Type - Part No. 8617954; Square Notch in Front Corner Adjacent to Front Pump Intake Pipe
 Second Type - Part No. 8618190; Saw Tooth Notch in Front Corner Adjacent to Front Pump Intake Pipe

When a second type shift valve body assembly is installed on a first type control valve assembly, it is necessary:

1. That the second type channel plate to valve body spacer be used.
2. That the channel plate without the 1/4" line drop ball check and spring be used (See December 1956 Service Craftsman News). NOTE: The new channel plate which does not have provision for the line drop check ball can be used to replace the first type channel plate without other change.

Shift valve body and spacer must both be either first type or second type. Second type channel plate can be used in place of first type by discarding 1/4" ball and spring, but do not use a first type channel plate with a second type shift valve body and spacer.

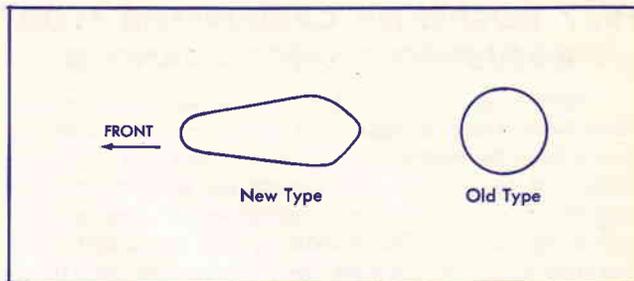
Fig. 3 Cross Section of New and Old Rails

Reports have been received that whistling and/or thumping noises are apparent in the roof area of Safaris equipped with luggage carriers, part number 988767.

A cross section of the new and old rails appears in Fig. 3. No other parts are necessary to make this modification. The suggested time allowance to replace these rails is .8 hr. straight time.

The whistling can be corrected by replacing the front and rear rails. New rails have been designed to reduce air noise. These rails are tapered at the front edge instead of round. The part numbers for the new rails are: front rail - 528386, rear rail - 528385.

Procedure for removing and replacing the front rail is as follows:

1. Remove 1/8 in. set screws from right and left corner rail supports.
2. Remove the four screws securing these rail supports to the roof panel.
3. Slide supports back away from junction of front and side rails.
4. Place a rag under each support to prevent scratching of roof.
5. Remove two pins connecting front rails and two side rails
6. Force front rails out of side rails with plastic hammer.
7. Exchange original rail with new front rail.
8. Insert pins between each side of front rail and two side rails.
9. Position supports and install screws.
10. Install and tighten set screws in supports.

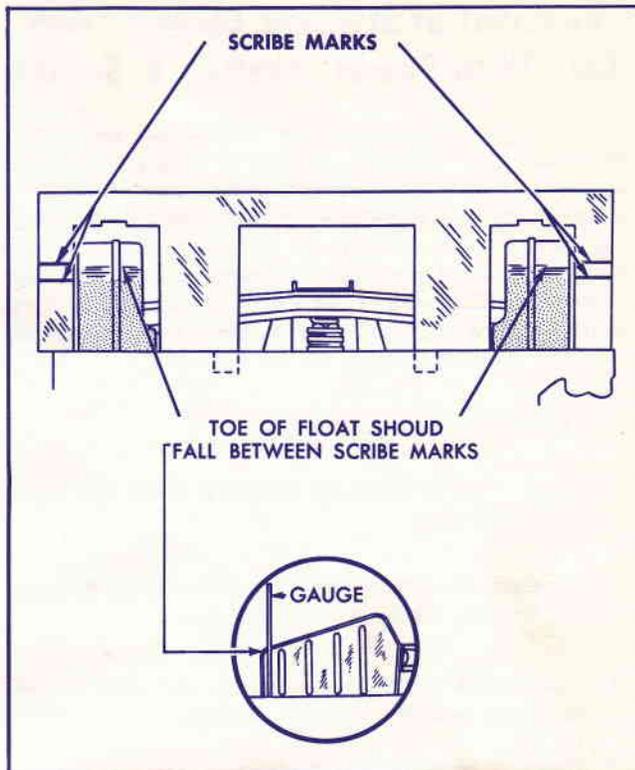
Fig. 4 Rochester Float Adjustment

Since the start of production, several changes have been made in float adjustment specifications and procedure to correct out of line conditions. Investigation of carburetor complaints shows that in many instances improper float adjustments are a contributing factor. The following is a summary of the current float adjustment procedures and specifications. This supersedes the information listed in the 1957 Shop Manual.

1. With air horn gasket in place and air horn inverted, position float level gauge J-6628 over floats so that gauge is located against the curvature in base of carburetor air horn.
2. Bent float arms vertically at center so floats just contact gauge. The vertical height is $1 \frac{3}{8}'' \pm \frac{1}{32}''$.
3. If necessary bend float arms horizontally until each float pontoon is centered between gauge legs.
4. Repeat same adjustment on opposite float assembly.
5. With air horn inverted lower tip of float should clear air horn casting by $\frac{1}{8}'' \pm \frac{1}{16}''$. (With gauge in position the scribe marks on face of gauge show required height of float toe necessary to ensure this clearance; see Fig. 4).

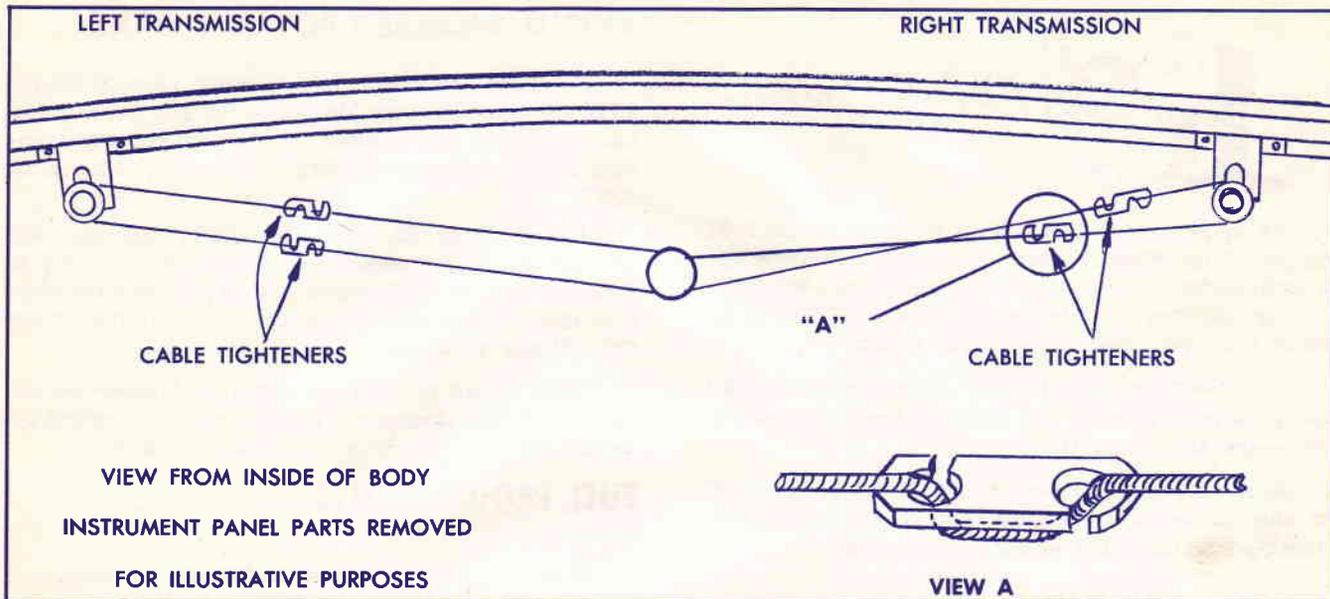
Fig. 5 Windshield Wiper Cable Tightener Installation

Windshield wiper blades that do not travel through the required pattern when operating at normal speed, or that slap the moulding when operating full speed may be caused by loose wiper transmission cables.

If the cables cannot be tightened sufficiently by pressing on the serrated end of the transmission shaft it may be necessary to install one or more cable tighteners, part number 4726957, (see Fig. 5). These tighteners are available through GMPD parts channels and are in stock at Master Warehouses. The suggested time allowance for installation of two tighteners (one on each side) is a straight .2 hr.

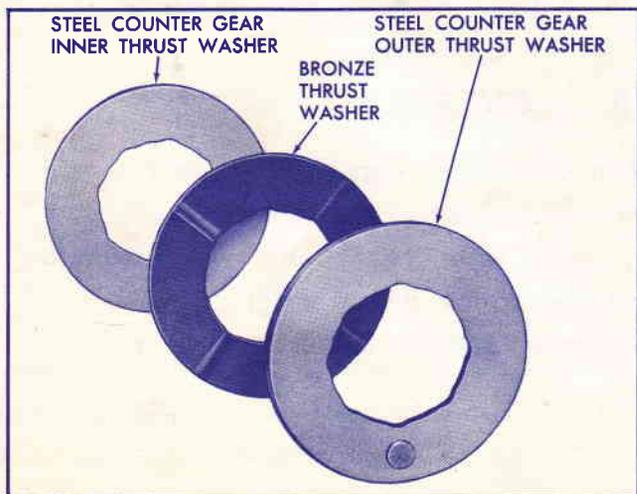
Fig. 6 Counter Shaft Thrust Washers

On all 1957 Synchro-Mesh transmissions, three thrust washers are installed at the rear of the countershaft to take thrust loading and limit end play of the counter-gear shaft. Three plain washers were installed on early production transmissions. The inner and outer rear thrust washers were steel and the center, bronze. However, it was found that as the washers turned with the counter gear shaft, it was possible for the outer washer to score and wear the counter gear shaft thrust boss at the rear of the transmission case.

A new steel outer counter gear rear thrust washer and pin assembly (Fig. 6) has been released for service to prevent such a condition. The pin on this washer (Fig. 6) indexes with the vertical oil groove in the case thrust boss and keeps the washer from turning. No change has been necessary for the steel inner thrust washer and the center bronze washer.

If a transmission is removed for repairs, replace the counter gear steel outer thrust washer with the new type washer. It is advisable to check the inner steel and center bronze washers for wear and replace if they are worn sufficiently to cause excessive counter gear end play.

Before installing the stationary washer assembly, check the locating pin groove depth in the transmission case. The depth should be between 5/64" and 3/32". If groove depth is less than minimum dimension given, cut to proper depth with a chisel.

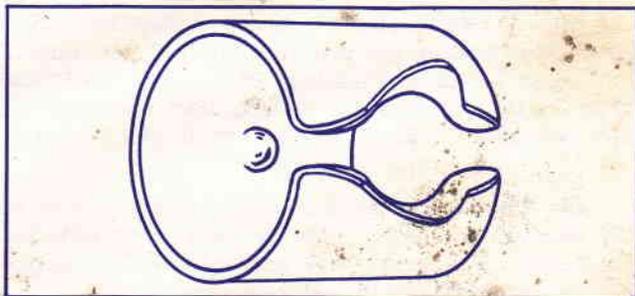
Fig. 7 Throttle Rod Ball Joint Retainer

On some early 1957 models, failure of the accelerator pedal rod assembly was experienced. This was caused by a faulty Hydra-Matic throttle rod ball joint stud retainer which would not hold up under normal usage. At that time it was necessary to replace the entire rod assembly because the retainer was not available for service.

The ball retainer has now been released as a service part under number 529475 (see Fig. 7) and should be installed if this condition occurs. It can be ordered in the usual manner.
