PONTIAC

Service Craftsman News

No. 8 S-297

August, 1957

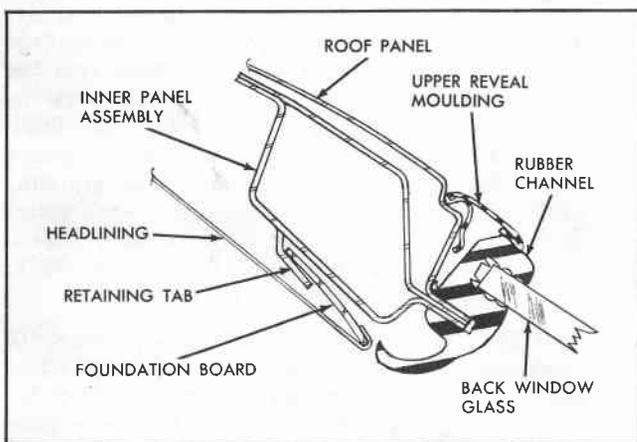
Fig. 1 Unconcealed Headlining

If a condition is encountered on 2711 and 2719 styles where the rear edge of the headlining is not concealed by the forward lip of the back window glass rubber channel, the condition may be corrected using the following procedure:

1. At affected area, as indicated in Figure 1, gently press rubber channel out of the way. Carefully grasp the rear edge of the headlining and pull the headlining down and rearward until the foundation board disengages from the retaining tabs in the rear roof bow. The retaining tabs may bend slightly during this operation.

2. Obtain a piece of 1/16 inch panel board stock which has not been treated with asphalt or other bleeding-type materials. Cut the panel board

into a shim approximately four to six inches longer than the affected area. Trim the width of the shim so that it will be equal to the width of the foundation board plus the width necessary to obtain approximately 1/4 to 3/8 inch overlap, between the lip of the glass rubber channel and the headlining.

- 3. Rebend retaining tabs back into their original shape. Allow enough of an opening for shim to slide in readily.
- 4. Place shim between headlining and foundation board as shown in Figure 10.
- 5. Engage foundation board and shim into retaining tabs. Always work toward the center of a repaired area when re-installing headlining.
- 6. Using a flat-bladed tool, carefully pry lip of rubber channel over edge of headlining.
- 7. Reinstall rear quarter window garnish moldings on two-door styles.

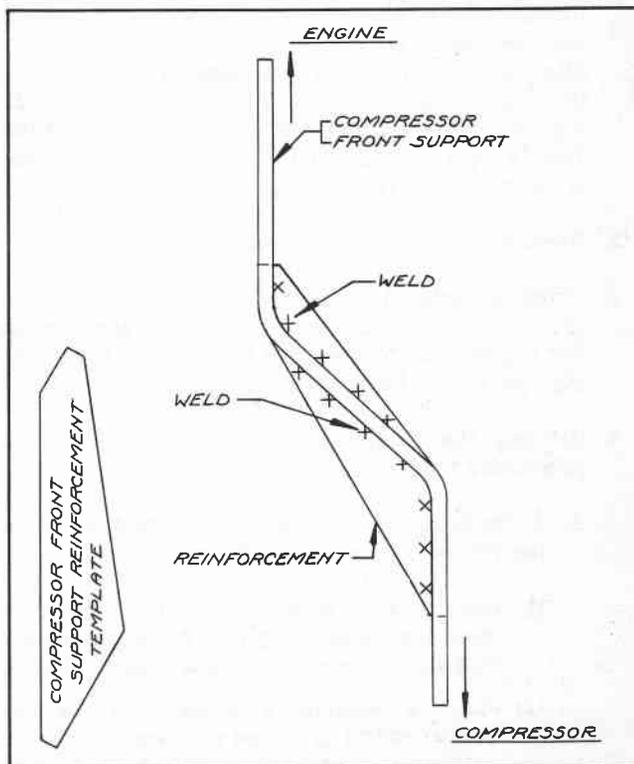
The vibrations experienced at 600-700 engine rpm may be eliminated as follows:

Fig. 2 Compressor Front Support Reinforcement

1. Remove the compressor front bracket.
2. Reinforce the compressor front bracket as shown in Fig. 2, with metal that is 3/16" or 1/4" thick using the template shown in the lower left portion of this same figure.

NOTE: This bracket should be reinforced so the metal is at the lower edge of the bracket when installed on the car.

3. Replace reinforced compressor front bracket.

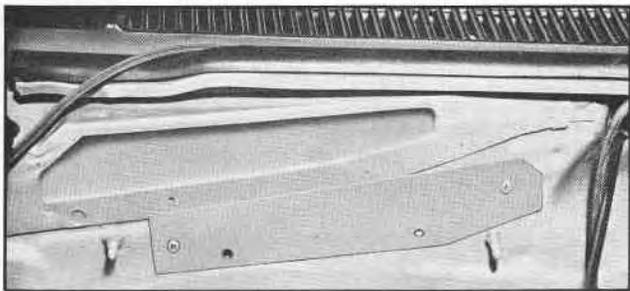
Fig. 3 Production Cover Plate

During the cooler weather, the owner may wish to have the plate positioned as shown in Fig. 3 to prevent outside air from entering the car.

partment into the inlet filter housing. This opening will be covered in production by a cover as shown in Fig. 3. Should the owner desire greater air cooling, it will be necessary to remove the filter housing and move this cover so as to form a baffle at the outside of the intake opening as shown in Fig. 4. Care should be used to seal between the dash and the cover to prevent water from entering the car.

NOTE: During cooler weather, the owner may wish to have the plate positioned as in Fig. 3 to prevent outside air from entering the car.

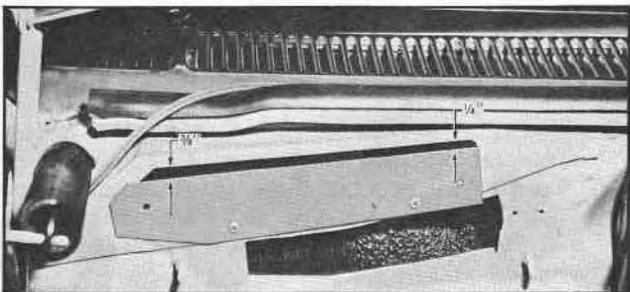
Fig. 4 Position of Plate for Cooler Weather

5. Place a bead of body sealer around the sides and lower outer edge of the 530753 cover. Place over the outside air opening to cover all but a gap 1/4", wide which would extend the entire length upper part of the hole (See Fig. 4).
6. Secure cover (530753) with sheet metal screws.
7. Replace air filter housing and adjust air valve cable.

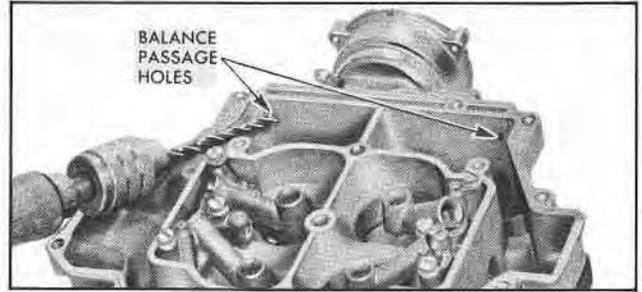
Fig. 5 Drilling Balance Passage

3. Remove fuel filter and inlet nut from carburetor air horn as a unit.
4. Using a 3/16" drill, drill out the balance passage holes (Fig. 5). Note: These holes are drilled at an angle and care should be used to see that drill does not contact other areas of carburetor while drilling. Position drill as shown. Remove all burrs and chips after drilling.

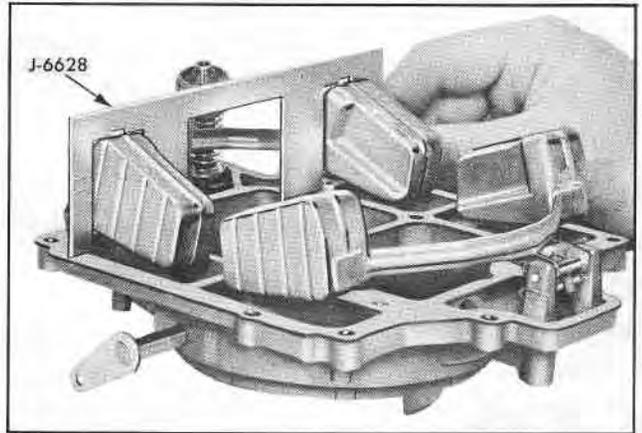
Fig. 6 Checking Float Level

- (1) With air horn gasket in place and air horn inverted, position float level gauge J-6628 over floats as shown in Fig. 6 so that gauge is located against the curvature in base of carburetor air horn.
- (2) Bend float arms vertically at center so floats just contact gauge. The vertical height is $1\text{-}3/8" + 1/32"$.
- (3) If necessary bend float arms horizontally until each float pontoon is centered between gauge legs.
- (4) Repeat same adjustment on opposite float assembly.
- (5) With air horn inverted, lower edge of toe of float should be flush to $+1/16"$ from gasket surface. With gauge in position shown in Fig. 7, the two scribe marks on the gauge show required height of float toe necessary to ensure this clearance. If adjustment is necessary, hold float

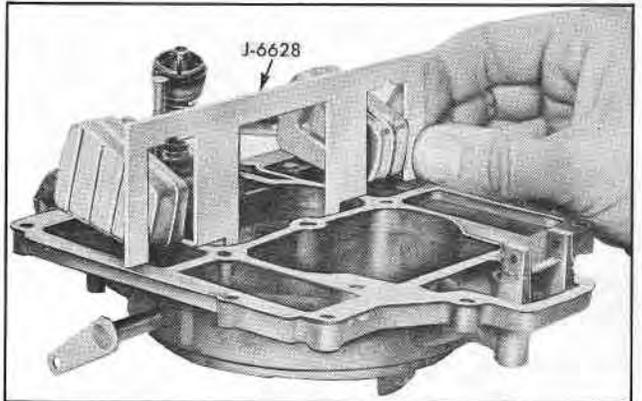
Fig. 7 Checking Float Toe Clearance

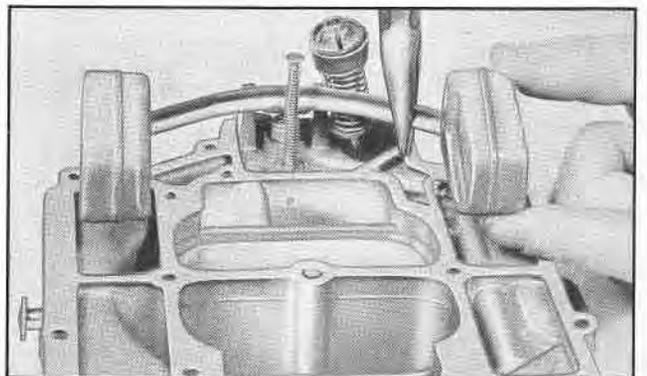
Fig. 8 Adjusting Float Toe Height

hanger adjacent to float pontoon, and with fingers bend toe of float up or down as required (See Fig. 8).

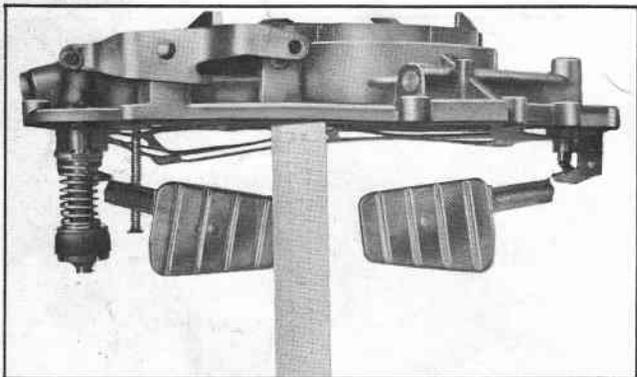
Fig. 9 Checking Float Drop

- (1) With float held in an upright position, check distance between air horn with gasket in place and the toe of float at end of radius as shown in Fig. 9. Float drop is correct when this distance is $1-13/16'' + 1/32''$. Note that this gauging is done at the toe of the float and NOT at the heel as shown in the 1957 Shop Manual.
- (2) If adjustment is necessary, bend float tang toward float needle seat to lessen drop and away from seat to increase drop.

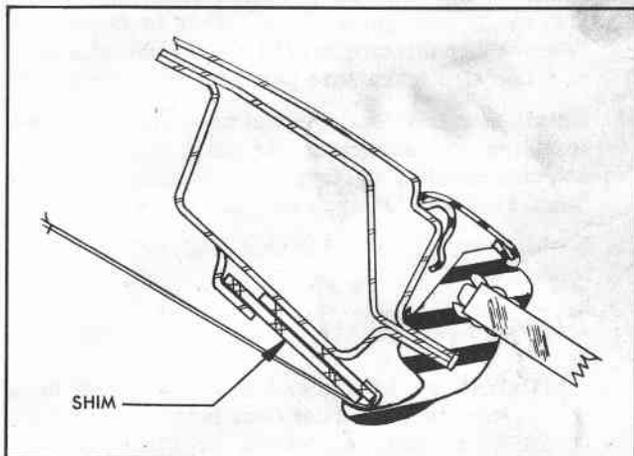
Fig. 10 Shim Installed
