April 4, 2005

I talked to Troy on March 31 regarding a problem with the front end lower inner shafts for a 1956 Pontiac. Reference attached Invoice# K26932, Order number K70221 5, dated 3/14/05.

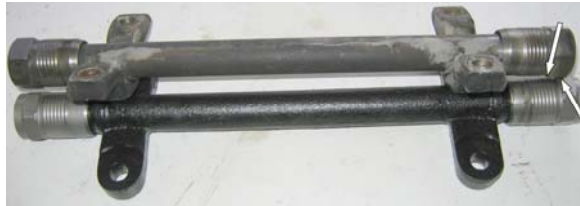
The shaft bottoms out in the bushings when the shaft/bushings are installed into the control arm. This causes the shaft to freeze in place (cannot turn the shaft.) I installed the shaft per Pontiac Shop manual instructions, insuring the specified 11½ inches between arms of the control arm.

The picture below shows the old shaft on top and the new shaft on the bottom, with the bushings screwed down until they stop. In this picture, the mating surfaces of the bushings are aligned on the left. Note the mating surfaces on the right bushings are not aligned. The new shaft bushings will not thread down as far as the bushings on the old shaft.

Hopefully, this clarifies the problem and you can fix it quickly. Per conversation with Troy, I am returning both shafts/bushings along with one of my old shafts/bushings. You can contact me by phone or email (see above.)

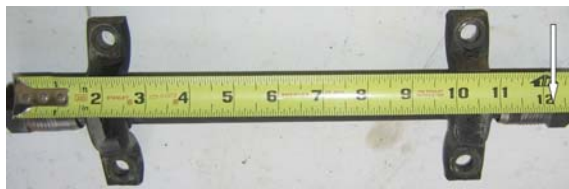
Old Shaft

Here you see measurements between the bushing mating surfaces.

These pictures show that there is nearly ¼ inch difference. The inability of the new shaft to thread down as far into the bushings results in the shaft not working correctly (the shaft locks up when properly installed) due to the shaft bottoming out as the bushings are tightened into the control arms.
