BATWING AIR CLEANER GUIDE

(with a Pontiac emphasis)

by Len Sokol, February 2006 (revised February 2012)

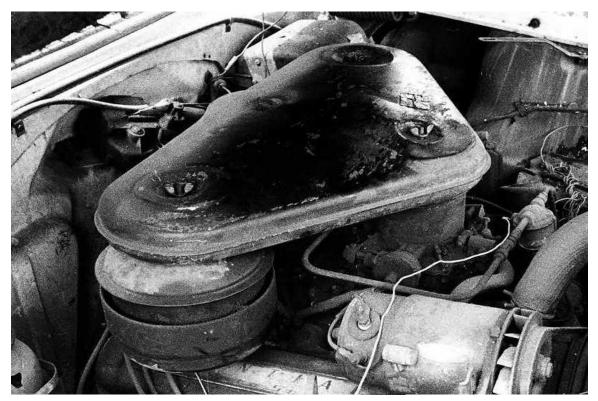
Original '56 Pontiac setup (c. 1979), 1 of 3

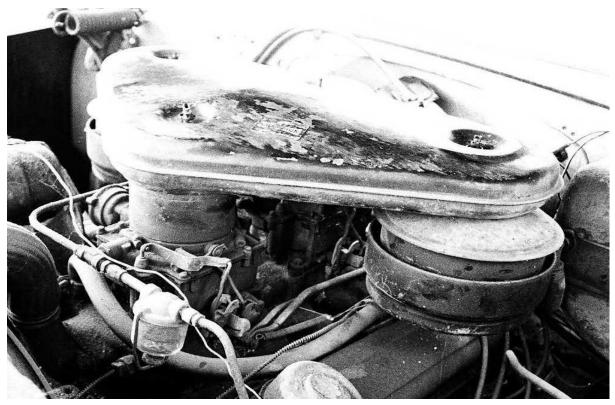
Original '56 Pontiac setup (c. 1979), 3 of 3

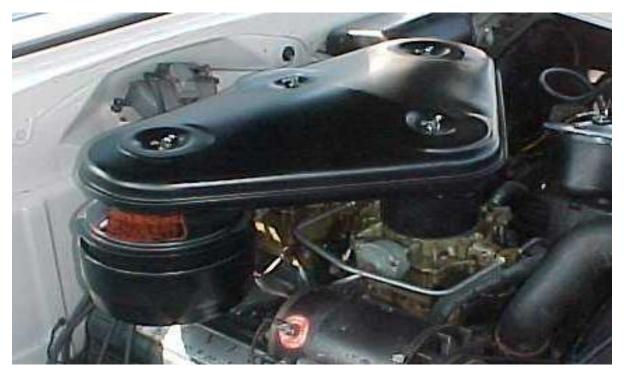
Pontiac unit on a restored '56 at 2001 POCI Convention

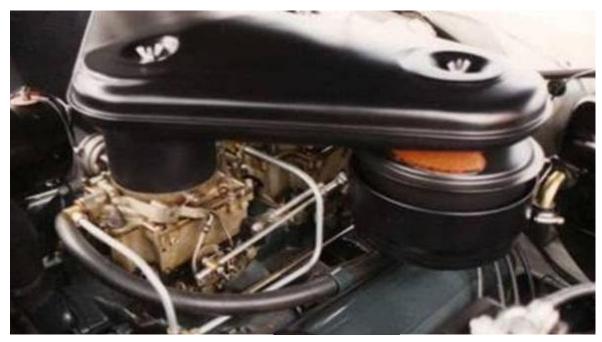
Another Caddy unit on a '56 Pontiac

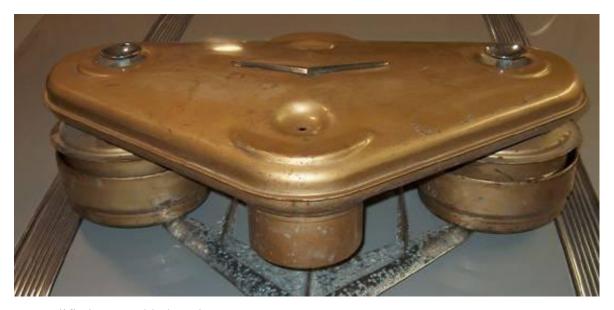
Unmodified '56 Caddy batwing

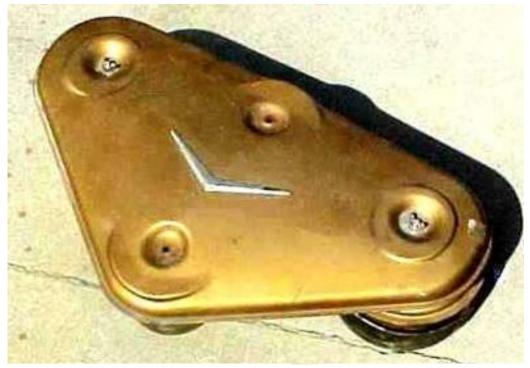
'56 Caddy unit undergoing restoration

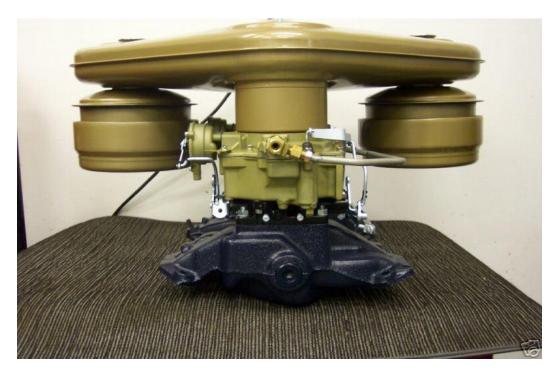
Another '56 Caddy - interesting view

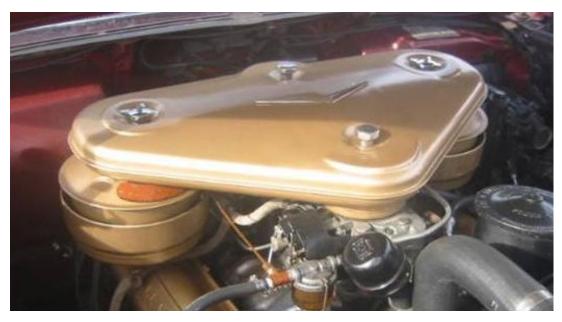
Original '57 Caddy setup

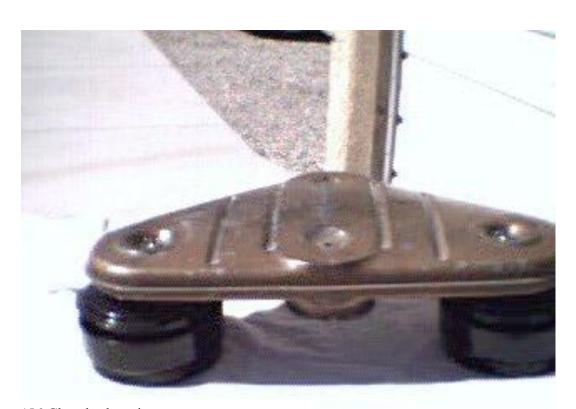
'56 Chrysler batwing

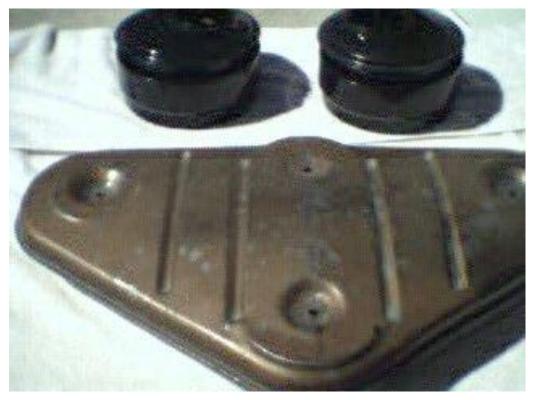
'56 Chrysler batwing disassembled

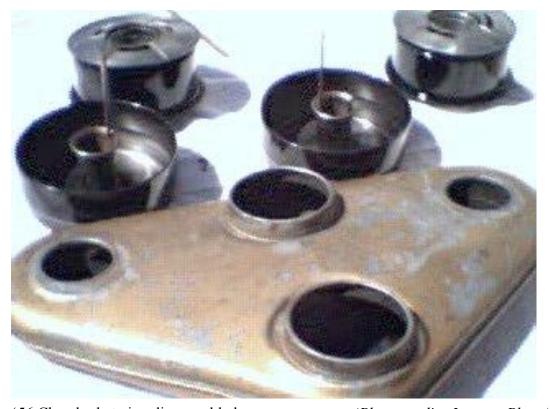
'56 Chrysler batwing disassembled

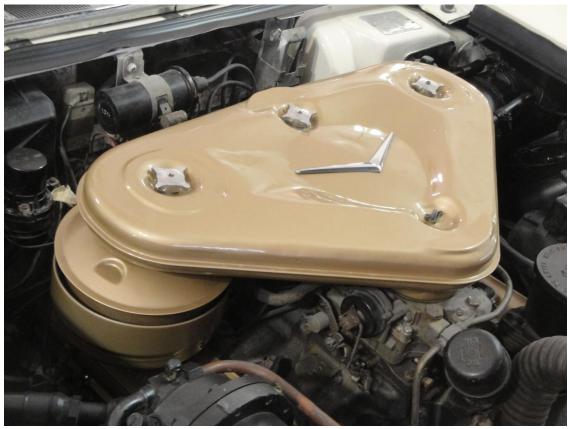
'57 Eldorado Brougham batwing (*Photo credit: Len Sokol*) Notice large recessed area in center. This was needed due to lowered body and hood on only the Brougham models. Unique and extremely low in production quantity.

⁵ Feb.2012 Top is smooth with a large recessed area in the center due to lowered body and hood on Brougham models only (see picture on page 11).

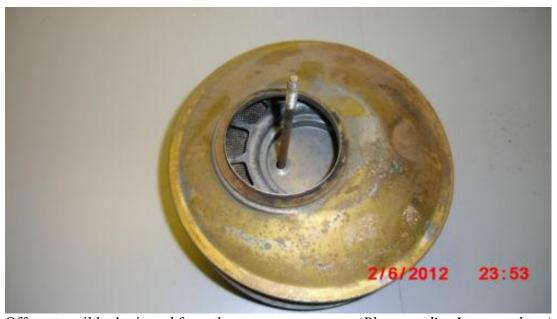
Off-center oil bath viewed from the top

$^{^{1}}$ C = Centered mounting hole on top of both oil baths; B = Off-centered mounting hole on both oil baths; R = Off-centered mounting hole on RH one only. (When mounting stud mates the off-centered hole thru the underside opening of the batwing, rotation of the oil bath enables it to be positioned in the proper orientation based on clearance requirements.) Feb,2012 Keep in mind that over the years, oil baths may have been mixed and matched incorrectly with their batwing shells.

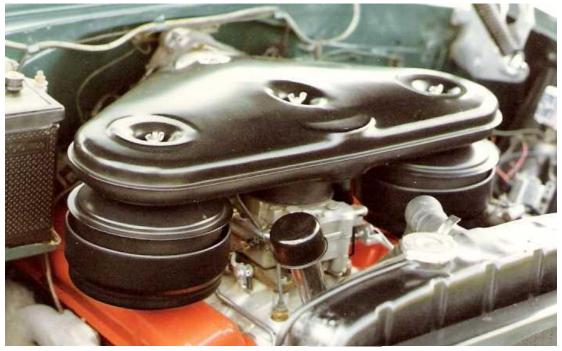
'56 Chevy batwing (c.1978)

³ When mounted, the Chevy batwing points toward the rear due to clearance requirements, primarily the battery on the firewall in '55-'56. (NOTE: If you know your Pontiac and Caddy units well, and you encounter your first Chevy batwing on a car, please refrain from telling the car owner he has it on backwards.)

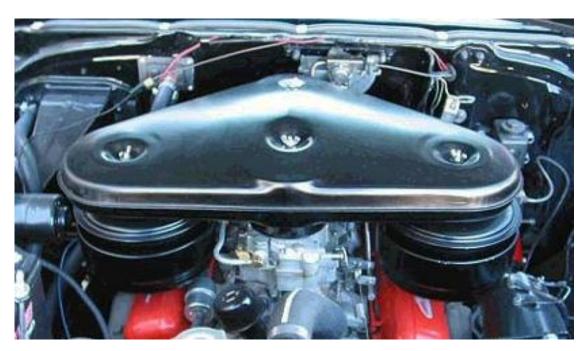
'57 Chevy with correct batwing (Note off-center RH oil bath -- '57 only)

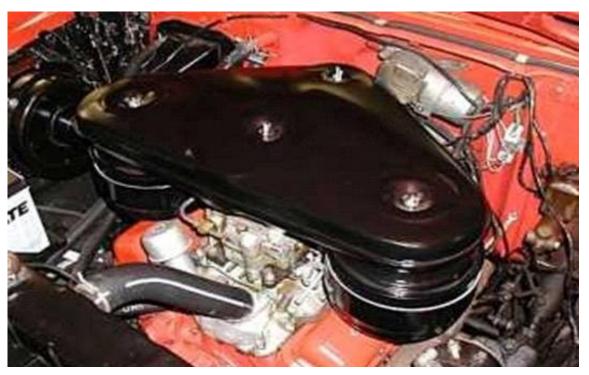
Another '57 Chevy with correct batwing

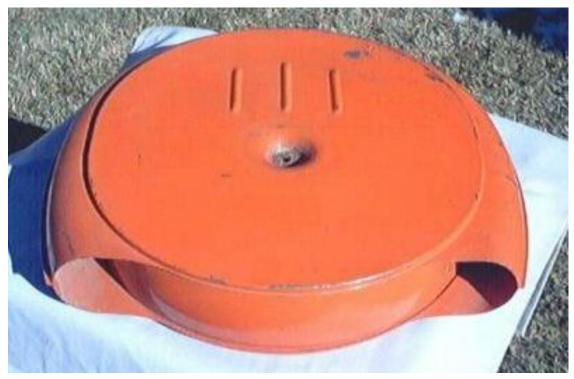
Air cleaner used on mid-50's Buick, Olds, Caddy

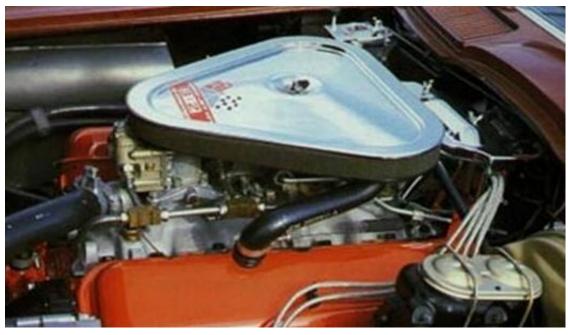
Mid-60's batwing wannabe: '67 Corvette 427/400 3x2 (Photo credit: Rick Gonser)
