Service Procedures for 1955-56 Pontiac Power Antenna

By Bob Johnson, editing and "webizing" by Larry Gorden
May 2011

This article describes service procedures for the 1956 power antenna. There may be minor differences in service instructions for other year Casco antennas.

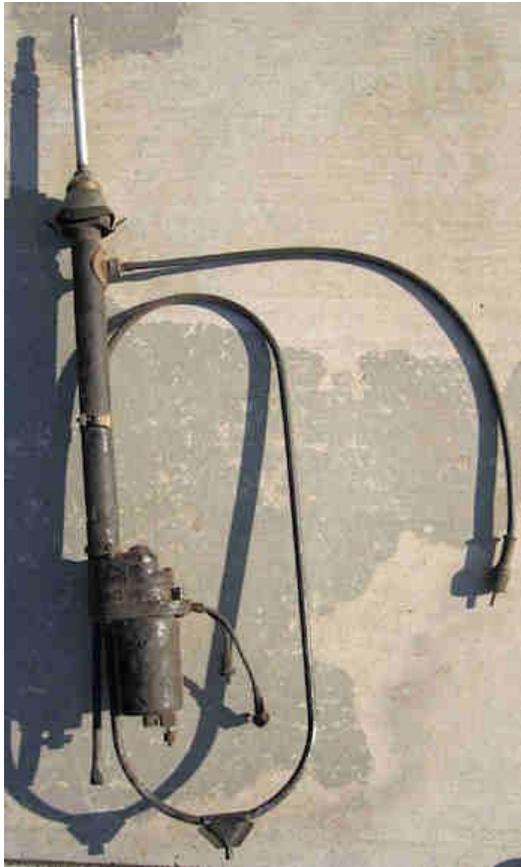
Power Antenna – Type I
1955 All Models
1956 Station Wagons Only
Mast Lead Aluminum Storage Tube
Upper End of storage tube clamps to antenna
mast tube
Crimped end of storage tube with drain at bottom
loop of tube
Short power leads with rubber boots

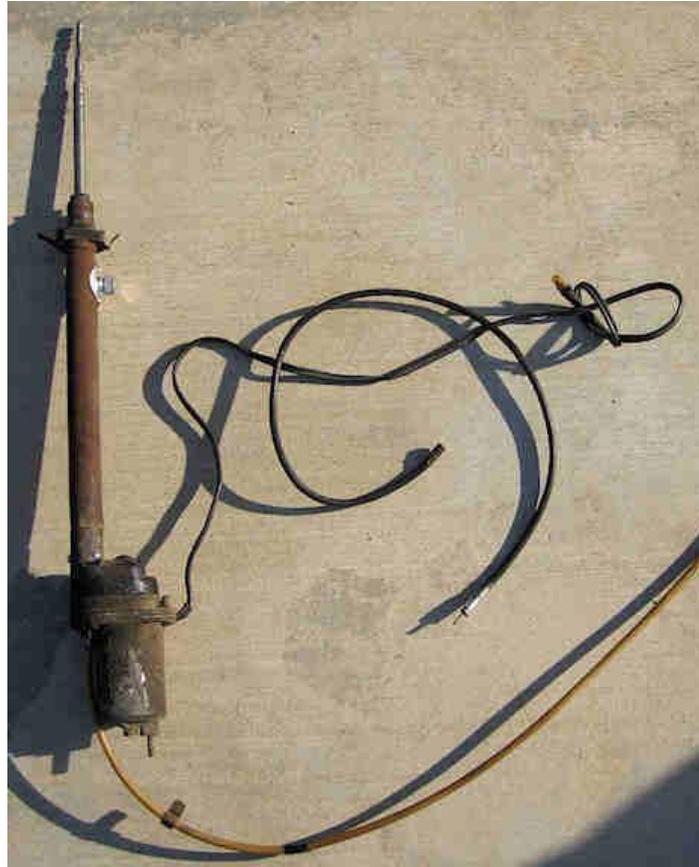
Power Antenna –Type II
1956 All models except Station Wagon
Mast Lead Nylon Storage Tube
Storage Tube clips to fuel tank flange
Felt filter in drainage end of tube
Long siamese power lead, no boots

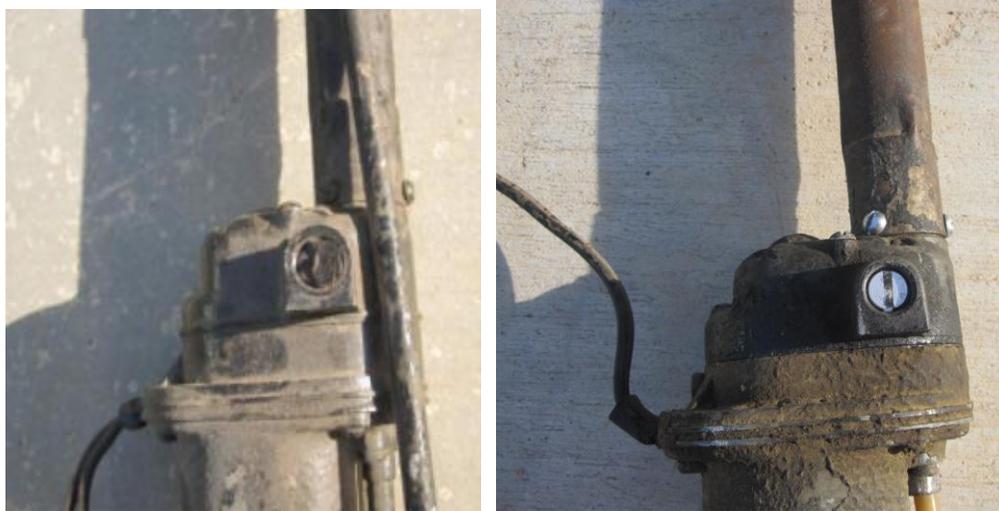
Adjustment Screw

Obviously, operation of the power antenna motor with a broken, bent or stuck mast is highly risky, and is not recommended. If you have a bent, broken or stuck mast, **before attempting to operate the antenna electric motor (even for testing purposes)** it is best to either remove the mast entirely, or at least relieve all tension on the nylon mast lead by completely removing the tension screw and spring from the drive mechanism. The adjustment screw is located in the upper drive mechanism case near the top (see photo below).

As can be seen in the first photo, this screw is often caked with dirt, grease or even undercoating material. So, remove all the gunk to reveal the face of the screw. I've found a stub handle straight bladed screw driver with a broad blade works best for adjusting this screw.

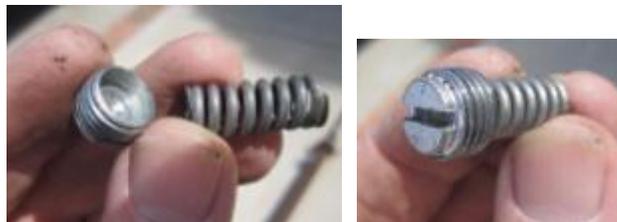
Adjustment screw and tension spring

After the adjustment screw and spring are removed, it is much safer to test the electric motor and/or antenna mast for proper operation.

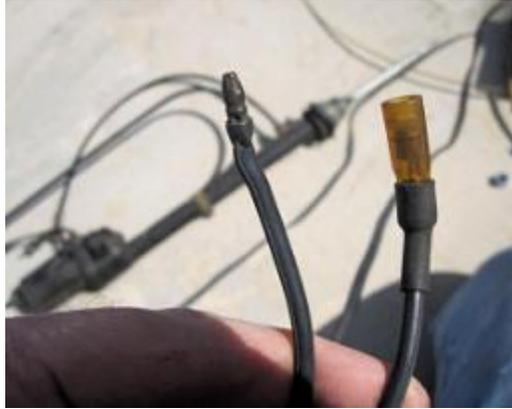
The motor receives power through a two wire electrical lead; one wire for each direction of mast travel (up or down).

The circuit is completed by the grounding of the antenna motor case through the lower mounting stud (and when installed on the car, then through the mounting bracket and its attachment to the lower fender of the car ...good to know when trouble shooting an inoperative antenna unit that's still on the car...remember to check first for good grounding before removing the unit).

The electric motor can be readily bench tested by connecting either wire of the power lead to the positive side of a 12 volt battery, and connecting the mounting stud on the bottom of the motor case to the negative side of the battery. Both wires of the power lead need to be tested to confirm proper operation of the electric motor in both directions. Remember to completely remove the tension adjustment screw and spring from the drive mechanism as described above. With these removed, a properly functioning motor should readily spin in both directions without any damage to the unit.

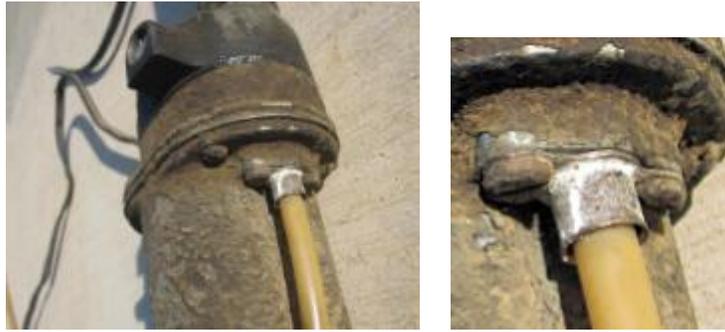
The above photos show the screws that secure the storage tube to the antenna motor assembly for the Type II antenna as used on the sedan, hardtop and convertible models.

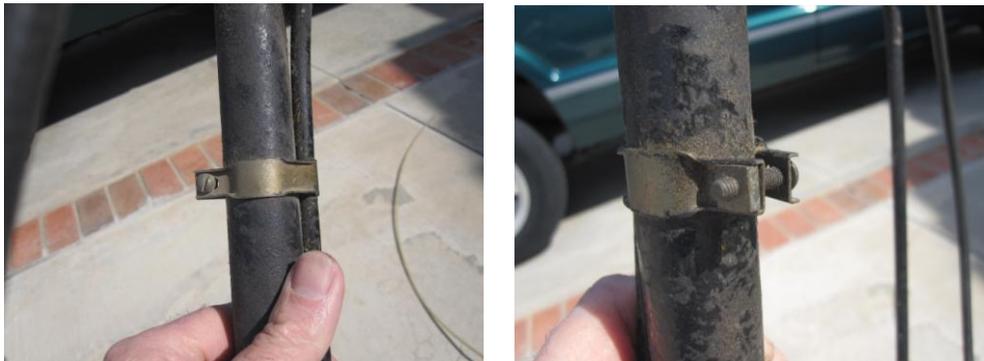
These photos show the connection of the clamp to the upper antenna mast tube and aluminum storage tube.

The aluminum storage tube for Type I antennas as used on station wagons is similarly secured to the motor, as well as clamped to the upper mast tube assembly. For station wagons, the clamp holding the aluminum storage tube to the upper antenna mast tube will also need to be removed.

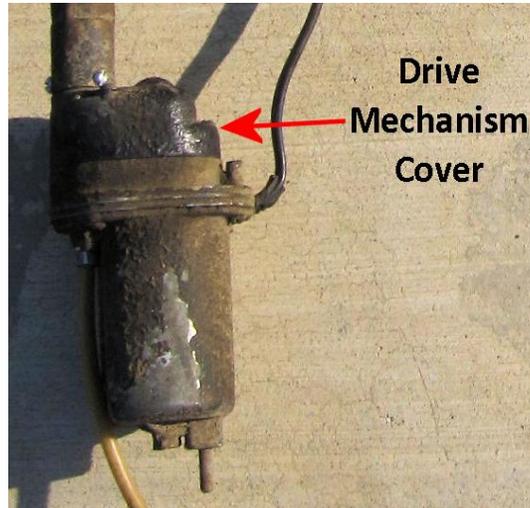
The drive mechanism cover, as shown in this photo, is that portion of the motor case that is dark black, as compared to the upper antenna mast tube and the upper & lower electric motor case sections which by contrast are a dirty brown color on this particular motor assembly.

With the three screws removed, the upper case (together with the upper mast tube and mast assembly) should readily come off the motor case and the nylon lead should slide out of the motor case.

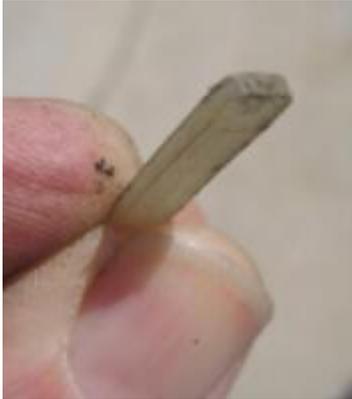
Nylon lead end view

If the mast lead is exhibiting any drag, open this case cover cautiously so as to avoid further damage to the mast lead. Rather than simply pulling the top section away, first try pushing the mast lead up from the bottom of the motor case into the drive mechanism to see if the mast will slide up some. If so, you can then raise the cover by the distance the mast has moved up by pushing the mast section down while pulling the case top up (hold the lead in place at the bottom of the motor case so it doesn't slide back out). With the drive mechanism case raised slightly, you should then be able to see inside it to determine whether anything inside the cover is causing the resistance on the antenna lead and hopefully relieve the problem so the entire lead can be pulled out through the drive mechanism. Sometimes the lead has simply become twisted and has turned ninety degrees and wedged between the two steel wheels it's designed to run between. The narrow sides of the lead do not run on the steel wheels. Rather, the wide sides are supposed to run against the wheels.

Although, the wheels are slotted in such a way that it looks logical that the lead might run with the narrow sides against the wheels and the lead being in the two notches....this is incorrect!. Not to say you won't find it that way upon disassembly...as sometimes the lead gets twisted or may have been incorrectly installed. If installed incorrectly, the tension spring will not provide sufficient tension for the mast to work properly as the running surfaces will be too narrow.

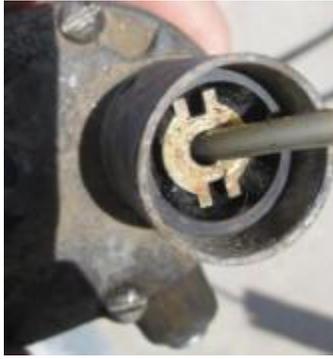
Step One – Disassembly of Upper Drive Mechanism Cover and Antenna Tube: With the upper drive mechanism cover and antenna tube and mast assembly removed, the mast tube can be disassembled from the drive mechanism case by removing the three ¼" long round head sheet metal screws that hold the tube to the case. Gingerly twist the tube free from the upper case being careful not to twist or kink the nylon lead. Slide the full length of the nylon lead out of the upper case. You should find a grommet and specialized brass washer in the top tube of the drive mechanism case,

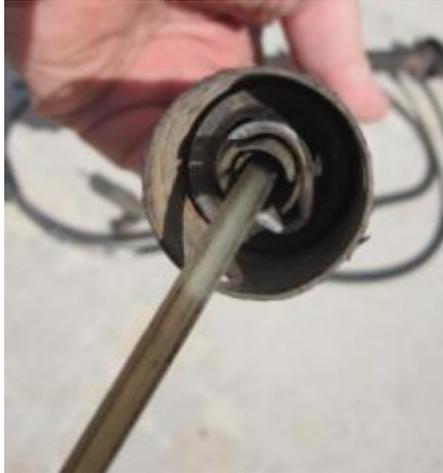
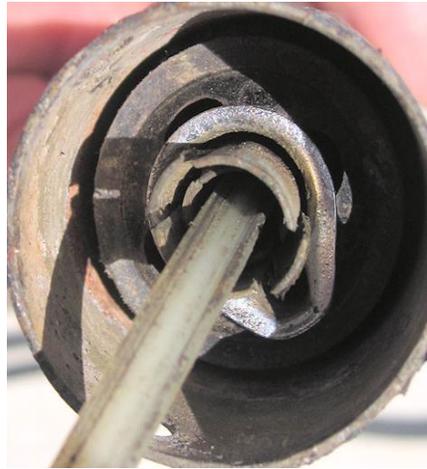
and another mating grommet in the lower end of the antenna tube.

This antenna mast is a replacement type, and differs slightly from the original equipment mast. The base of an original mast has two square tabs 180 degrees apart that mate to the two notches in the brass washer that seats in the grommet found in the drive mechanism case.

Carefully note their relative positions, and how the brass washer mates to the bottom of the antenna mast. Both grommets and the washer should be removed, cleaned and waxed in preparation for reassembly of the mast. Do not attempt to remove the mast assembly from the antenna tube before disconnecting the antenna lead wire.

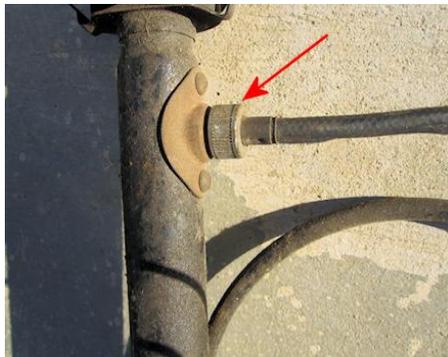
Aluminum collar

Step Two – Antenna Cable Lead Removal: Remove the antenna cable lead from the upper antenna tube. There are a couple of ways this can be done. The antenna lead is attached to a special bracket on the upper tube by a fine threaded screw collar. This collar is an aluminum piece, and the bracket to which it is attached is a steel bracket.

Consequently, due to corrosion problems associated with dissimilar metals, the screw collar does not always come off readily. Additionally, because of its fine threads, dirt and grime can bind the two together to the point they cannot be unscrewed. A liberal application of liquid wrench/WD 40 is usually helpful, but be careful not exert too much force on this collar, as the aluminum threads often strip out easily. If you are successful in unscrewing the aluminum collar, you can disconnect the antenna lead from the lead plug. If you find you cannot unscrew the collar, then go to Plan B below.

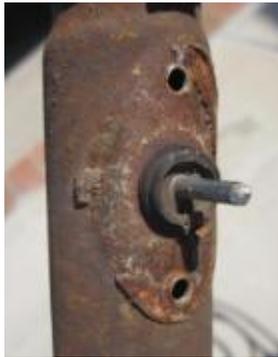
Pin and grommet in place

Step Three – Antenna Lead Bracket and Pin Removal: The antenna lead bracket is fastened to the antenna tube with two ¼” long round head metal screws, and a cork gasket seals the joint between the bracket and the tube. Remove the two screws and gingerly pry the bracket loose from around the antenna lead pin. The lead pin is held in place by a rubber gasket that is a press fit into the hole in the antenna mast tube which keeps the pin centered in the bracket. Once the bracket is removed, this rubber gasket and pin can be worked out of the press fit hole in the antenna tube. The pin itself is attached to a small washer held within the rubber gasket. I’ve never been successful in getting the washer and pin out of the gasket. The pin is also soldered to a very fine multi-strand wire the other end of which is in turn soldered to the outer-most antenna mast telescoping tube. The wire connecting the pin to the mast tube is **very** short. In past efforts to unsolder the wire from the antenna pin, I’ve found the rubber gasket often melts before the solder connecting the wire to the pin. So, typically once I pry the rubber grommet and pin out of the antenna tube, I will carefully cut the connecting wire, leaving sufficient length attached to the pin so a splice can be made and soldered to a new connecting wire between the pin and replaced mast.

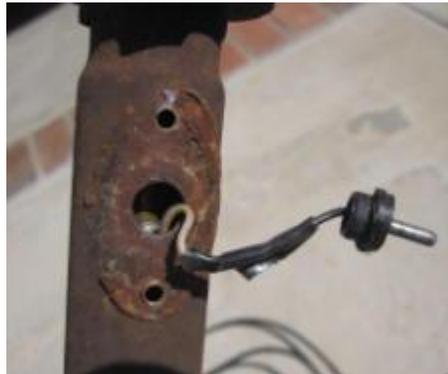
Pin and grommet
spliced to new mast lead

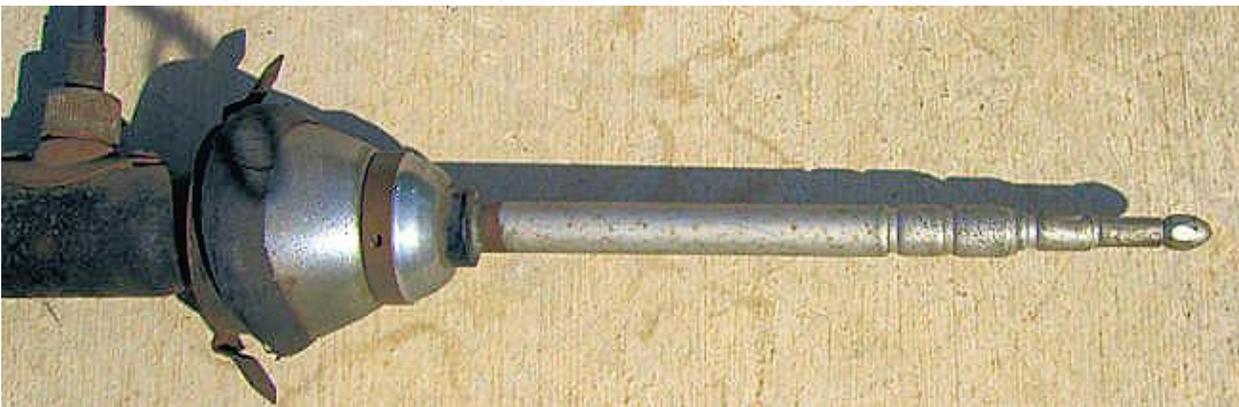
The mast itself is made up of five pieces, that taken in total reach an overall dimension of 70-1/2 inches in length when fully raised, or 20-1/2 inches in length when fully lowered (as measured from the bottom of the mast assembly to the tip of the mast. Note: 14 inches of the mast length remains below the top grommet within the antenna mast tube, so the visible portion of the mast when installed on the vehicle is that much shorter). The five pieces consist of three chrome plated telescoping tubes, a solid stainless steel rod (with a nylon lead attached to its bottom), and a chrome plated brass mast tip screwed to the top of the stainless steel rod.

During operation of the antenna, the largest diameter tube remains stationary, with the other sections sliding up and down telescopically inside each other. This outer (largest) tube has two 1/8" wide grooves near the top, as well as a 1/16" wide "half groove" at its very tip. The next two telescoping tubes simply slid in and out. The larger of the two has a single groove near the top, and a "half groove" at its very tip, and the smaller of the two has a single groove near the top, but no half groove at its tip. Instead, the smallest tube has a rolled upper edge at its tip with a hole sized to fit the diameter of the final mast section, the solid stainless steel rod. It's this final mast section, the solid stainless steel rod,

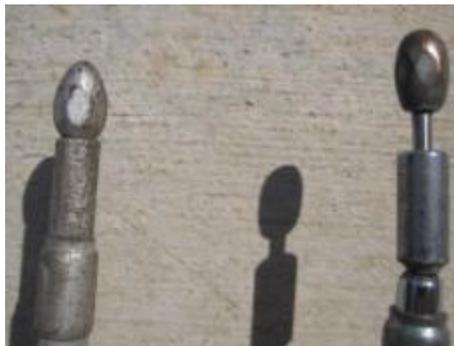
There are slight differences in the mast tip from antenna mast to antenna mast. The tip most commonly acknowledged as being "correct" for 1955-56 Pontiac is the one shown on the left in the below photo.

Other tips include a "replacement mast" tip that is similarly shaped to the "technically correct" tip (see tip shown in photo above on the right vs "correct" tip on left), and a small sphere which is commonly used on many antenna masts of the period. But only a total purist would fault a restorer for the wrong antenna tip, eh?

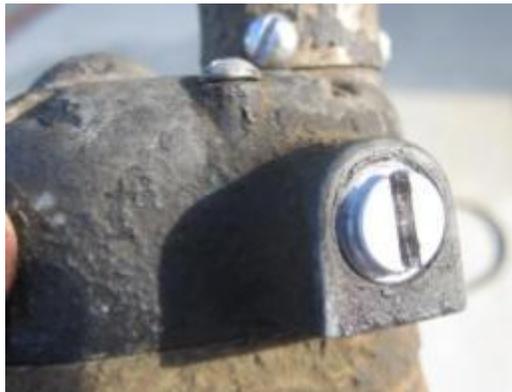
Reinstall the adjustment screw and spring, screwing down to the point where all the screw threads are in the case, but the end of the adjustment screw still protrudes slightly out from the screw hole (about 3/32").

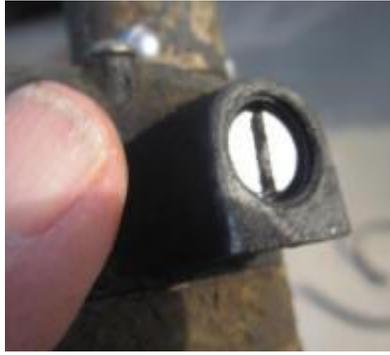
Turn the adjustment screw for 7 one-half turns (counting them off a half turn at a time). The adjustment screw should now be about halfway down in the hole.

Bench test the antenna at this point for smoothness of operation of the mast. The mast should raise and lower smoothly without hesitation or pausing. If any slipping is noticed, further tighten the adjustment screw a half turn at a time, retesting for smooth operation after each half turn until satisfactory smooth travel is achieved.
