# PONTIAC

## Service Craftsman News

No. 3 S-270

# ELECTRIC WINDOW REGULATOR SERVICE INFORMATION

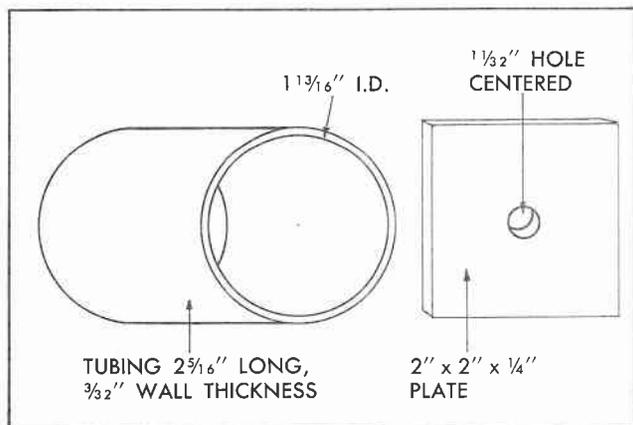
Fig. 9 Seal Bellows Installation Tool

On some early model compressors it may not be possible to install the seal bellows assembly using the fingers only. In this case make the installation tool shown in Fig. 9 and install as shown in Fig. 10. Hold the head of the bolt and tighten the nut so that the spacer forces the seal bellows assembly into position.

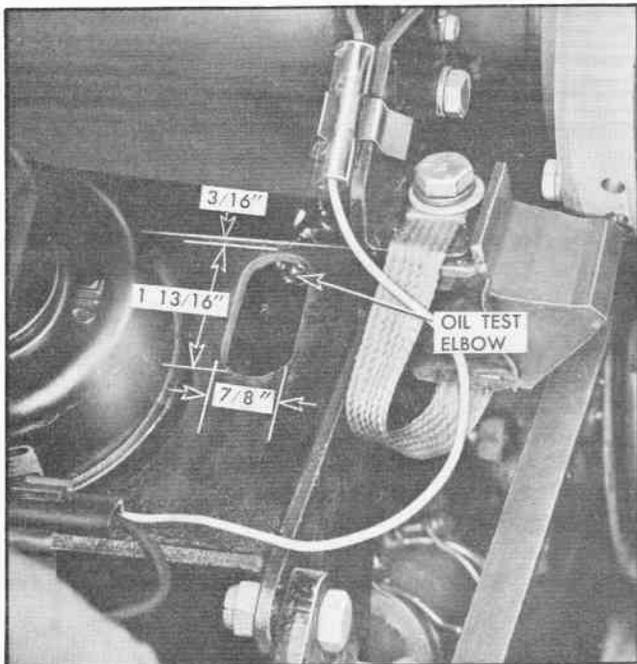
Fig. 12 Slot Cut in Compressor Mounting Bracket

Cut a slot in the compressor mounting bracket to allow a gauge line and Schraeder adapter J-5420 to be attached to the oil test elbow. The slot should start  $3/16$ " from the compressor edge of the bracket and be  $7/8$ " wide and  $1\ 13/16$ " long. (See Figure 12). One method of making the slot is to drill two  $7/8$ " holes  $1/16$ " apart and then cut the web from between them with a cold chisel. The suggested time allowance for cutting this slot is .6 hrs.

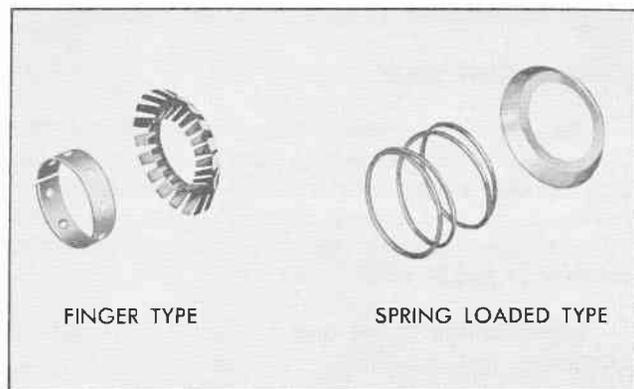
Fig. 14 Power Brake Secondary Seal Expanders

Temporarily a spring loaded expander (Fig. 14) was used in production. This expander is used without a spacer.

A finger type expander (Fig. 14) is the latest type and the only one which will be serviced. When the spring loaded type is encountered it may be re-used or the finger type can be used.

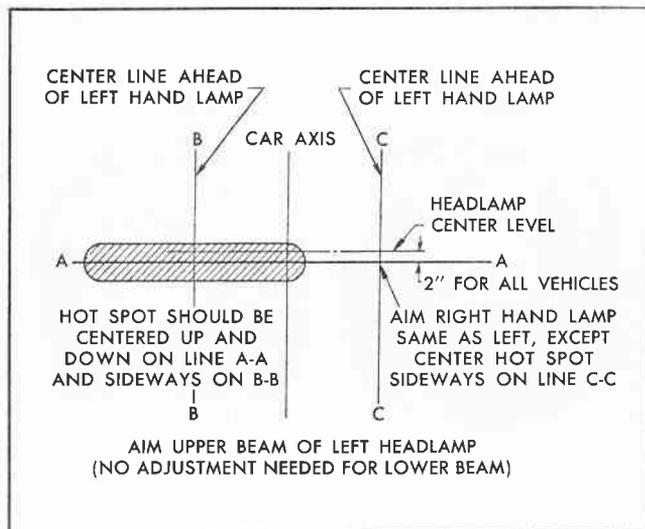
Fig. 16 Headlamp Adjusting Chart

Aiming procedure on the new unit is the same as given in the 1949-1954 Pontiac Shop Manual with the exception that line A-A on the headlamp adjusting chart is now 2 inches below the headlamp center level instead of 3 inches. (See Fig. 16).
