Service Craftsman News

No. 11 S-278

December, 1955

4-BARREL CARBURETOR CHANGES

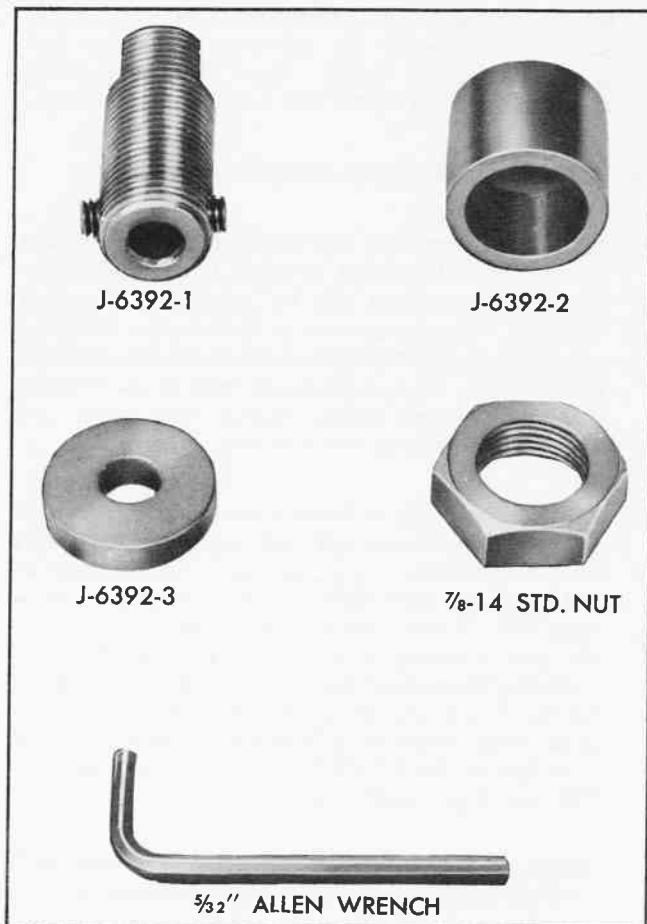
Fig. 2 Rocker Arm Stud Remover J-6392

To aid in removing rocker arm studs when replacement is needed tool J-6392, Rocker Arm Stud Remover (Fig. 2), has been made available through Kent-Moore Organization. The tool is applicable to 1955 and 1956 models and is especially valuable for removing broken rocker arm studs which defy ordinary methods of removal. Following are complete instructions for the use of this tool:
