PONTIAC

Service Craftsman News

No. 7 S-285

July, 1956

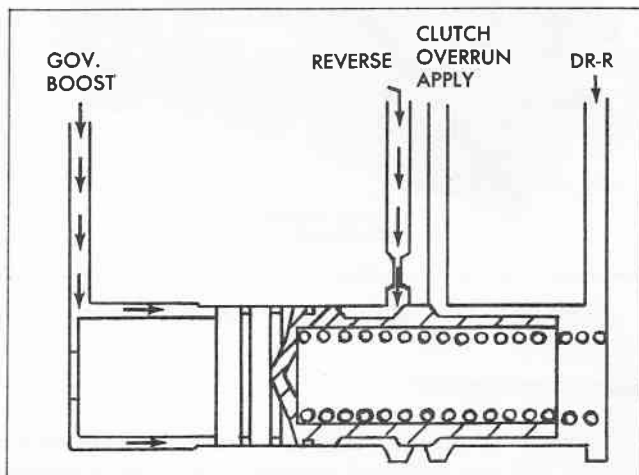
The overrun clutch valve is now controlled by governor boost pressure on one end working against a spring at the other end. At speeds under approximately 5 MPH the spring holds the valve to the left cutting off reverse oil to the overrun clutch (Fig. 1). Eliminating the overrun clutch application prevents starvation of the reverse clutch when shifting to reverse since it is not necessary to fill the relatively large volume behind the overrun clutch piston. A much firmer reverse clutch application results, which eliminates the grunt which was previously noticed in some transmissions. At speeds above 5 MPH the overrun clutch valve moves to the right to allow application of the overrun clutch (Fig. 2).

Fig. 1 Overrun Clutch Valve Below 5 MPH

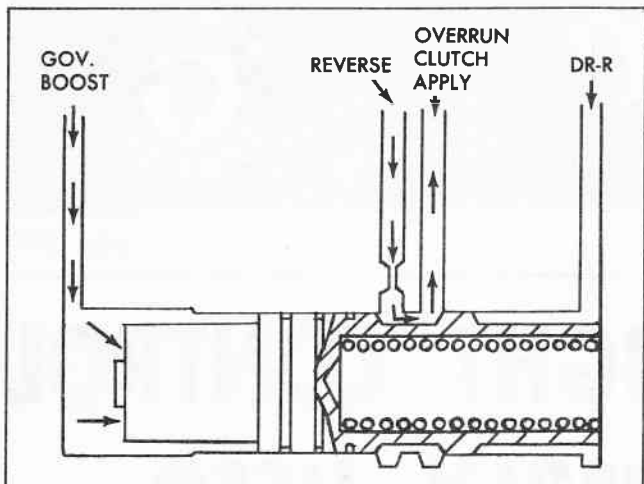
Fig. 2 Overrun Clutch Valve Above 5 MPH

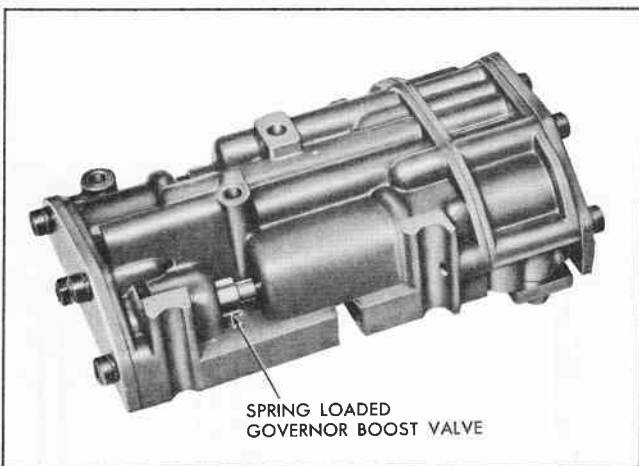
Fig. 3 Second Type Service Shift Valve Body

The 2nd type service shift valve body has the new governor boost valve with the spring which results in higher governor boost pressure than in the 1st type. If this 2nd type is installed on an assembly having the 1st type overrun clutch valve body, the spring must be removed from the governor boost valve so that it will put out the proper pressure to operate the early type coupling valves.

Service parts can be identified by the part numbers listed above. Visual inspection of the shift valve body on the transmission will show whether it is the 2nd type (with spring) or the 1st type (no spring). The valve will appear as shown in Fig. 3 on the 2nd type and the spring tension can be felt. On the 1st type the valve may or may not be visible, but it will be obvious that there is no spring tension.

When the 2nd type service overrun clutch valve body is installed in place of the 1st type, the shift valve body must also be changed to the 2nd type.

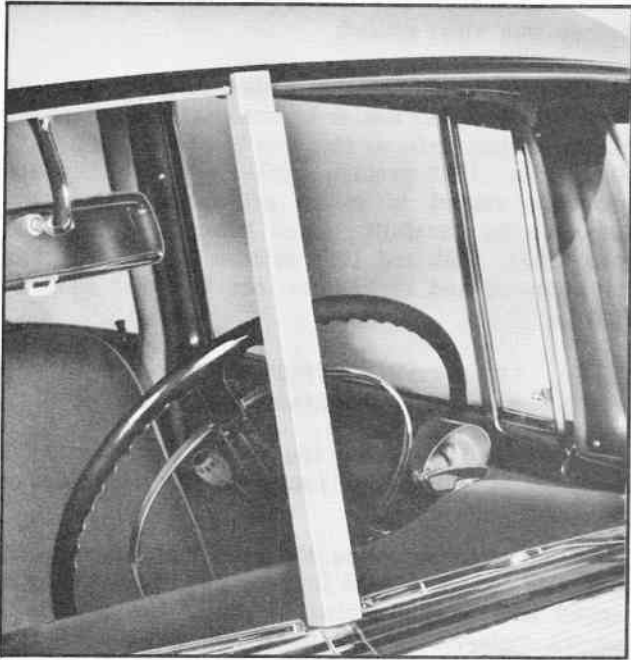
To aid in correct installation, it is necessary that a wooden gauge, as shown in Fig. 9, be used. Quiet visor installation cannot be made without this gauge. The gauge can also be used to check existing installations for correct dimensioning. Note that the gauge is so designed that it can be used on all models by merely changing sides. Fig. 10 shows the gauge position for measuring the height of leading edge of the visor on a four-door sedan. On a Catalina or Custom Station Wagon the other notch would be used.

Fig. 10 Gauge Position on 4 Door Sedan

at the rear center. In this instance the gauge should not enter between the roof and visor.
