PONTIAC

Service Craftsman News

No. 4 S-293

April, 1957

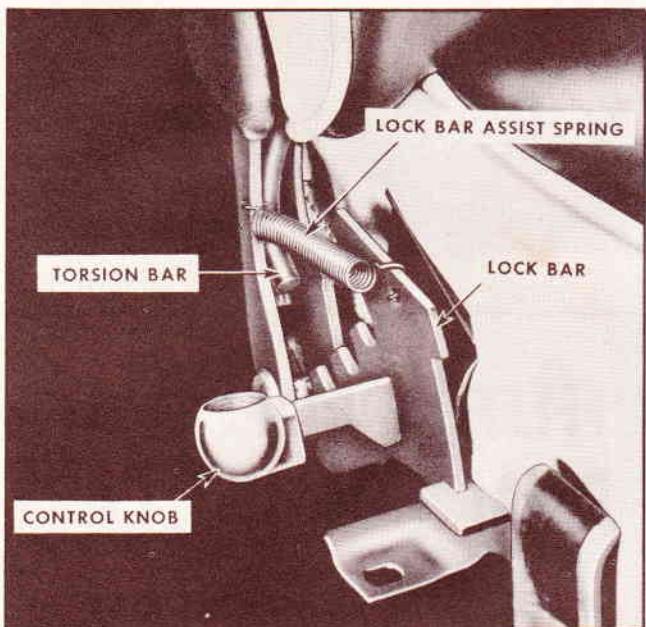
Fig. 2 Reclining Seat Back - Side View

1. Remove seat assembly including seat adjusters and place on a protected surface.
2. Remove right seat side panel and right seat back outer panel.
3. Remove lock bar assist spring, Fig. 2.
4. Remove trim protector plate and lock bar and support assembly secured by four (4) bolts, shown in Figures 3 and 4.
5. Remove cap nut securing inner hinge pin to hinge pin support.
6. With reclining seat back assembly in normal position, disengage seat back outer hinge arm torsion bar shown in Fig. 2.
7. With seat back outer hinge arm disengaged from torsion bar, carefully hold seat back outward to disengage from hinge pin, then remove seat back assembly from body.

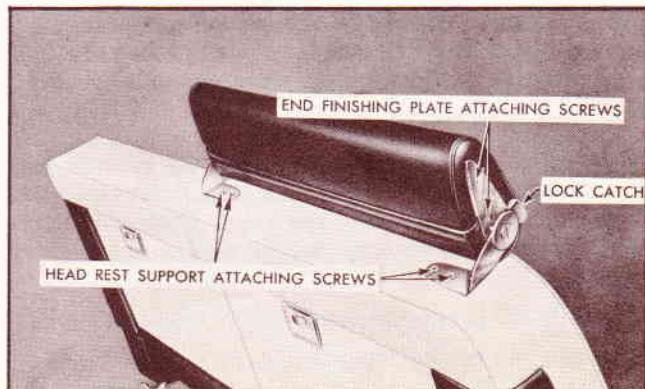
Fig. 5 Reclining Seat Back Head Rest Removal

1. Raise head rest to the rest position, as shown in Fig. 5.
2. Remove screws securing head rest supports to seat back assembly, Fig. 5 and remove assembly from seat back.
3. To remove head rest inner support assembly or head rest outer support and lock assembly, remove head rest end finishing plate attaching screws, Fig. 5 and remove assembly from head rest.
4. To install head rest supports and head rest assembly, reverse removal procedure.

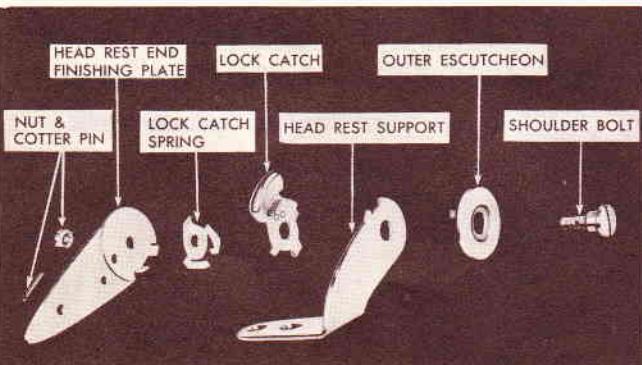
Fig. 6 Head Rest Outer Support and Lock Assembly

1. Remove front seat back head rest assembly (including supports) from reclining seat back.
2. At end of head rest from which support is being removed, remove head rest end finishing plate attaching screws, Fig. 5 and remove support assembly from head rest.
3. Remove cotter pin and the nut which secures component parts of outer support and lock assembly and/or inner support assembly (See Figs. 6 and 7). Disassemble the entire assembly.
4. To assemble reclining seat back head rest outer support and lock assembly and/or inner support assembly, reverse removal procedure. Assemble component parts in order shown on Figs. 6 or 7.

IMPORTANT: Cotter pin should be installed so that ends of pin do not extend more than $1/16''$ beyond sides of nut. This is to allow clearance for installing nut end of support assembly into head rest assembly.
